Docket No. 272 – Development and Management Plan Inspection

Segment 1a Inspection

Date: September 29, 2008

Location: Segment 1a – Scovill Rock Switching Station to Chestnut Junction, Oxbow Junction to Beseck Switching Station (excluding Royal Oak Bypass), and Black Pond Junction to Beseck Switching Station

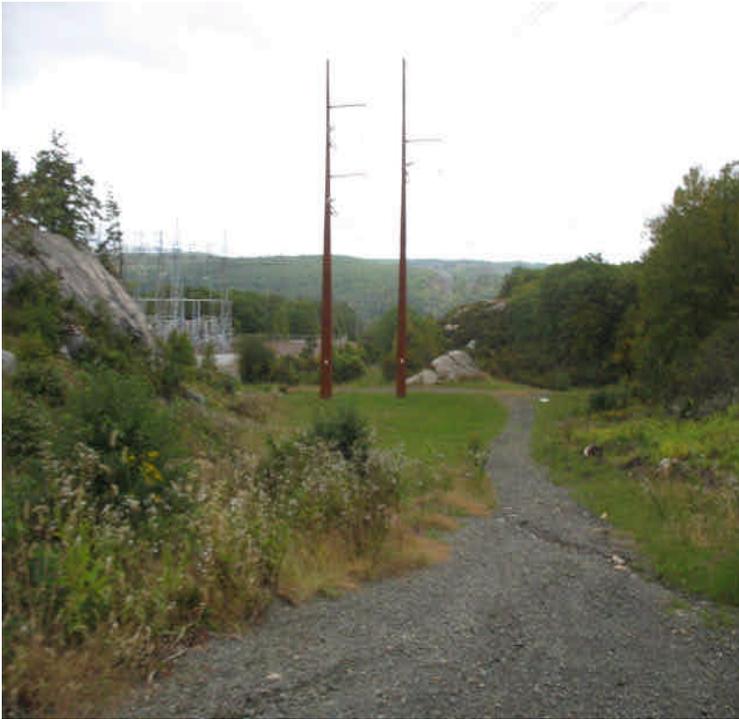
Oxbow Jct: Pad upgradient from Oxbow has is stable with at least 70% vegetative cover.

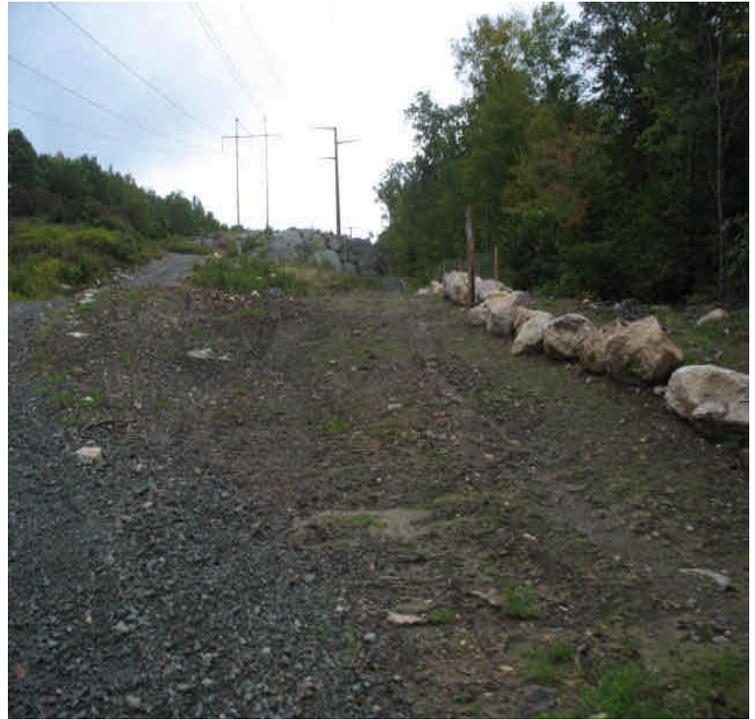
Route 9 towards Oxbow: Several areas of exposed soils need seed. Access road upgradient to this slope has several small washouts/gullies

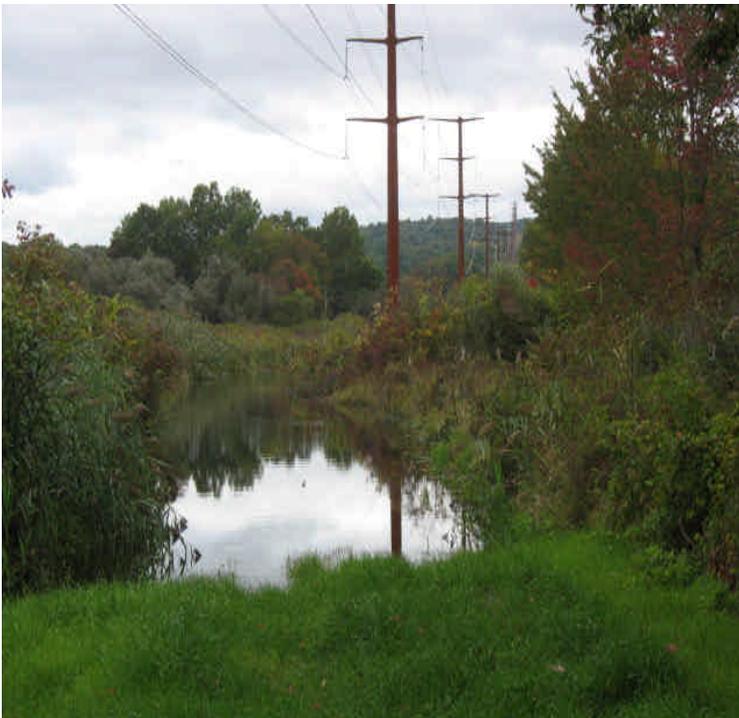
Durham Rd: Access road remains at final grade. Areas of exposed soil here are regularly flooded and will be difficult to stabilize the traditional way with seed and mulch.

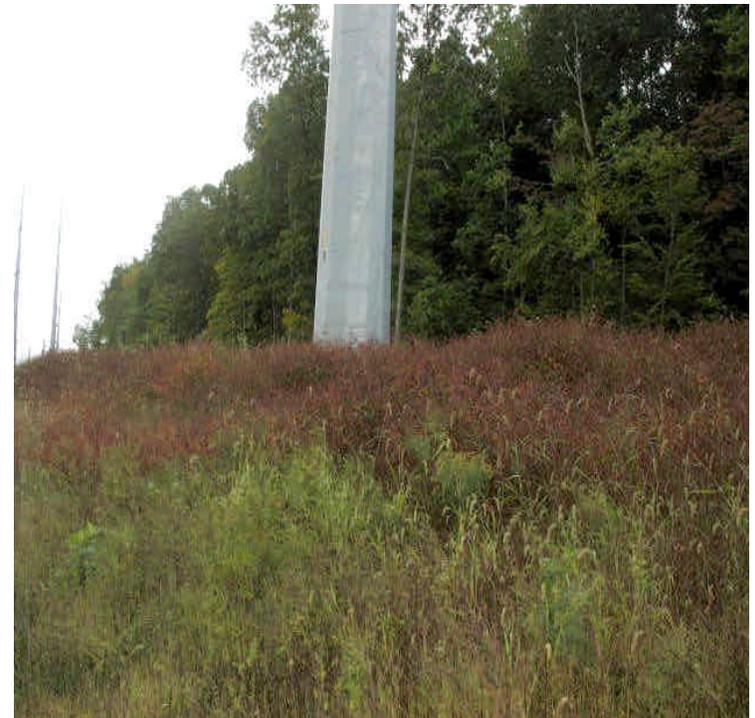
North of Beseck: Previously sparse areas along the slope have filled in with vegetation and are now stable.
