Docket No. 272 – Development and Management Plan Inspection

Segment 1a Inspection

Date: October 6, 2008

Location: Segment 1a – Scovill Rock Switching Station to Chestnut Junction, Oxbow Junction to Beseck Switching Station (excluding Royal Oak Bypass), and Black Pond Junction to Beseck Switching Station

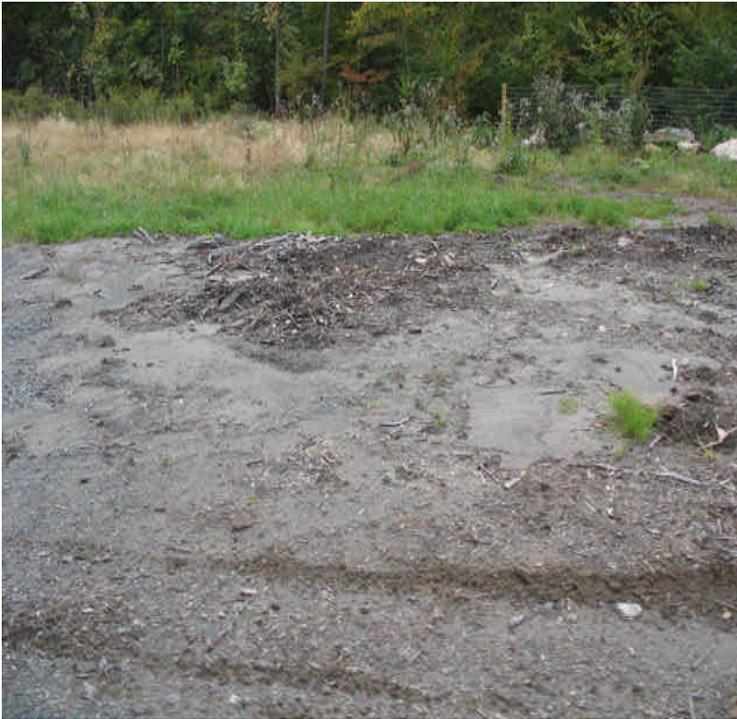
Route 9 towards Oxbow/Chestnut: Some small rills and washouts were noted along the slope of the access road.

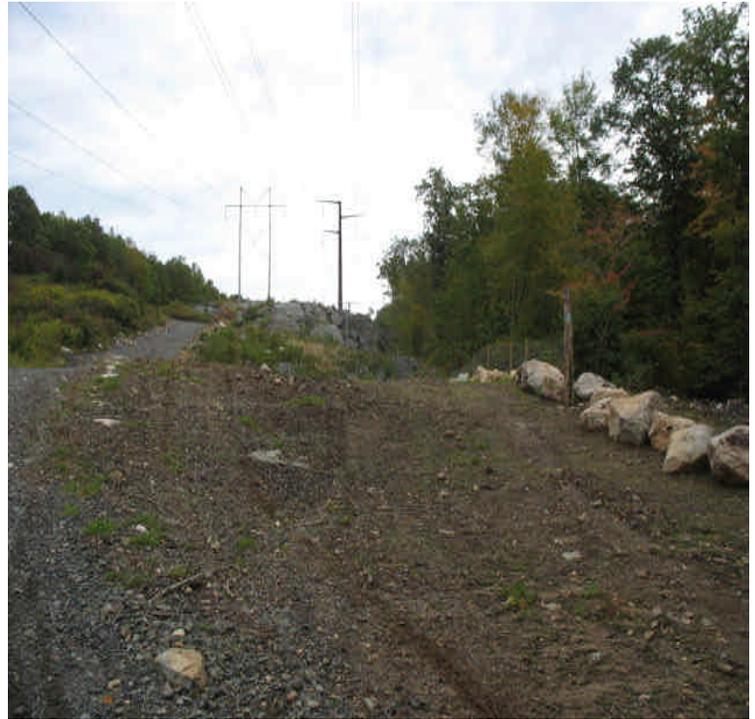
Route 9 towards Oxbow/Chestnut: Several areas of exposed soils need additional seed. Access road upgradient to this slope has several washouts/gullies.

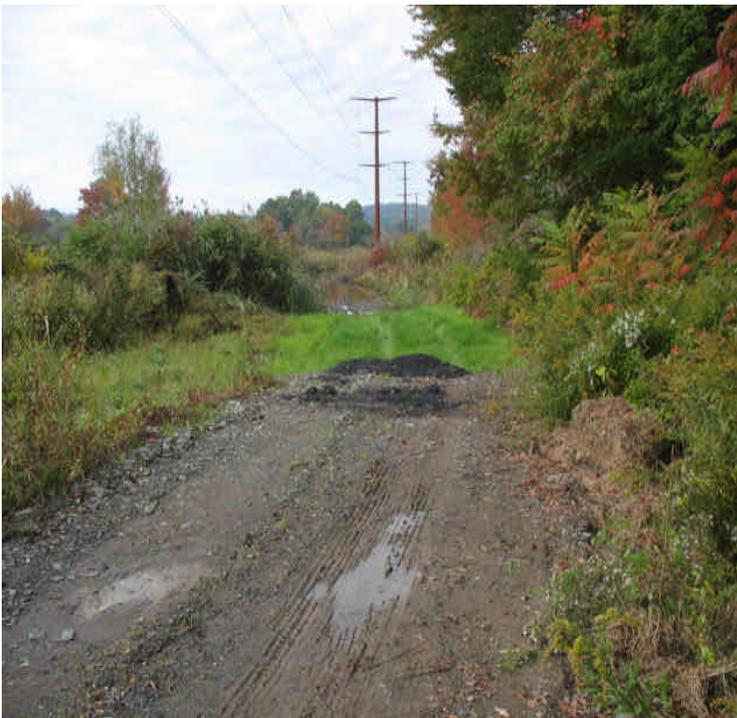
Areas of Inspection	Observation	Recommended Action	Corrected Action
Additional Observations	A pile of asphalt that is not related to project was observed at the access road within Durham Meadows. 10/6/08	If feasible, remove the material and attempt to restrict access to unauthorized vehicles. 10/6/08

Durham Rd: Area adjacent to the flooded portion of the wetland has vegetative cover. A small pile of asphalt that was not related to the project was noted at the end of the access road. If feasible, remove the material and prevent unauthorized access.

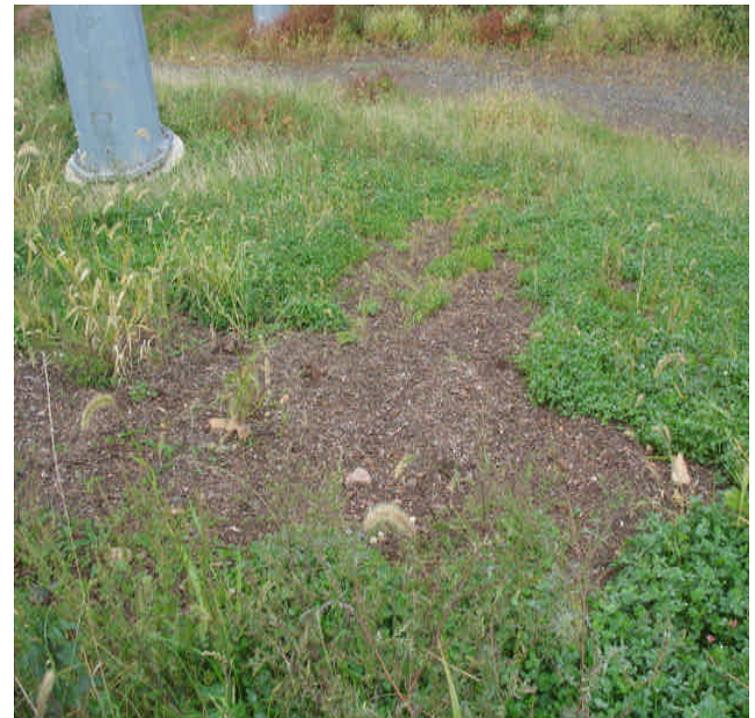
E. Meriden SS: A previously sparse has filled in with vegetation/mulch and is stable.
