Docket No. 272 – Development and Management Plan Inspection

Segment 1b (Royal Oaks Bypass) Inspection

Date: January 15, 2008

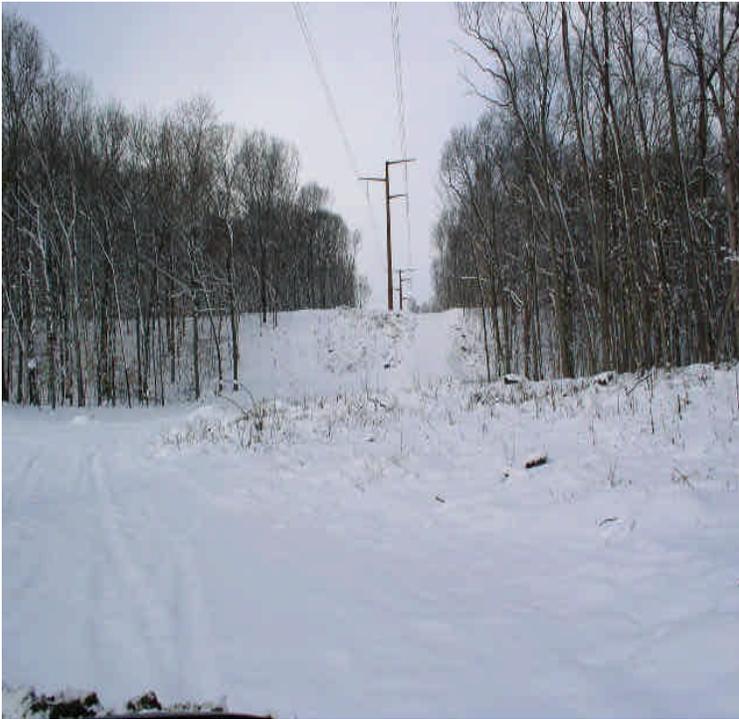
Black Walnut Dr. entrance is currently under snow cover and temporarily stable.

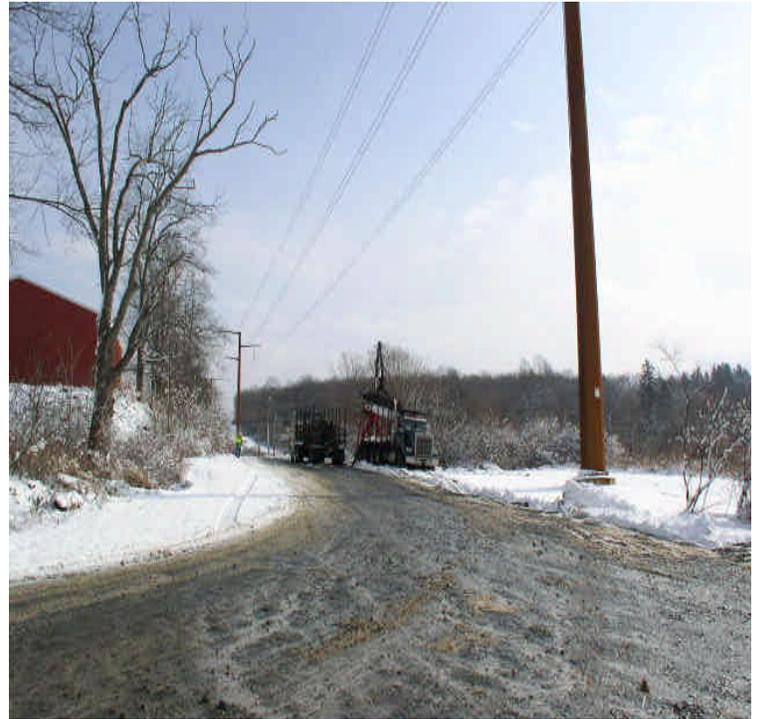
Contractor receiving yard entrance. Crews were removing timber mats at this time.

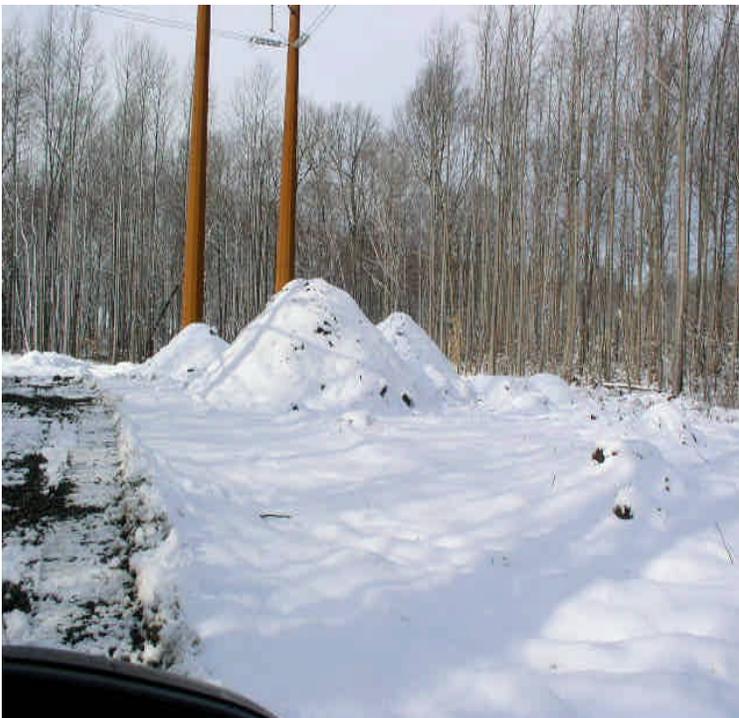
Areas of Inspection	Observation	Recommended Action	Corrected Action
	1/15/08 Most of the soil stockpiles noted along this segment have been removed. However, two stockpiles were noted at the edge of the wetlands near the receiving yard. 1/7-1/15/08	1/15/08 Monitor and add controls as needed. Ensure soil is no stockpiled with 100 feet of wetlands. See erosion control section. 1/7-1/15/08	Most stockpiles have been removed. Two near wetlands need attention.
Additional Observations	None. 1/15/08	None. 1/15/08	NA

Soil stockpiles remain near the edge of the wetlands near the receiving yard. Ensure that controls are in place and stockpiles are not stored within 100 feet of wetlands where feasible.

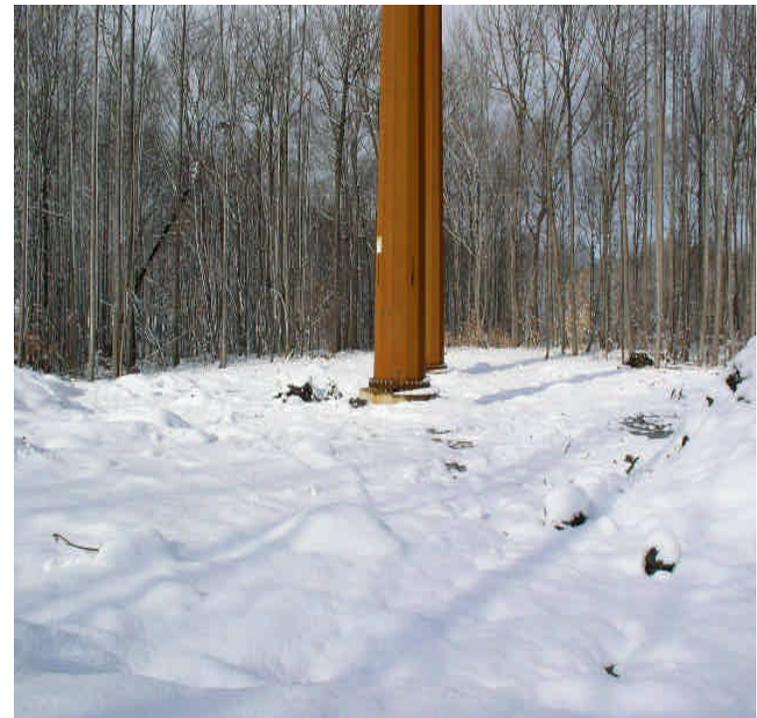
Stone pad appears to be removed and graded but further evaluation will be needed when snow cover is gone.
