Docket No. 272 – Development and Management Plan Inspection

Segment 1b (Royal Oaks Bypass) Inspection

Date: February 4, 2008

Location: Segment 1b (Royal Oaks Bypass)

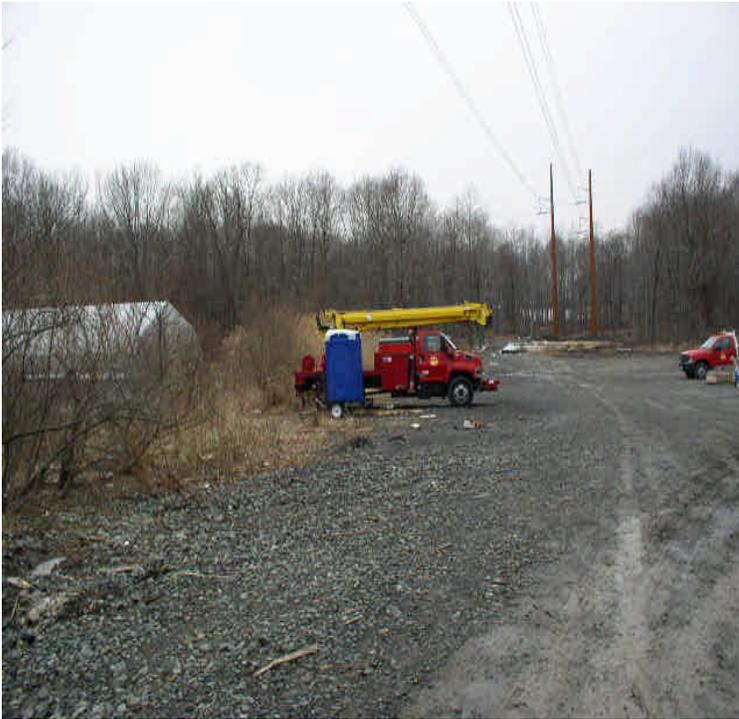
Sanitary facility located upgradient from wetlands should be moved to a location over 100 feet from resource areas.

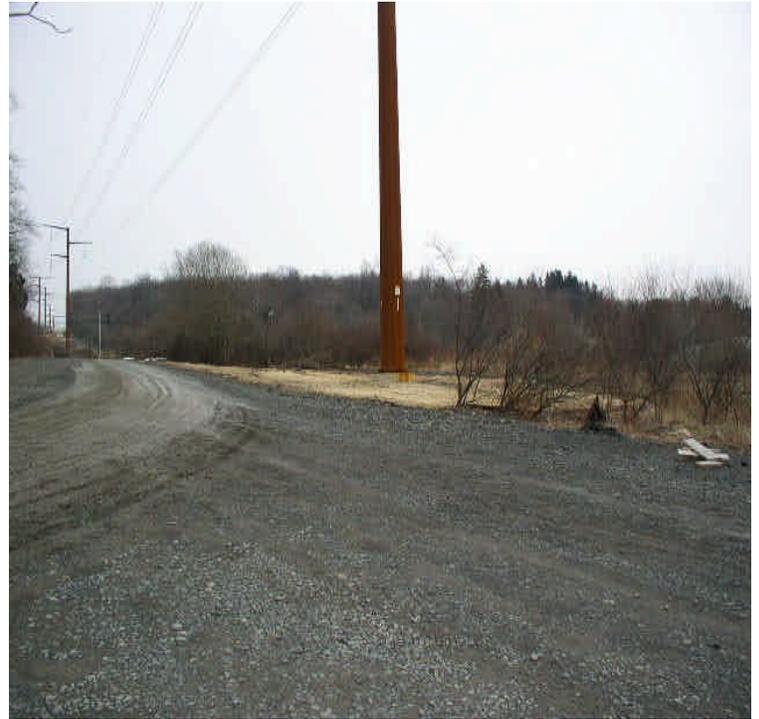
Exposed/restored area within the receiving yard has been mulched and seeded.

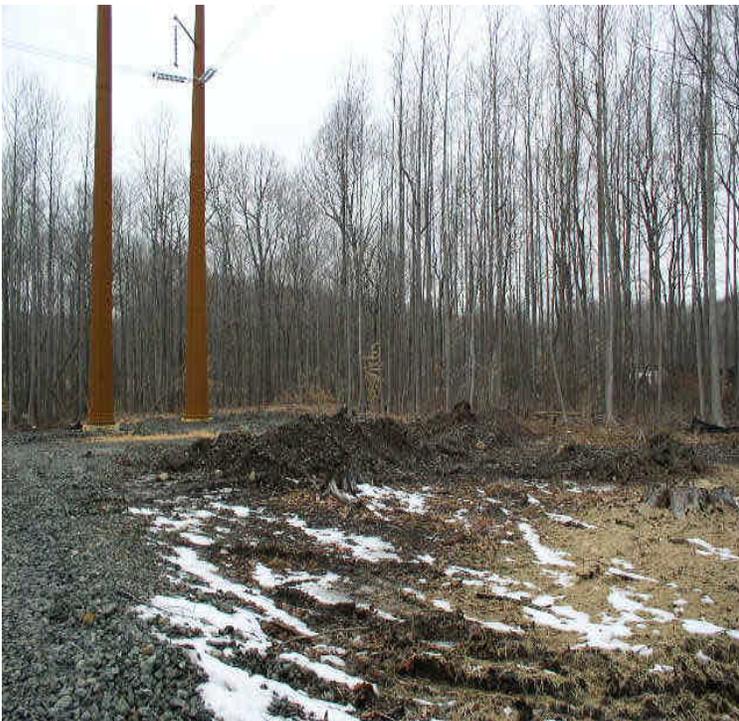
Soil stockpiles and disturbed areas remain at the turn in ROW, adjacent to the receiving yard.

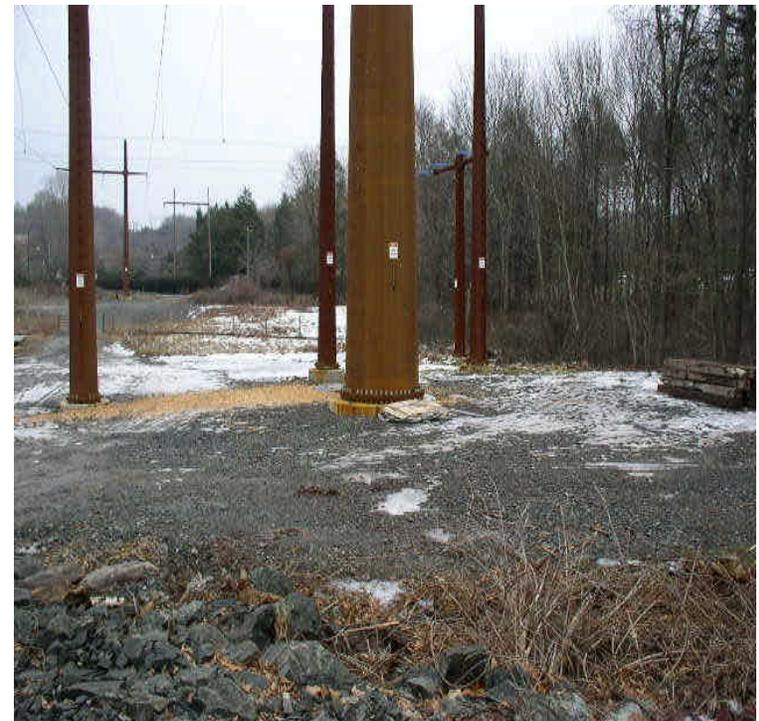
Little Lane: Minor tree trimming from last week is complete. Area is stable for the winter.
