**Docket No. 272 – Development and Management Plan Inspection**

**Segment 1b (Royal Oaks Bypass) Inspection**

**Date:** February 19, 2008

**Location:** Segment 1b (Royal Oaks Bypass)

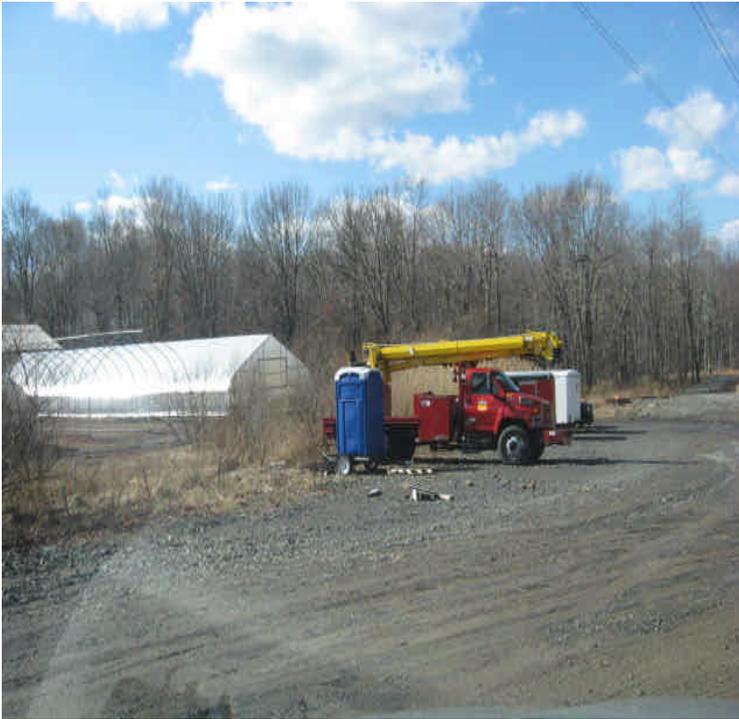
**Sanitary facility located upgradient from wetlands should be moved to a location over 100 feet from resource areas.**

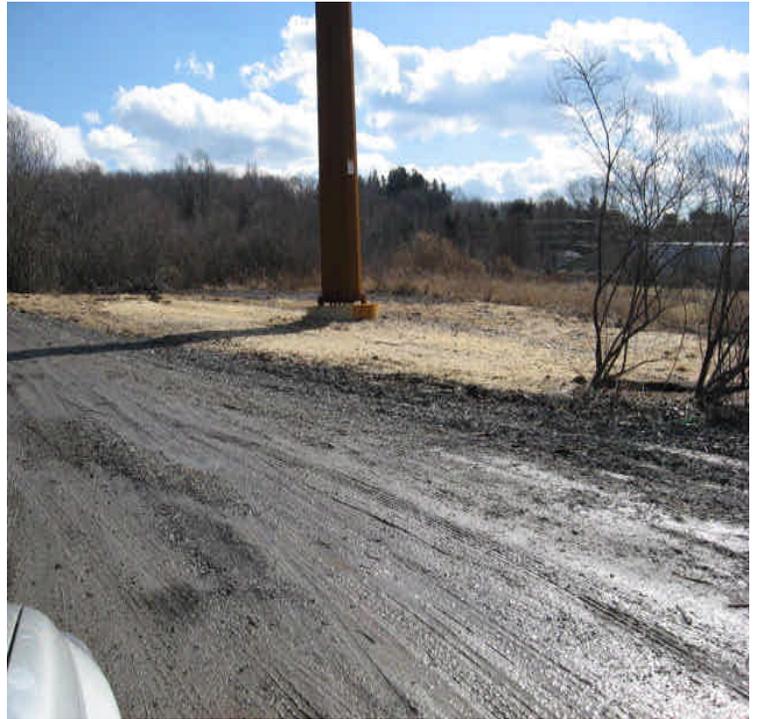
**Exposed/reclaimed areas have been mulched and seeded west of Rte 17 in the receiving yard.**

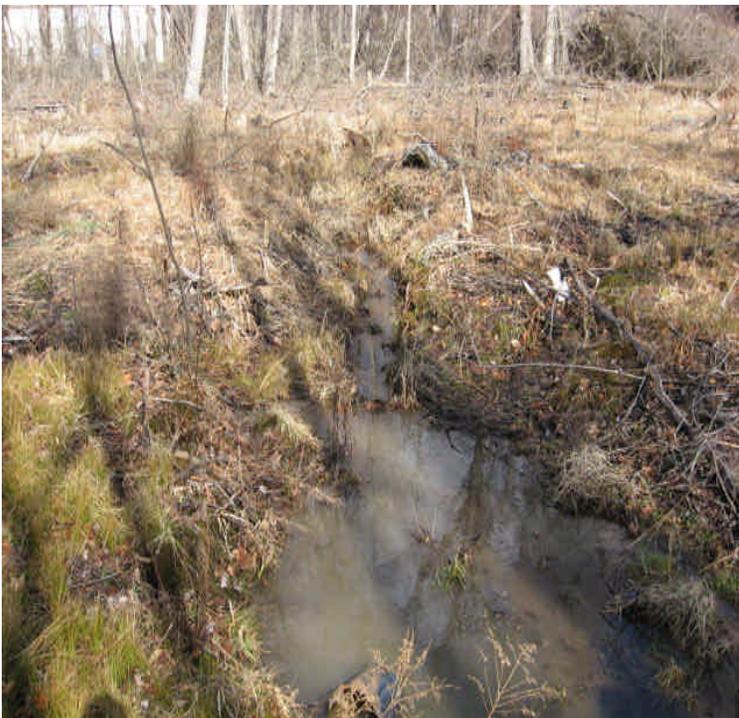
**Slightly turbid water was noted at the culverted crossing for the access road**

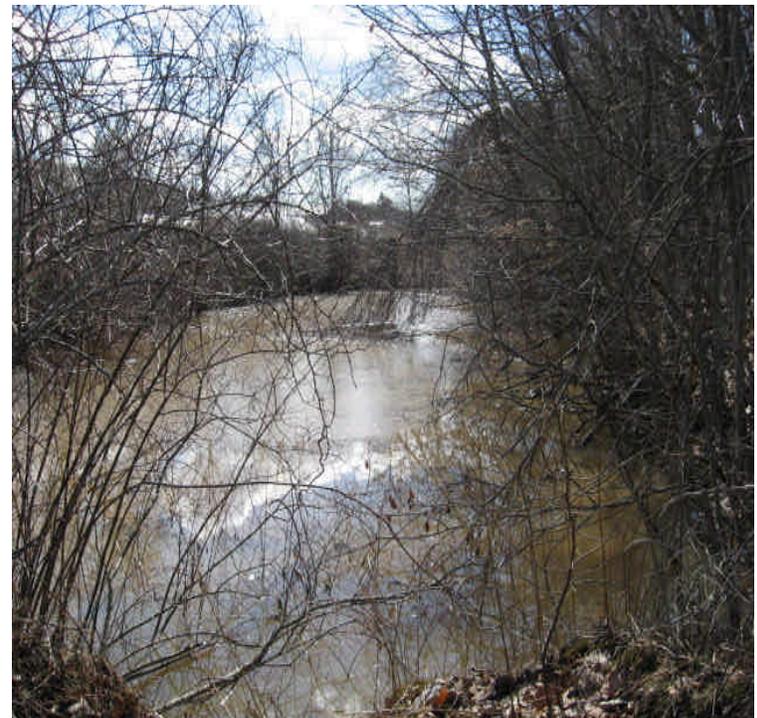
Areas of Inspection	Observation	Recommended Action	Corrected Action
	<p><b>heavy rains (12/31).</b></p> <p><b>The pond located adjacent to the receiving yard is turbid and flowing into the stream, which crosses under the access road. Controls around the pond are degraded and run-off from the yard is a potential source of the sediment. 2/19/08</b></p>	<p><b>Identify the source of turbid water in the pond. If run-off from the yard is resulting in the turbidity, address the controls. In the past, the adjacent landowner may have been pumping into/out of the pond, causing the turbidity. 2/19/08</b></p>	<p><b>Needs evaluation. Controls around the pond need attention. (also see 1A report)</b></p>
<p><b>Foundation and site construction</b></p>	<p><b>No new work has taken place this week. 2/19/08</b></p>	<p><b>NA</b></p>	<p><b>NA</b></p>
<p><b>Erosion and sediment controls</b></p>	<p><b>Culverts and controls are in place along the access road and pads within the receiving yard west of Rte. 17. Turbid water appears to enter the wetlands from a source below the substrate near the access road during rain events (noted since 1/16) and was recently noted from the overflow of the nearby turbid pond. 2/19/08</b></p> <p><b>Timber mats have been removed from east and west of Rte. 17 within the wetlands. 2/19/08</b></p> <p><b>Haybales, stone sediment traps, and/or fiber rolls were used to filter water flowing from the timber mats east/west of Rte 17. A channel with check dams remains along the access road east of Rte 17. 2/19/08</b></p> <p><b>Sediment was noted at the edge of the no access</b></p>	<p><b>Monitor this area closely as it is located within a protected watershed and ensure that controls are adequate. Reinforce controls as necessary and repair those that have deteriorated around the pond. (See 1A report). Locate the source of the turbidity and add controls as needed. 12/31-2/19/08</b></p> <p><b>Ensure sufficient stabilization for winter months during the reclamation process. Adjacent upland soils will need mulch and wetland contours should be carefully restored. 2/11-2/19/08</b></p> <p><b>Continue to monitor and stabilize disturbed areas when work is complete and activity will not return within 21 days. Add/maintain controls as necessary. Ensure sufficient stabilization for winter months. 2/19/08</b></p> <p><b>Add controls as necessary and begin restoration on</b></p>	<p><b>Needs attention</b></p> <p><b>Turbid water entering the wetland during storms.</b></p> <p><b>NA at this time until conditions allow.</b></p> <p><b>NA at this time</b></p> <p><b>Area needs monitoring and evaluation.</b></p>

**The pond adjacent to the contractor receiving yard is turbid. The turbidity noted in the stream at the access road crossing is flowing from this pond. Controls adjacent to the pond are degraded and it needs to be evaluated whether run-off from the yard is the source of turbidity**
