Docket No. 272 – Development and Management Plan Inspection

Segment 1b (Royal Oaks Bypass) Inspection

Date: April 21, 2008

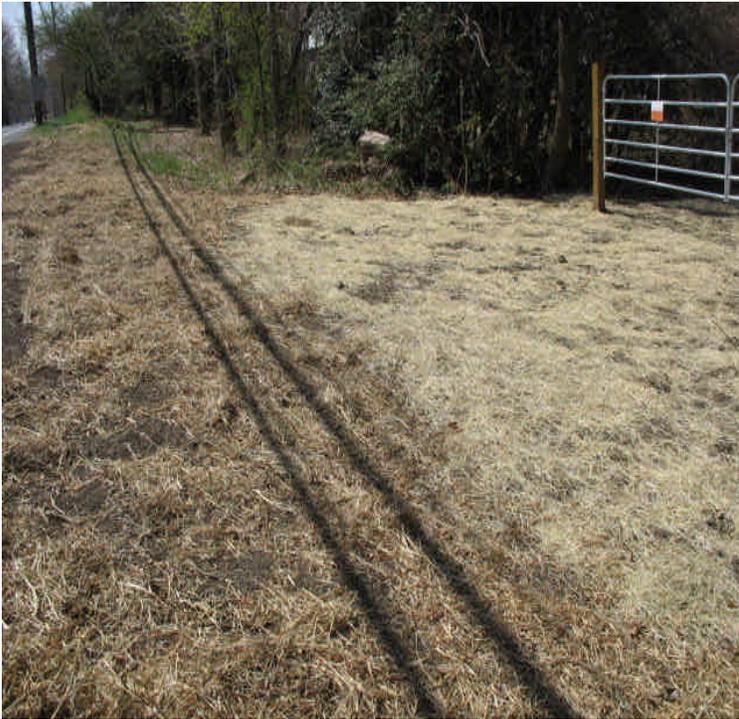
View of site entrance off Rte 17 north of Little Ln and south of contractor yard to reach #24580. Hay, seed, and topsoil were applied to restore the area.

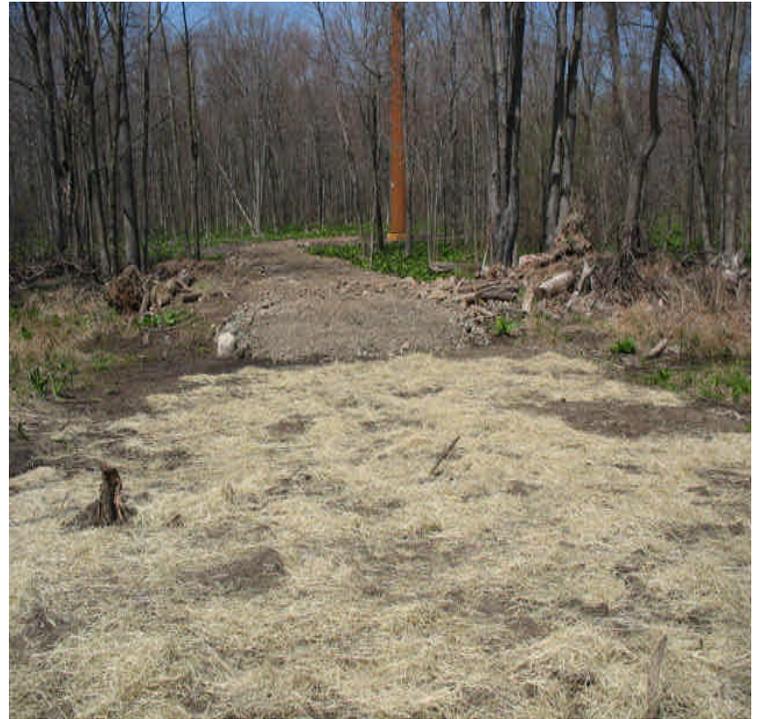
View of the reclaimed upland access road where it meets the wetland boundary and the new stone access to #24580 begins.

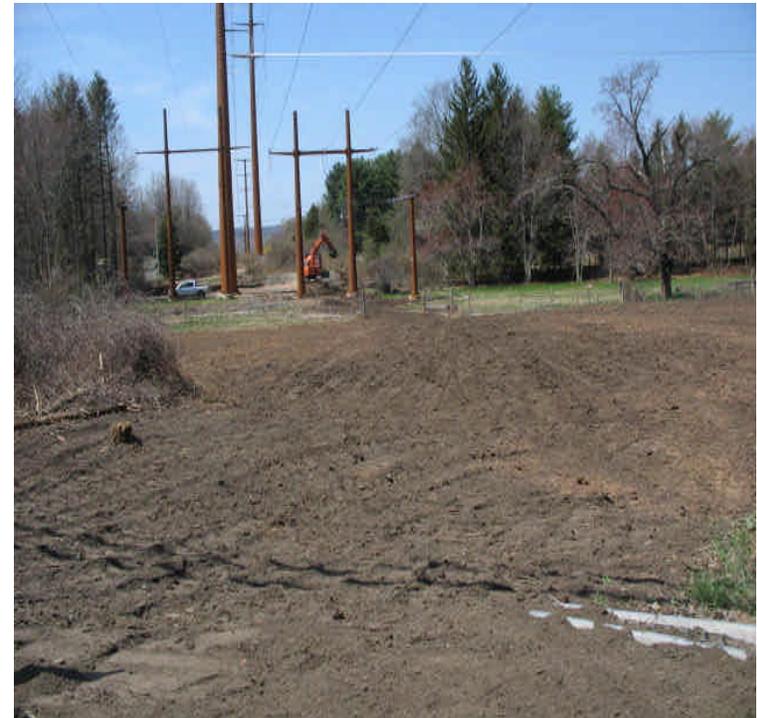
Timber mat removal and final grading from Rte 17 to Little Ln. Crews were stockpiling soils in the 1A ROW off Little Ln.
