**Docket No. 272 – Development and Management Plan Inspection**

**Segment 1b (Royal Oaks Bypass) Inspection**

**Date:** May 12, 2008

**Location:** Segment 1b (Royal Oaks Bypass)

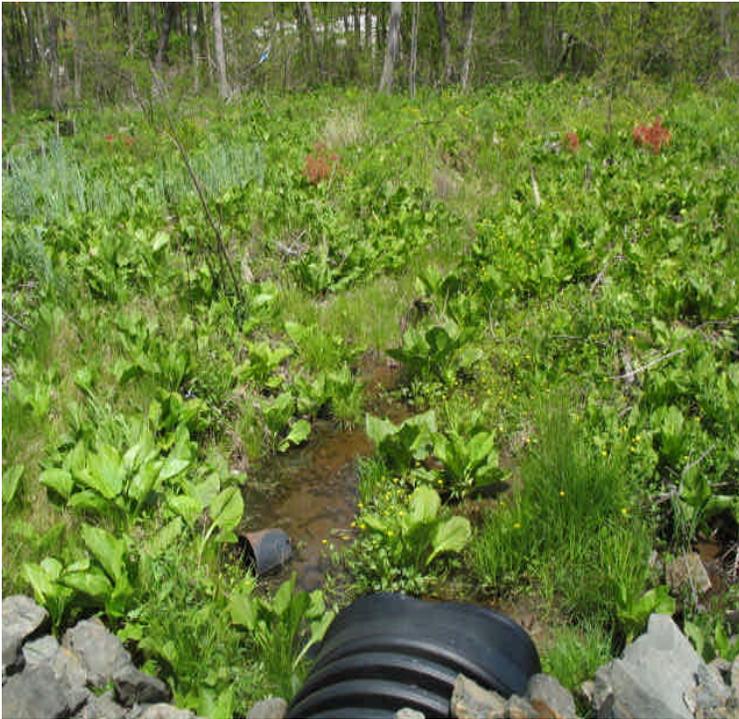
**Clear water and new vegetative growth noted in the wetlands adjacent to the contractor yard.**

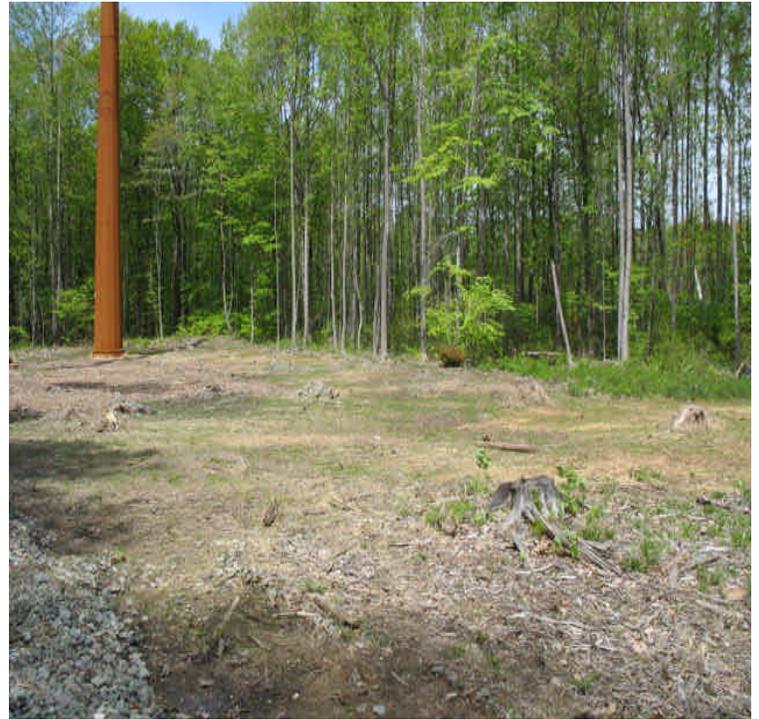
**Stockpiles and pad were removed/reclaimed at the CSC approved pull site. Controls will remain until final stabilization with vegetative cover occurs. Some grass growth was noted.**

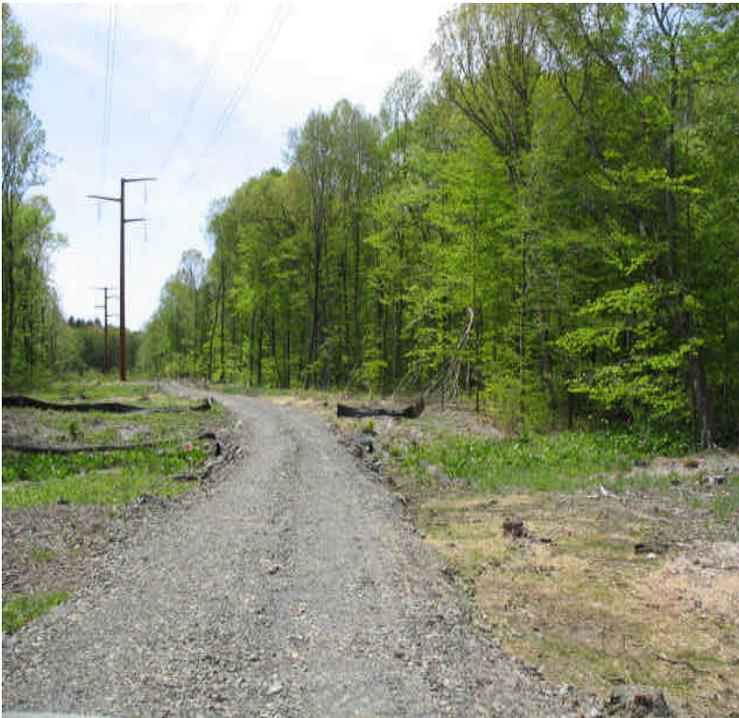
**View of permanent wetland crossings looking north toward Little Ln.**

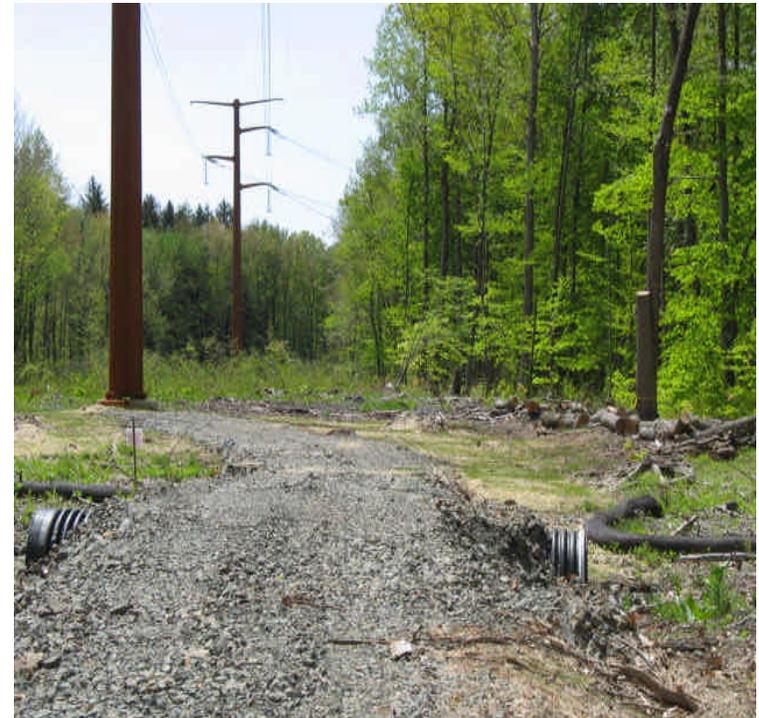
**Grass growth noted in the recently restored areas at the final pad site before the no access area.**
