Docket No. 272 – Development and Management Plan Inspection

Segment 1b (Royal Oaks Bypass) Inspection

Date: May 27, 2008

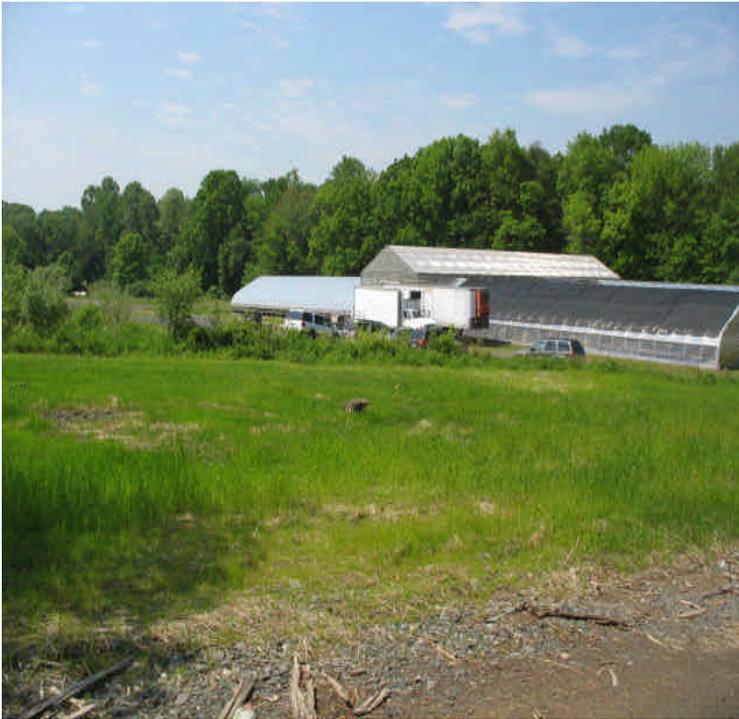
Grass growth noted at previously seeded area within the receiving yard.

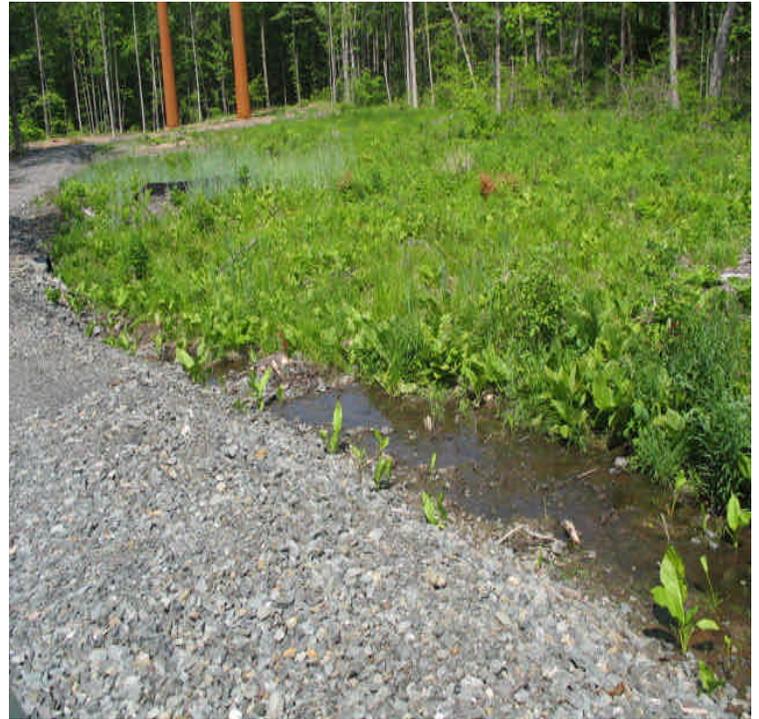
View of wetland crossing from the contractor yard. Establishment of vegetative cover is well underway.

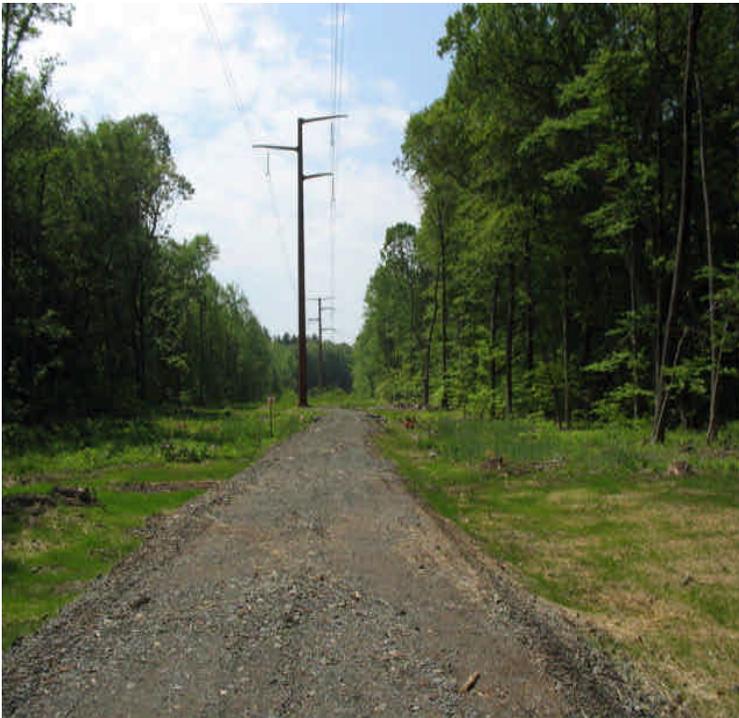
View of permanent wetland crossings looking north toward Little Ln. Vegetation was returning along the access road.

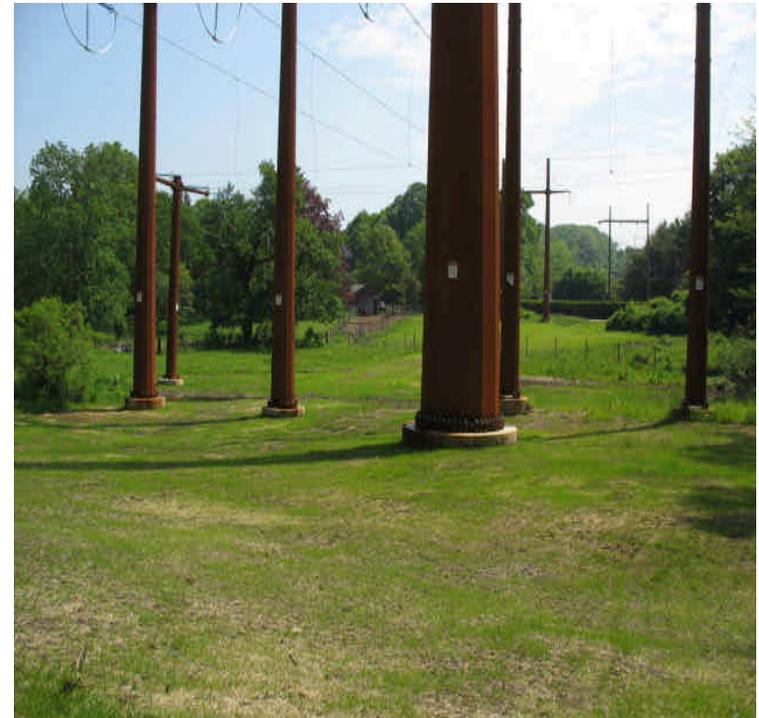
Grass growth noted at the reclaimed final pad site off Little Lane.
