Docket No. 272 – Development and Management Plan Inspection

Segment 1b (Royal Oaks Bypass) Inspection

Date: August 18, 2008

Location: Segment 1b (Royal Oaks Bypass)

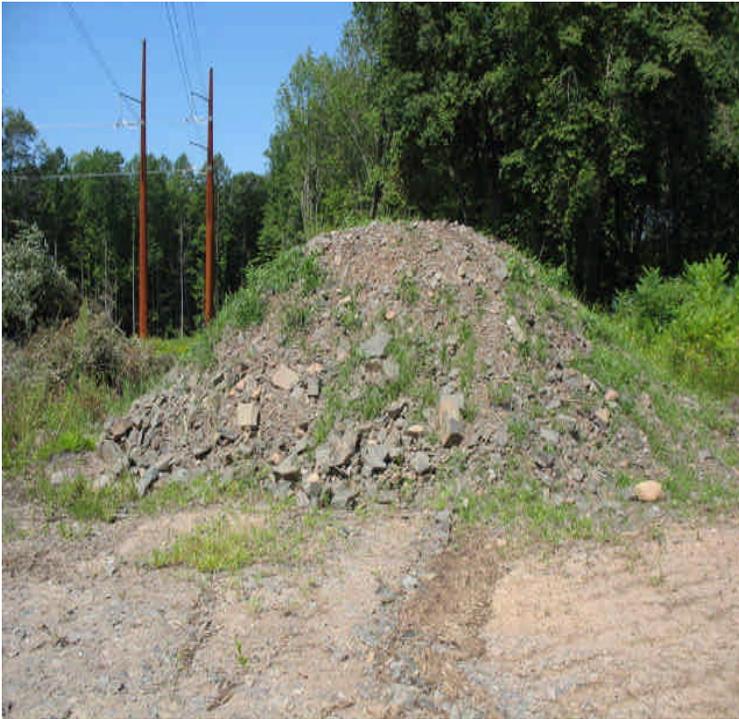
View of the stone/soil stockpile remaining in the contractor yard. Controls are in place but the pile is located just upgradient from wetlands and should be relocated.

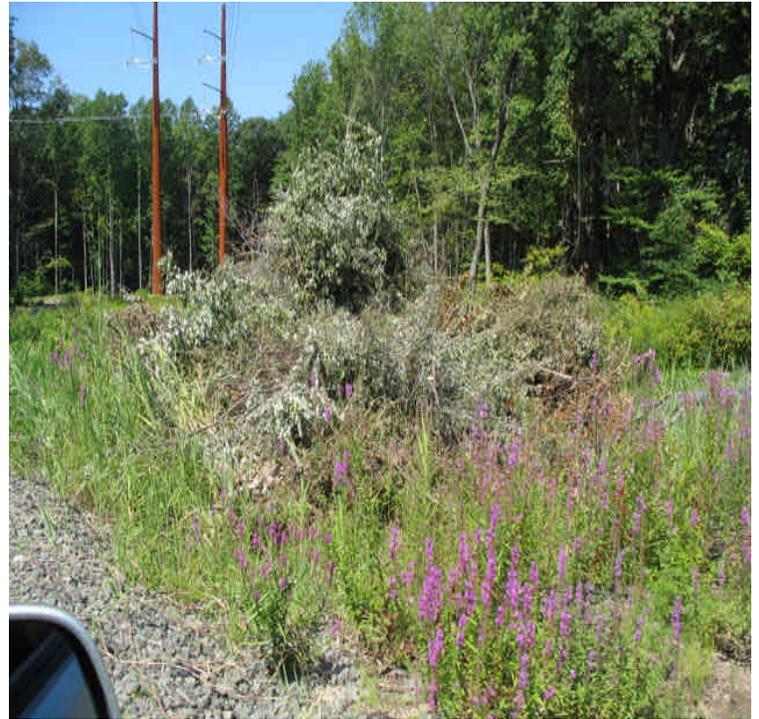
The private property owner at the old Contractor Yard has been performing non-project related clearing activities along the access road and has deposited shrubs just upgradient from the wetlands.

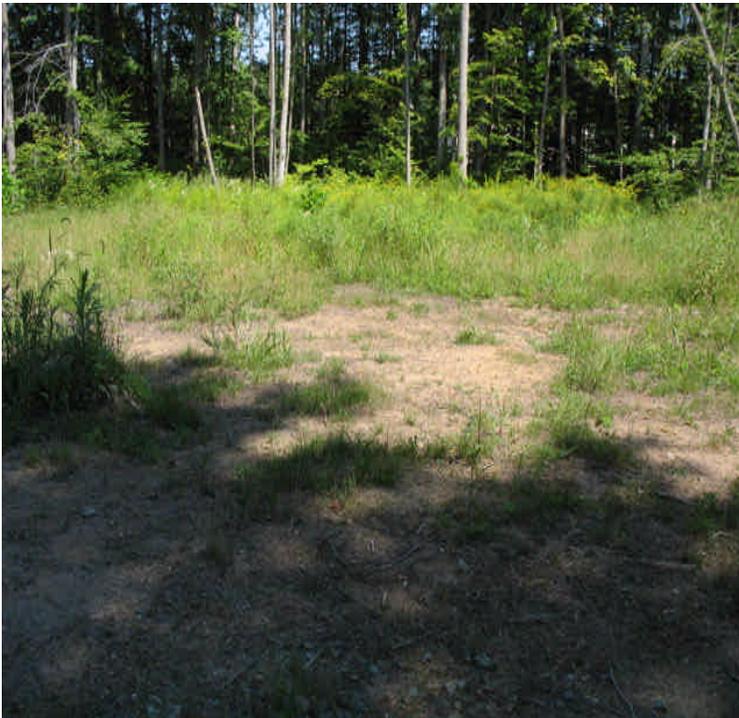
View of a small area of sparse vegetation located near the pad/angle structure at the turn in the ROW off the contractor yard.

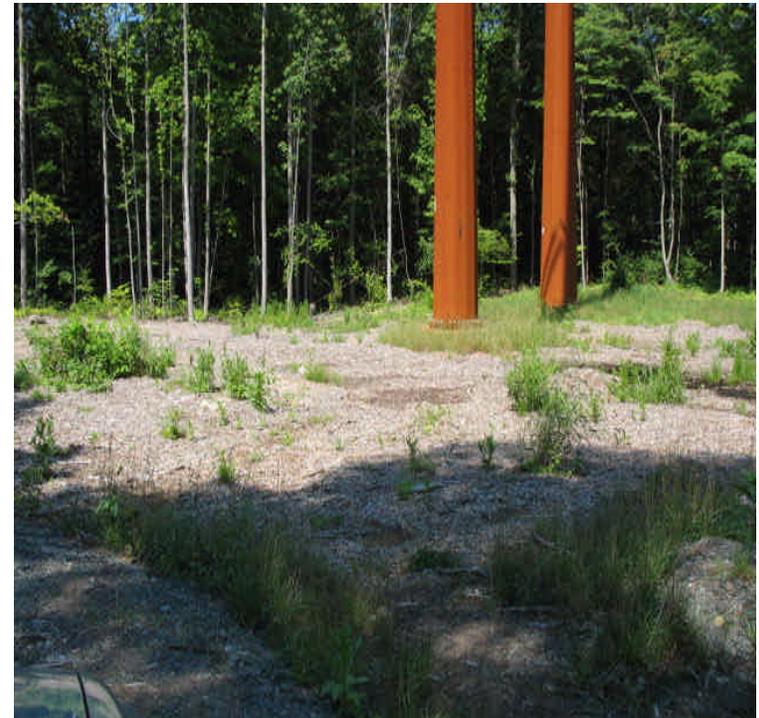
Another view of the pad/angle structure where vegetative cover is still sparse. The area remains stable with thick wood chips but vegetation will not be able to establish fully. The contractor plans to remove the chips and seed the area when feasible.
