Docket No. 272 – Development and Management Plan Inspection

Segment 1b (Royal Oaks Bypass) Inspection

Date: August 25, 2008

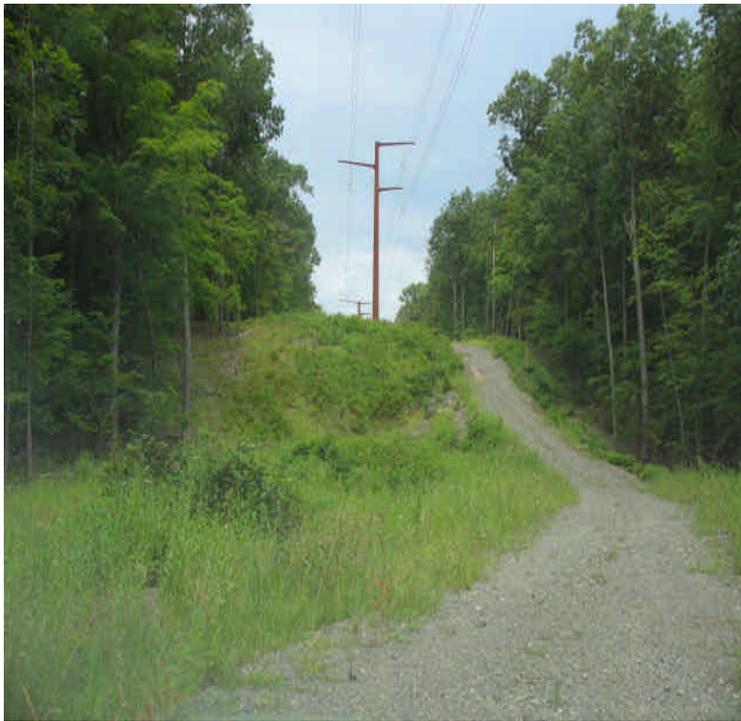
Vegetated and stabilized slope at the 1A and 1B intersection.

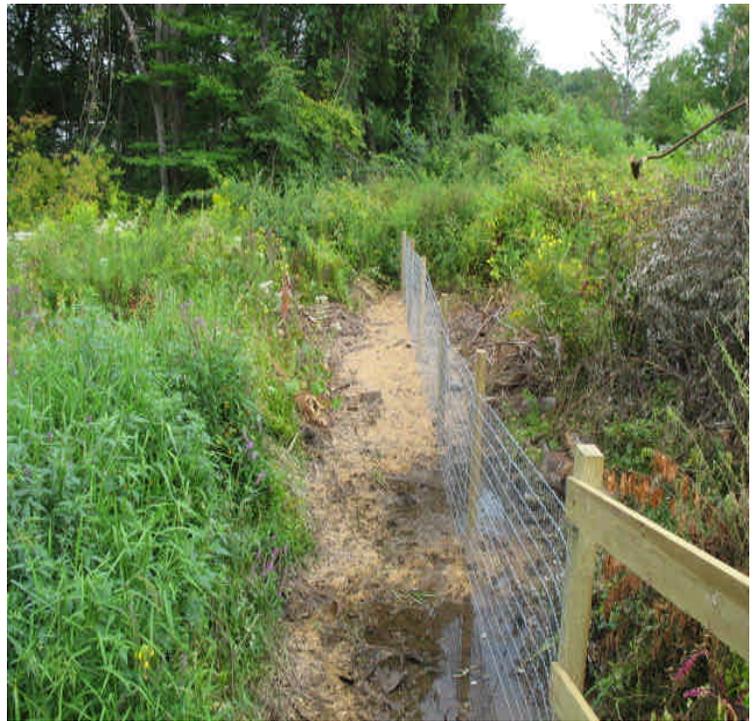
New fence installed upgradient of the wetland and across the access road past the contractor yard. Hay mulch was applied over exposed soils. This was likely installed by the private property owner.

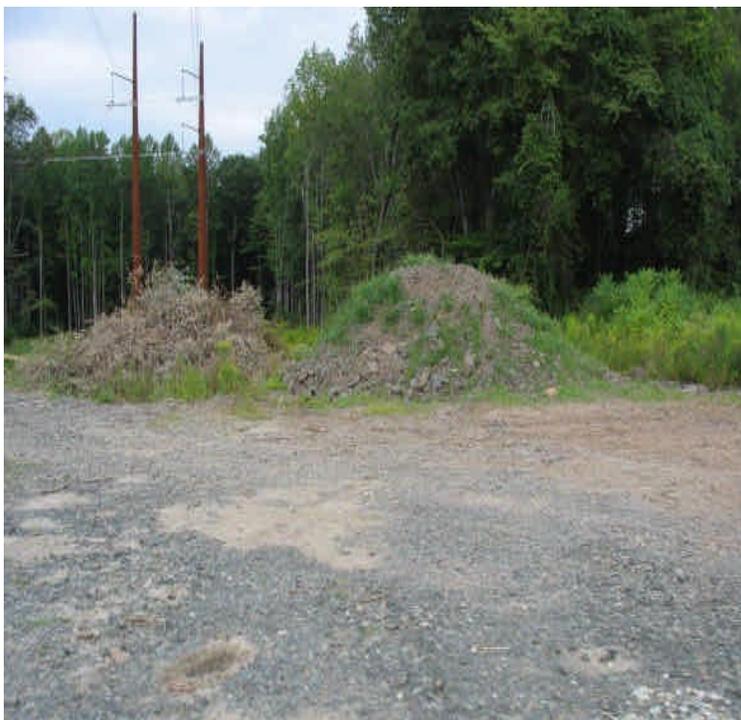
Material stockpile and property owner's brush pile at the receiving yard. Controls are in place but the pile is located just upgradient from wetlands and should be relocated.

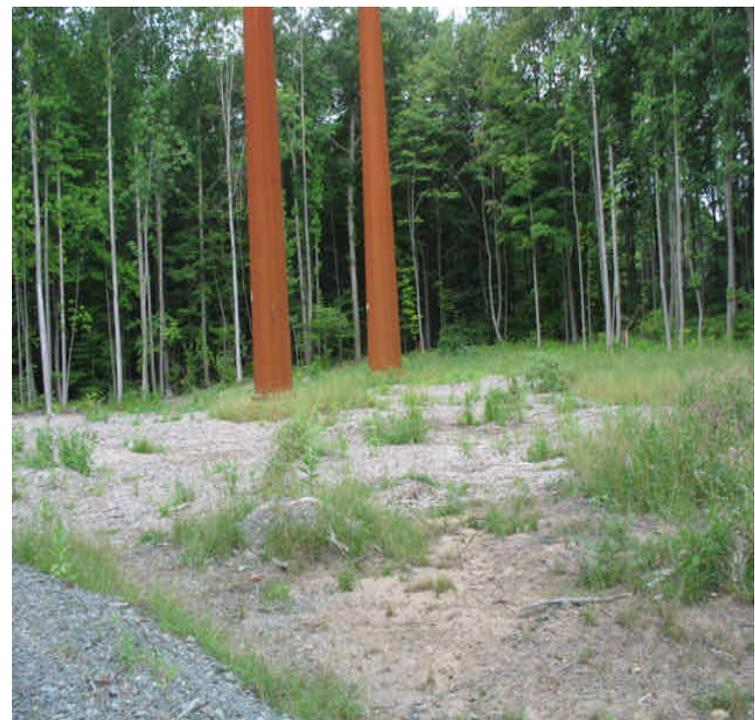
Another view of the pad/angle structure where vegetative cover is still sparse. The area remains stable with thick wood chips but vegetation will not be able to establish fully. The contractor plans to remove the chips and seed the area when feasible.
