Docket No. 272 – Development and Management Plan Inspection

Segment 1b (Royal Oaks Bypass) Inspection

Date: October 6, 2008

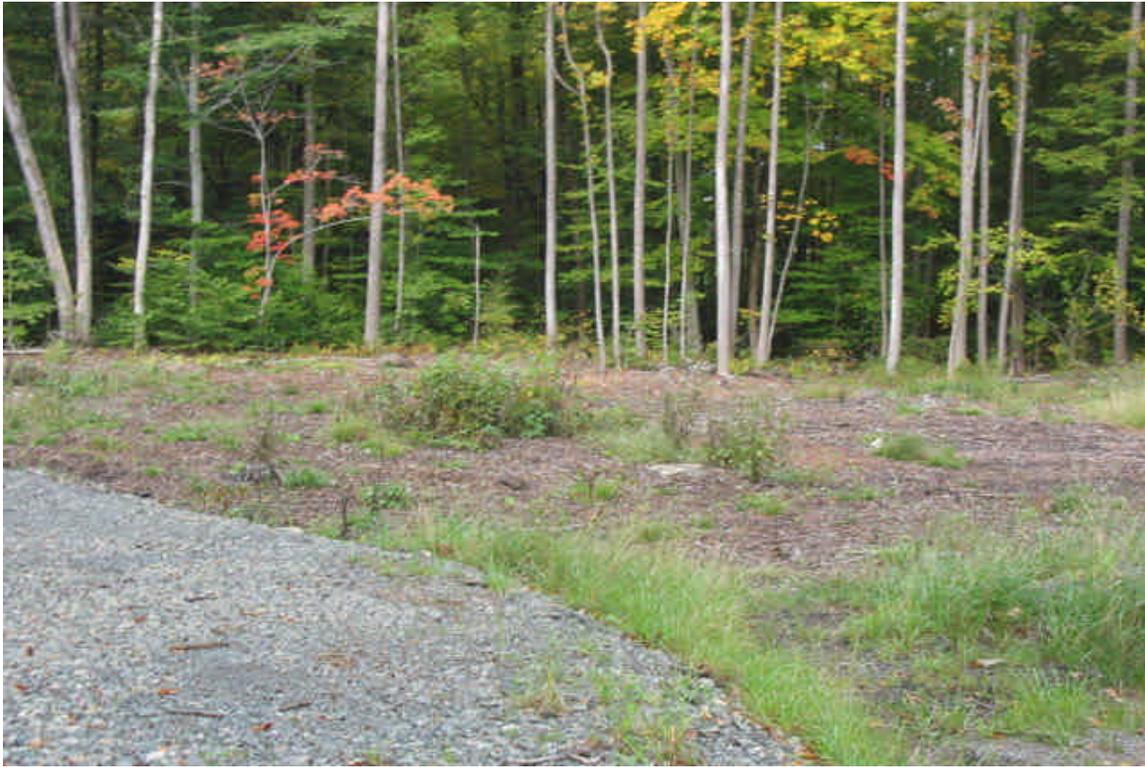
Vegetative cover is still sparse at the pad/angle structure. The area remains stable with thick wood chips but vegetation will not be able to establish fully. The contractor had planned to remove the chips and seed the area. However, this may be placed on hold until next spring due to the upcoming end of the growing season.

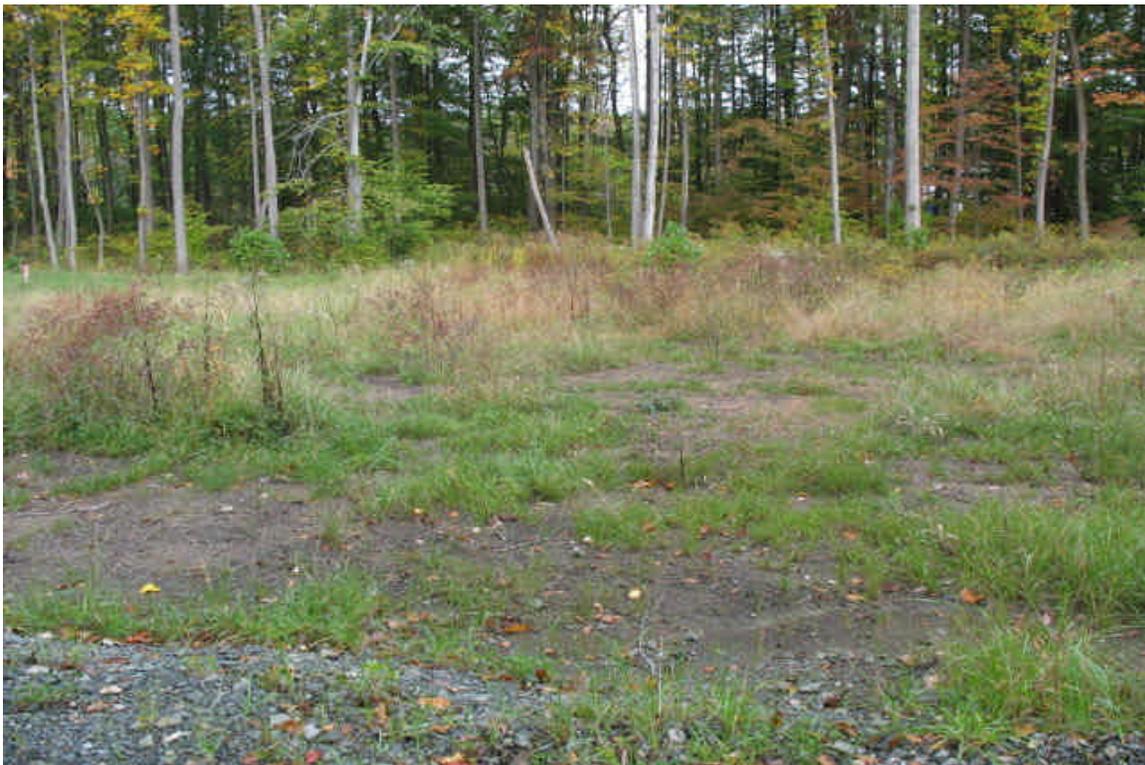
Another view of the area near the angle structure.
