Docket No. 272 – Development and Management Plan Inspection

Segment 2a Inspection

Date: January 8, 2008

Location: Segment 2a – Beseck Switching Station to Cheshire/Hamden Town Line

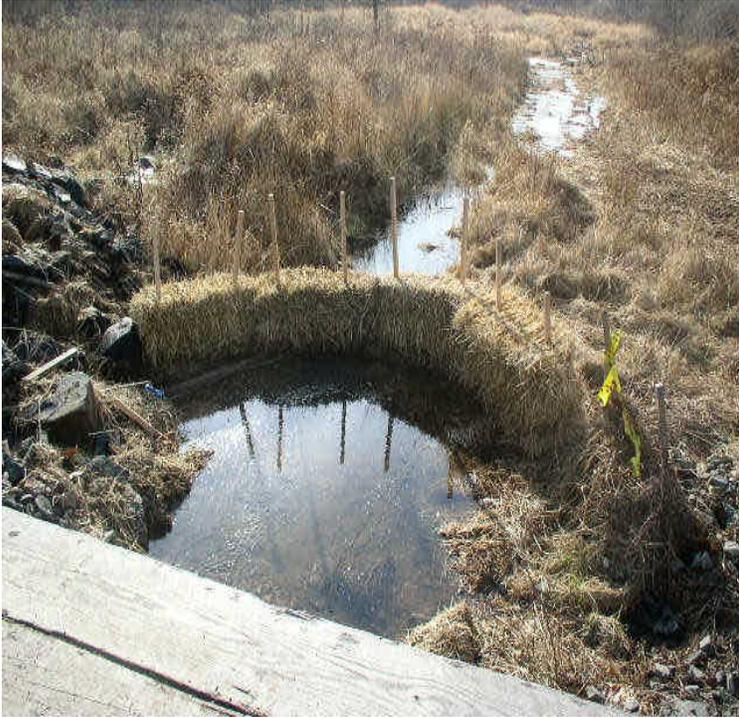
Carpenter Lane: New haybales remain at the wetland outlet. Previously accumulated sediment should be removed prior to restoration.

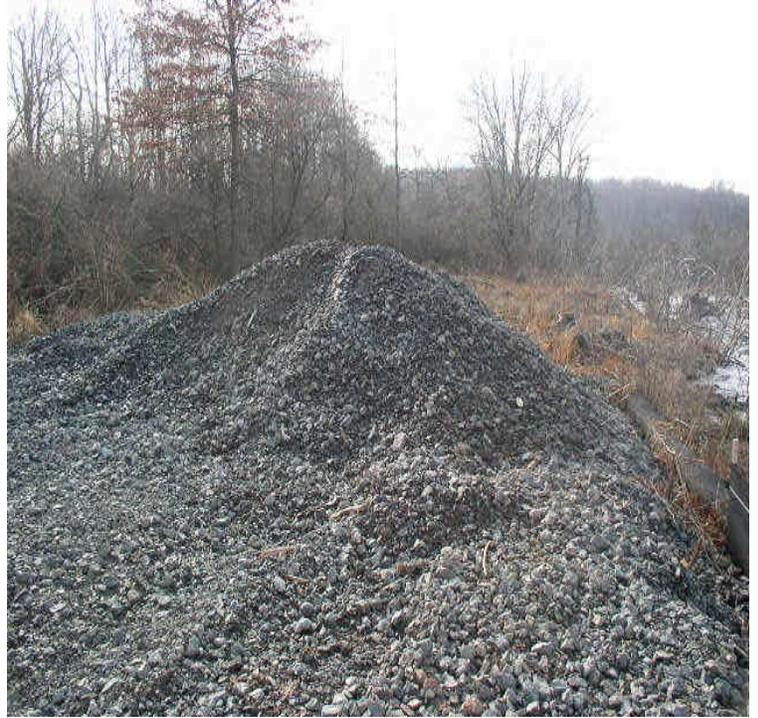
Tamarack Swamp Rd: Stone and sediment plowed off the pad up to the controls at the wetland boundary. This is a large amount of material that should be pulled back to avoid encroachment.

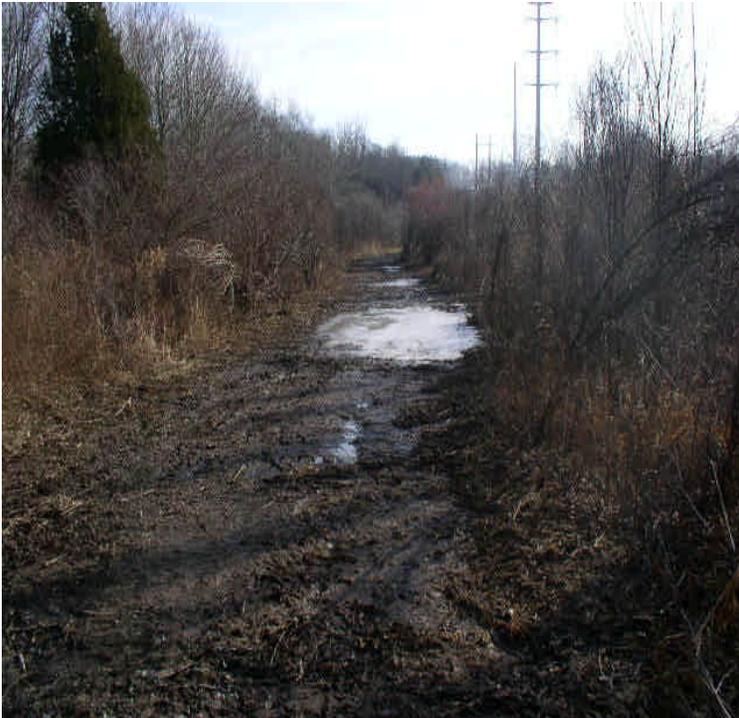
Pond Hill Rd: Timber mats were removed from the wetland crossing several weeks ago. Monitor the area for stabilization and seed for vegetative cover at the growing season.

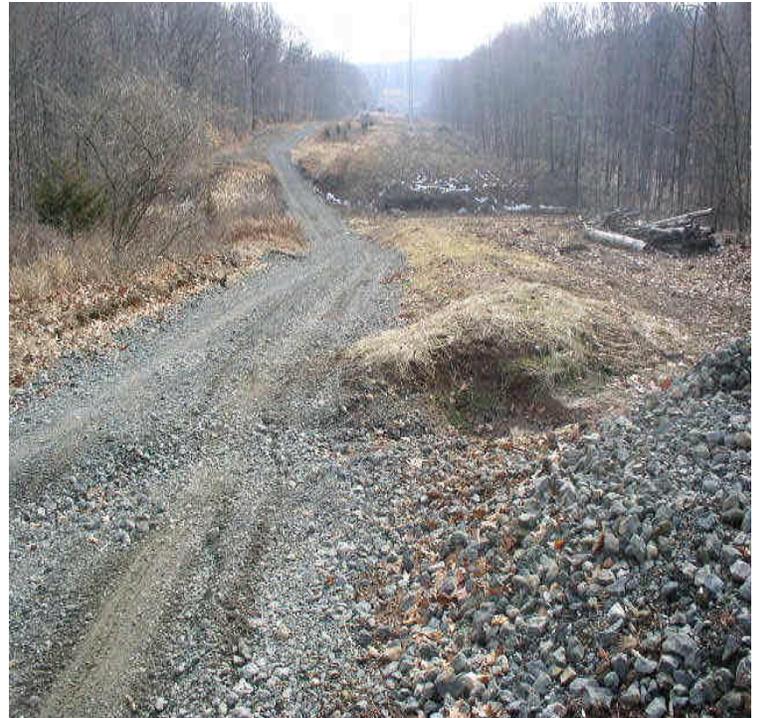
Tuttle Ave: Stormwater controls consisting of drainage ditches and small detention traps, appear to keep sediment out of wetlands.

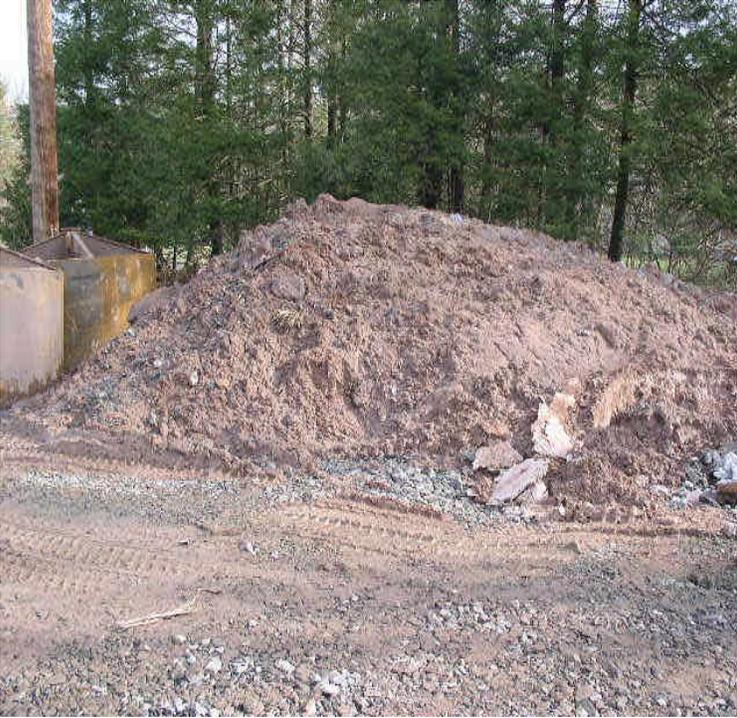
Old Farms Rd: New stockpiles need controls. Ensure that spoil is not being stored within 100 feet of wetlands.

Areas of Inspection	Observation	Recommended Action	Corrected Action
	<p>Several small soil stockpiles have been noted along the overhead segment in active areas. 1/8/08</p>	<p>Add controls as needed around stockpiles or remove piles when feasible. Ensure that spoil is not stored within 100 feet of wetlands. 1/8/08</p>	<p>Needs attention.</p>
<p>Additional Observations</p>	<p>None 1/8/08</p>	<p>None</p>

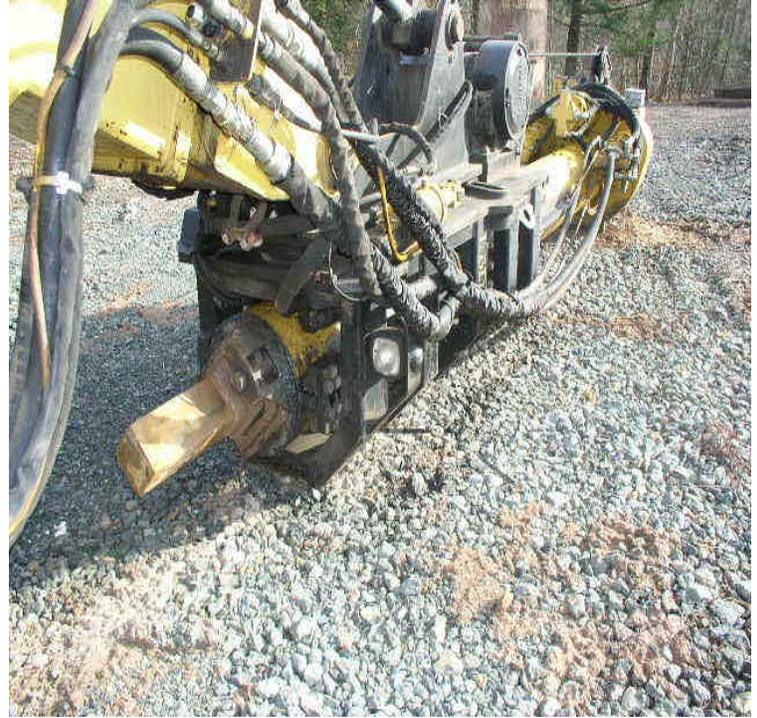
Old Farms Rd: Drill rig leaking hydraulic fluid. Repair the equipment and remove affected stone.

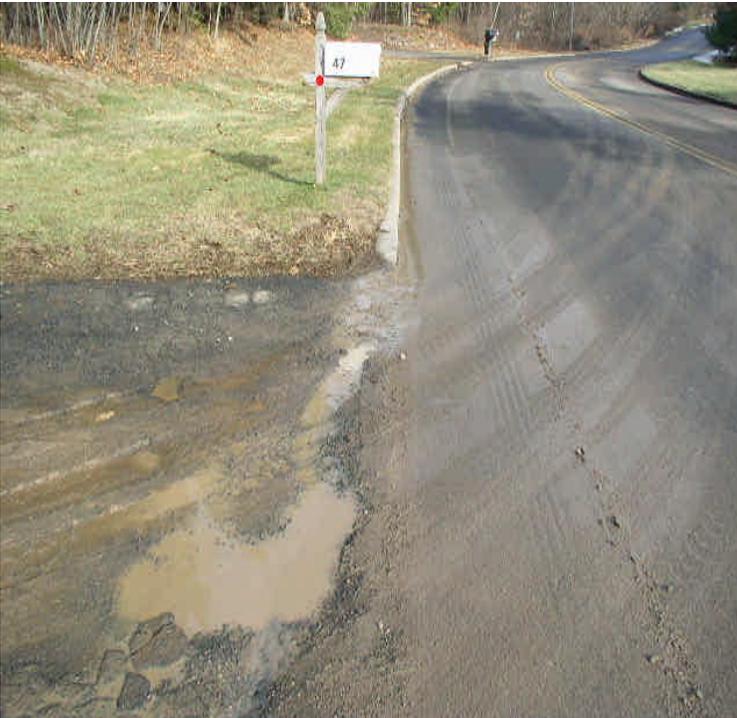
Old Farms Rd: Sediment tracking and turbid runoff still occurring to the roadway.

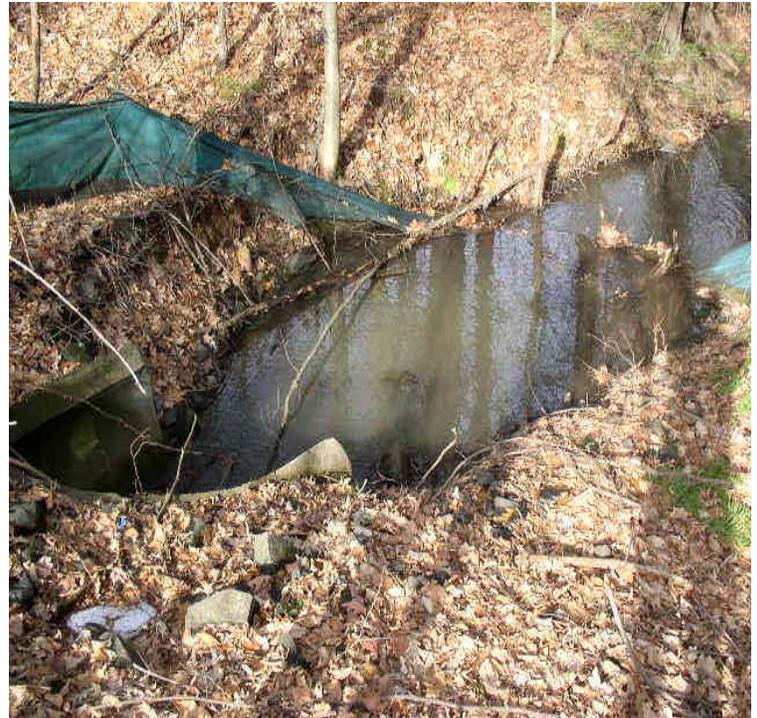
Old Farms Rd: Even with some controls in some CBs, turbid run-off is reaching the wetland from the ROW. Provide more controls and stabilize at the source as soon as feasible.
