Docket No. 272 – Development and Management Plan Inspection

Segment 2a Inspection

Date: January 16, 2008

Location: Segment 2a – Beseck Switching Station to Cheshire/Hamden Town Line

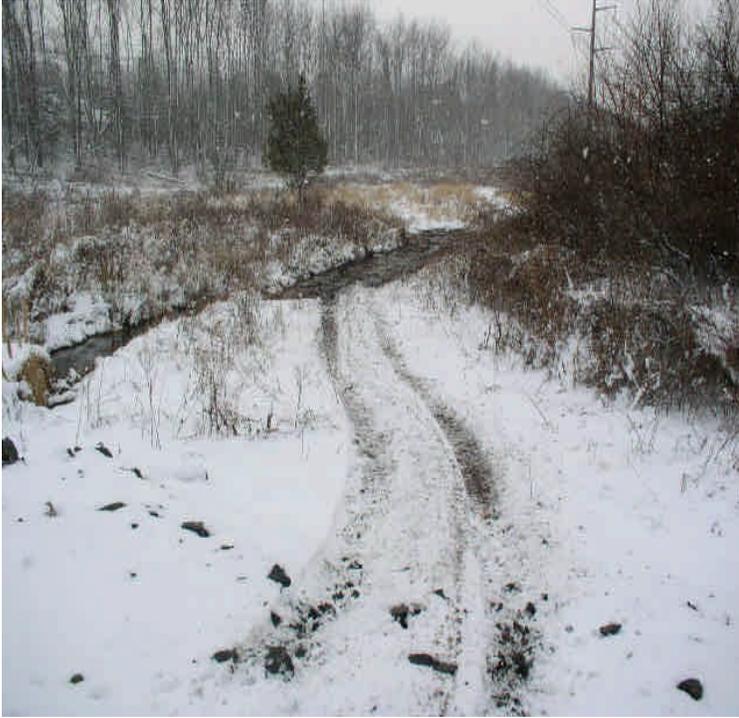
Carpenter Lane: Haybales remain at the wetland outlet. ATVs continue to deteriorate controls and leave tracks in wetlands.

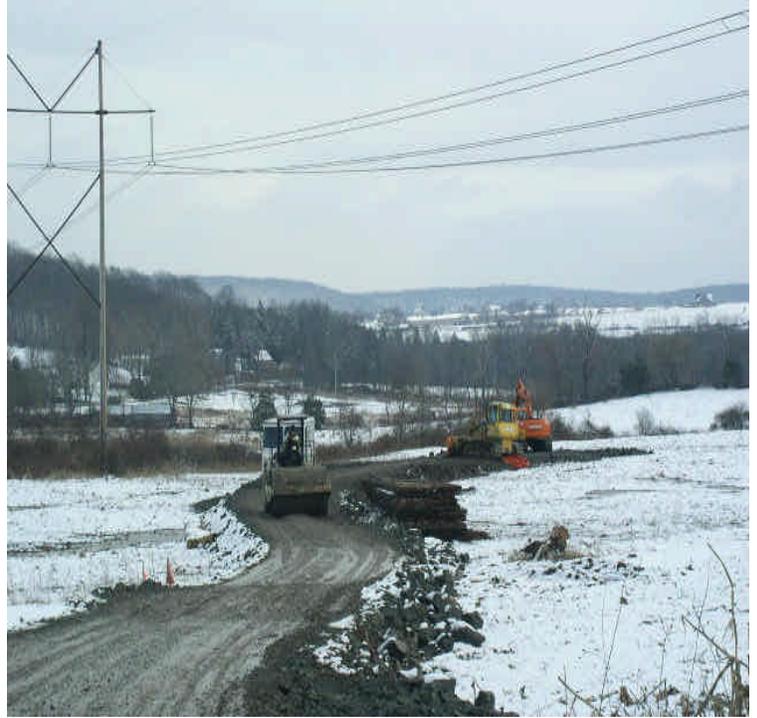
Tamarack Swamp Rd: New access road installation underway. Wetland crossing is noted and controls will be needed. Sediment tracking is an issue.

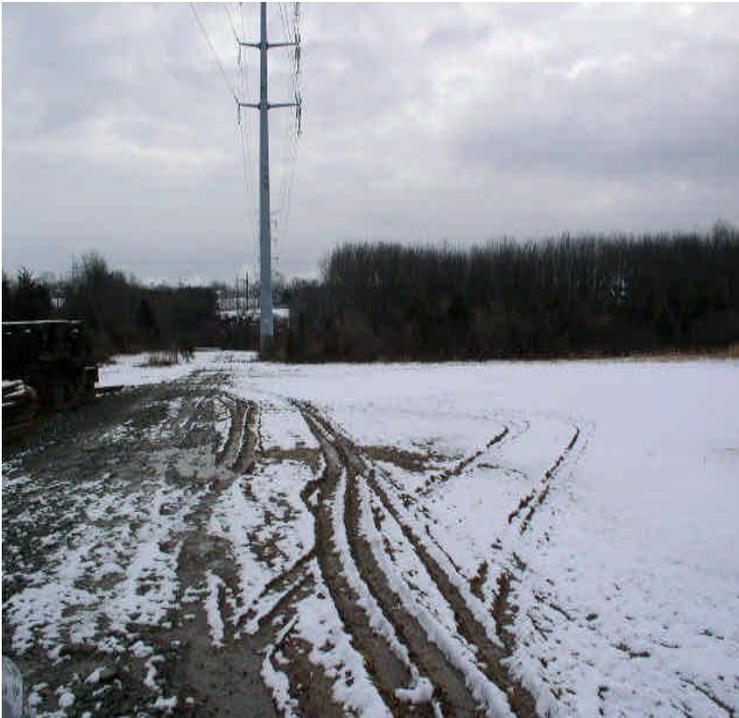
Pond Hill Rd: Timber mats were removed from the wetland crossing several weeks ago. Monitor the area for stabilization and seed for vegetative cover at the growing season.

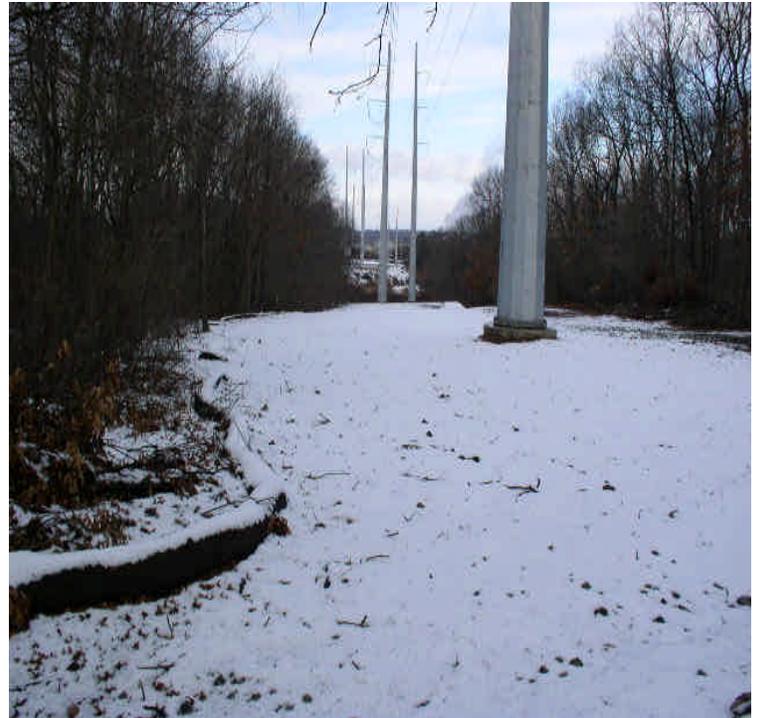
Docker Dr: The large area of disturbed soil is currently frozen under snow cover. When thaw occurs, provide temporary stabilization as previously noted.

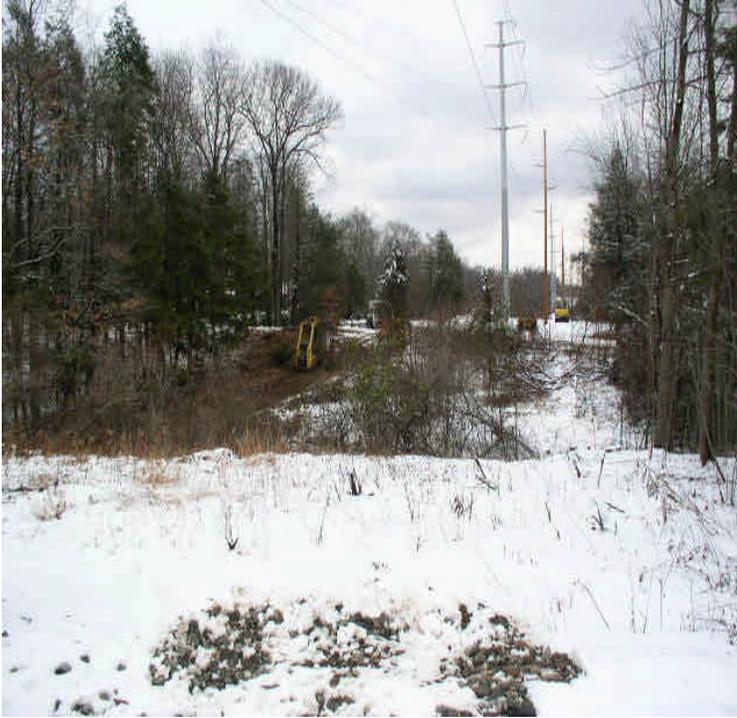
Old Farms Rd: Clearing was underway at a wetland crossing. Retain all woody species approved in the D&M plan.

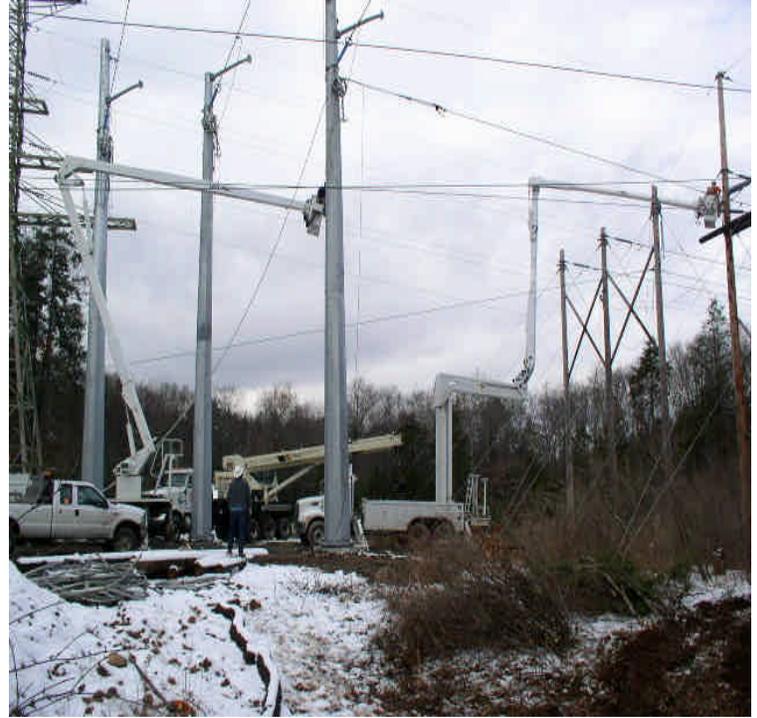
Old Farms Rd: Overhead line work was underway at new structures.

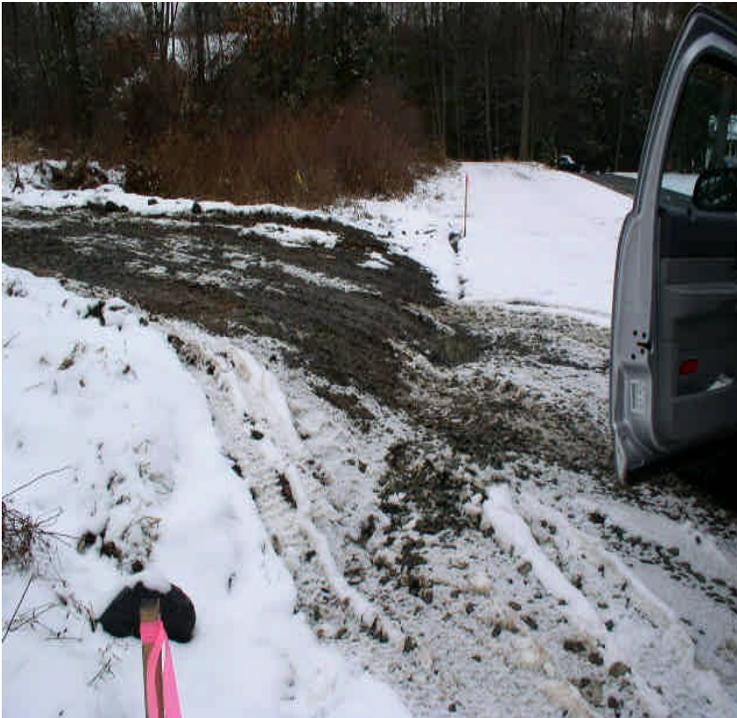
Old Farms Rd: New drainage ditch/water bar installed along a low, saturated section of driveway.

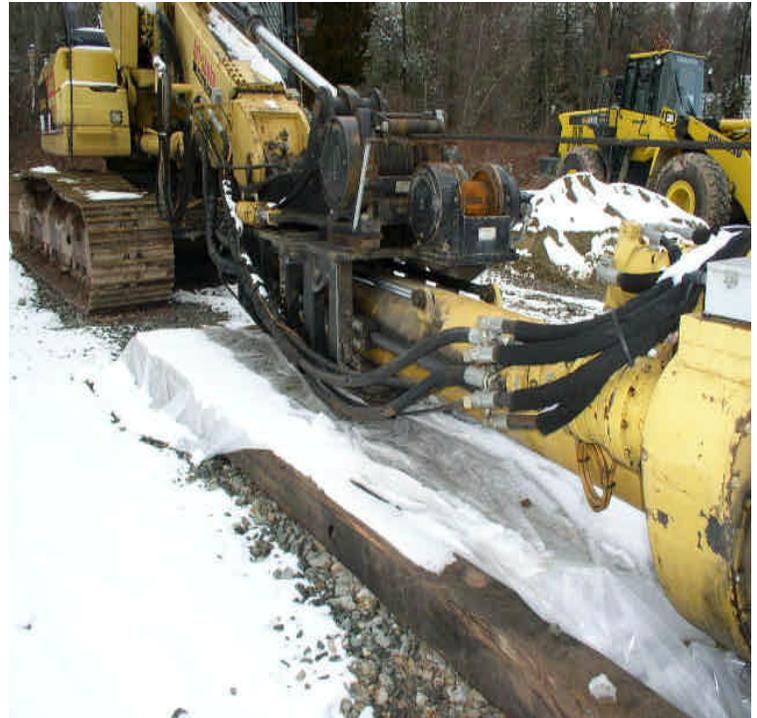
Old Farms Rd: Leaking equipment now has a plastic tarp to contain drips. However, fluid is still washing onto the ground off the tarp. Leak should be repaired as soon as possible.
