Docket No. 272 – Development and Management Plan Inspection

Segment 2a Inspection

Date: January 29, 2008

Location: Segment 2a – Beseck Switching Station to Cheshire/Hamden Town Line

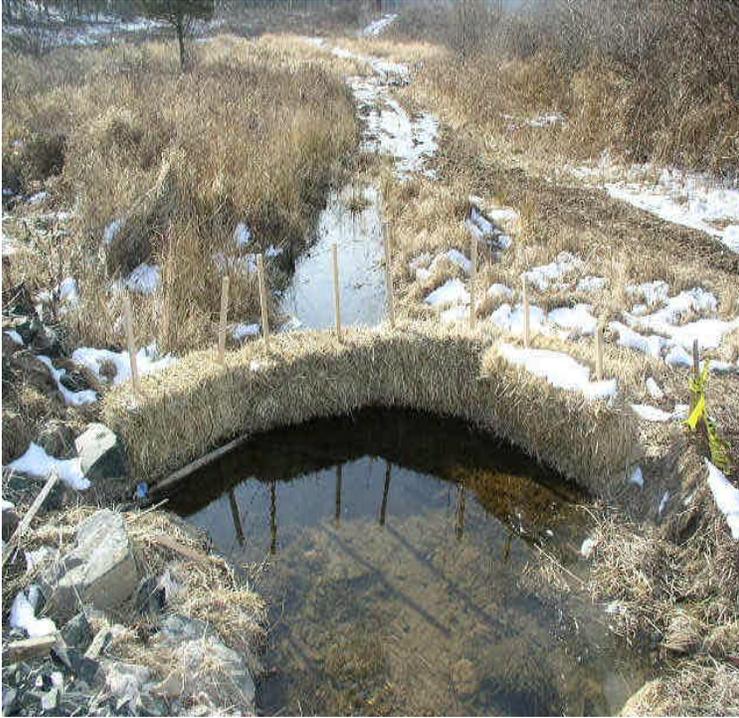
Carpenter Lane: Haybales remain at the wetland outlet. ATVs continue to damage controls and leave tracks in wetlands.

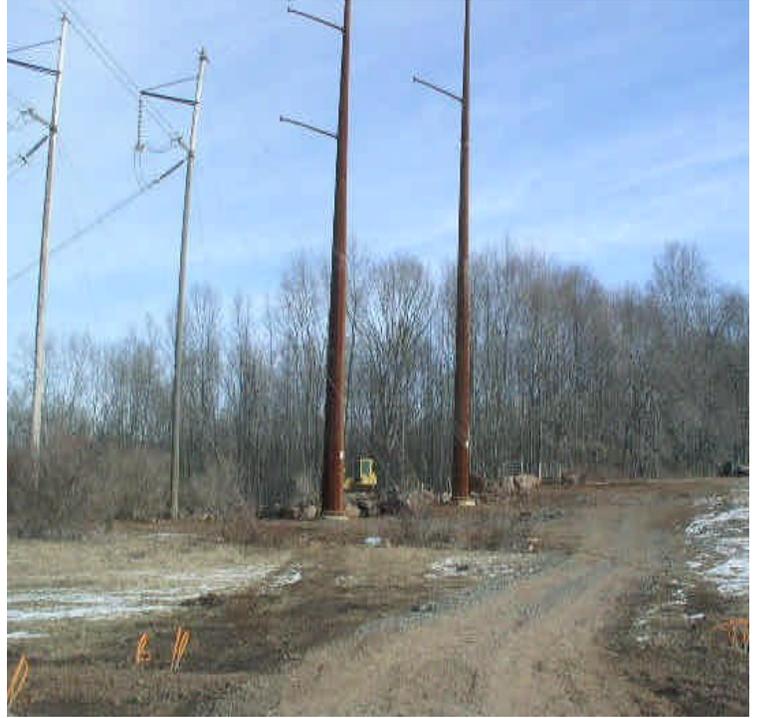
Liney Hall Rd: New access road installation and pad work were underway.

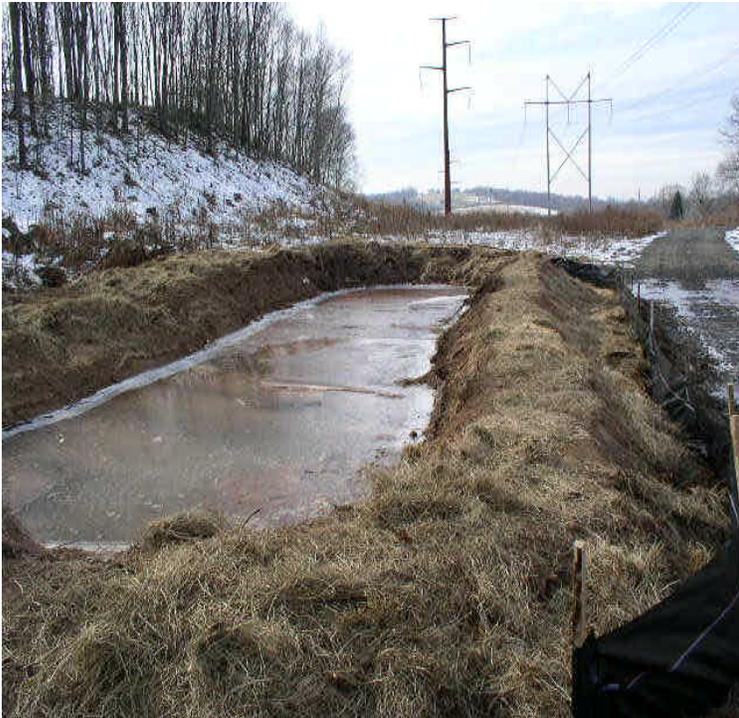
Stony Brook: A temporary detention basin with controls was constructed to hold water for a dust control truck.

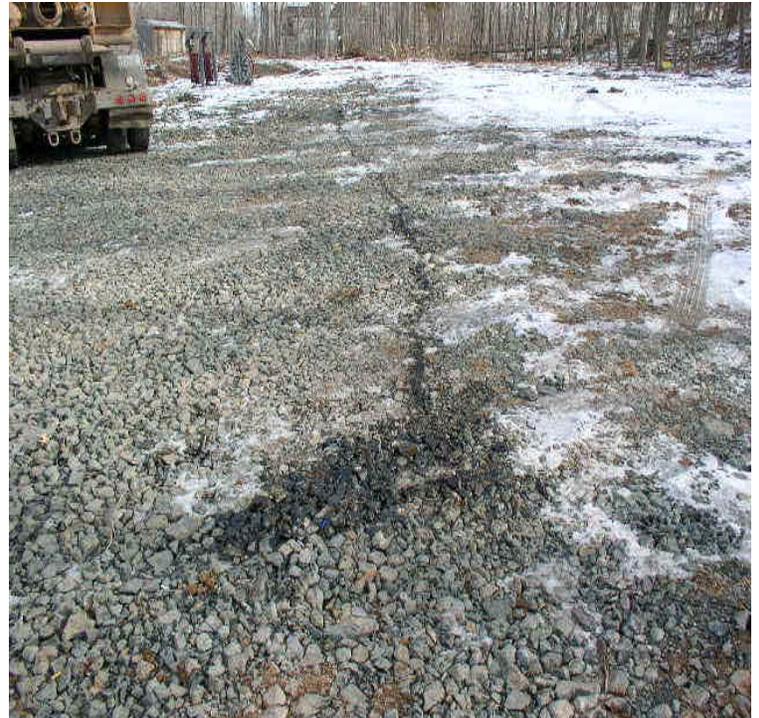
Stony Brook: One of two spills attributed to the leaking dust control truck. Controls should be installed under the equipment and the leak should be repaired.

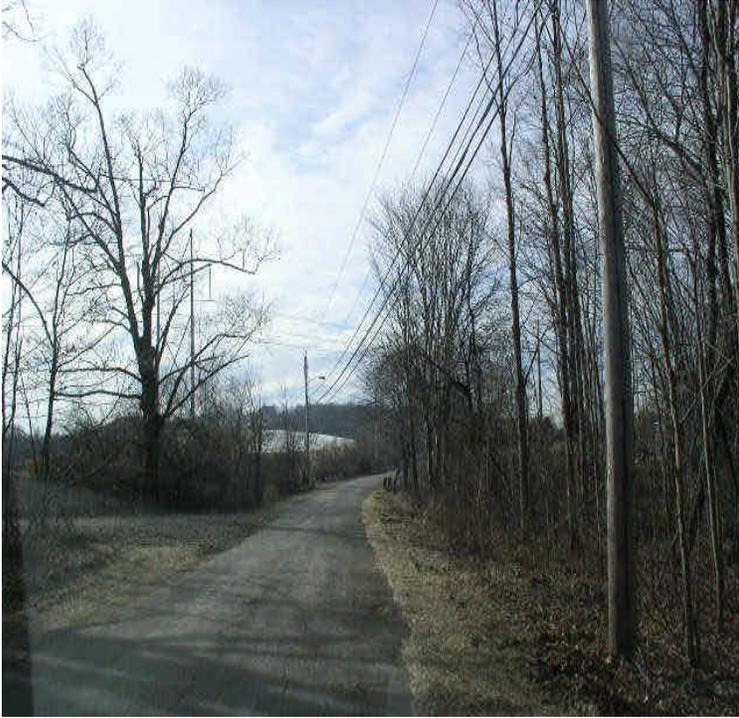
Tamarack Swamp Rd: Grading was noted along the edge of the roadway and mulch/seed was installed to help with erosion. Roadway was also swept clean.

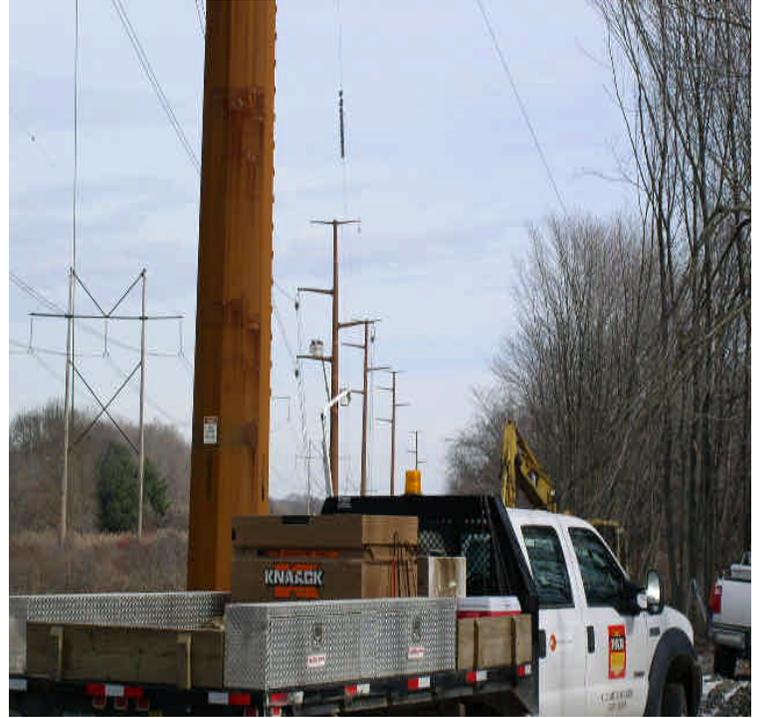
Powers Rd: Line work underway at multiple structures.

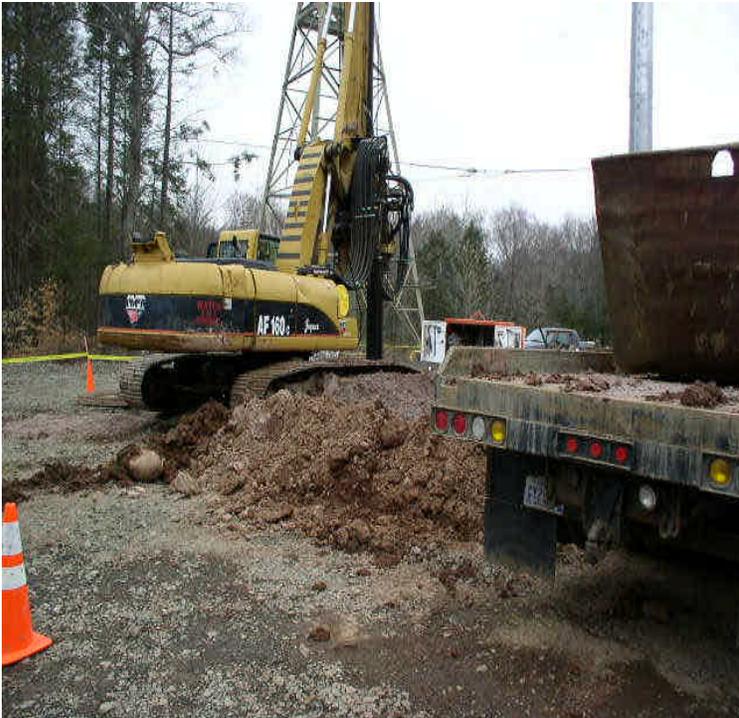
Old Farms Rd: A new foundation was being drilled with the previously leaking piece of equipment (Note: it is unclear whether the equipment was repaired first.)

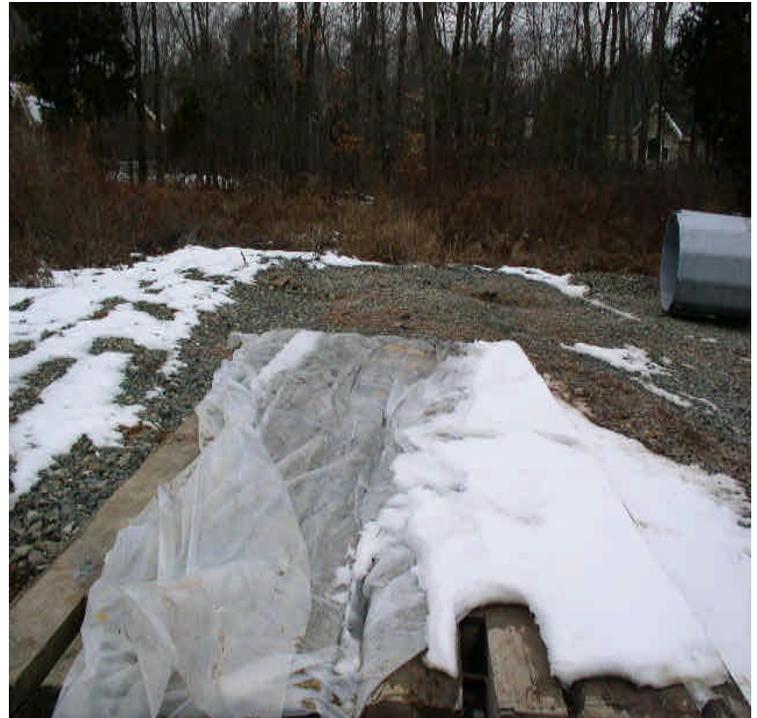
Old Farms Rd: Plastic tarp and timber mats where leaking equipment was previously stored. Spill still needs containment and clean up as it has the potential to wash off the plastic to the ground.
