**Docket No. 272 – Development and Management Plan Inspection**

**Segment 2a Inspection**

**Date:** February 12, 2008

**Location:** Segment 2a – Beseck Switching Station to Cheshire/Hamden Town Line

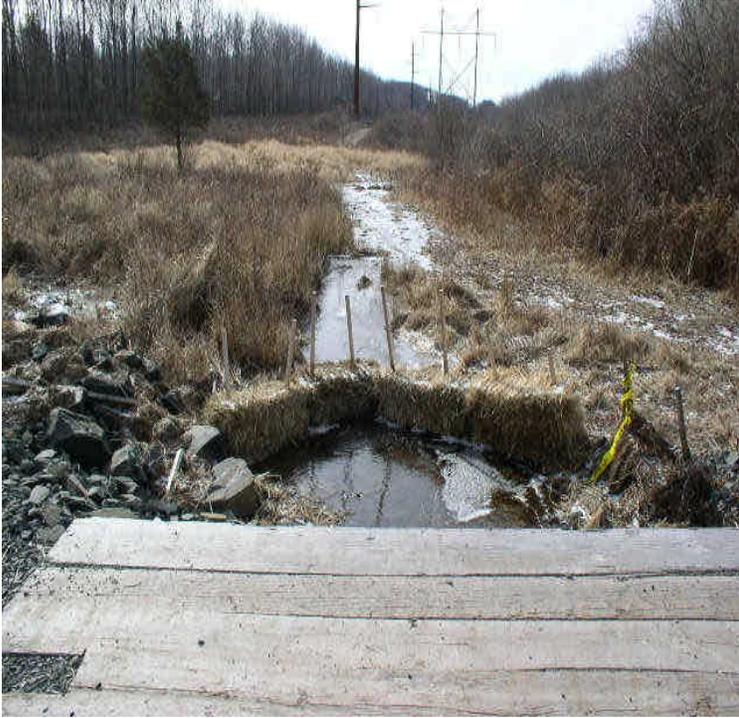
**Carpenter Lane: Haybales have been restored at the wetland outlet. ATVs continue to damage controls and leave tracks in wetlands.**

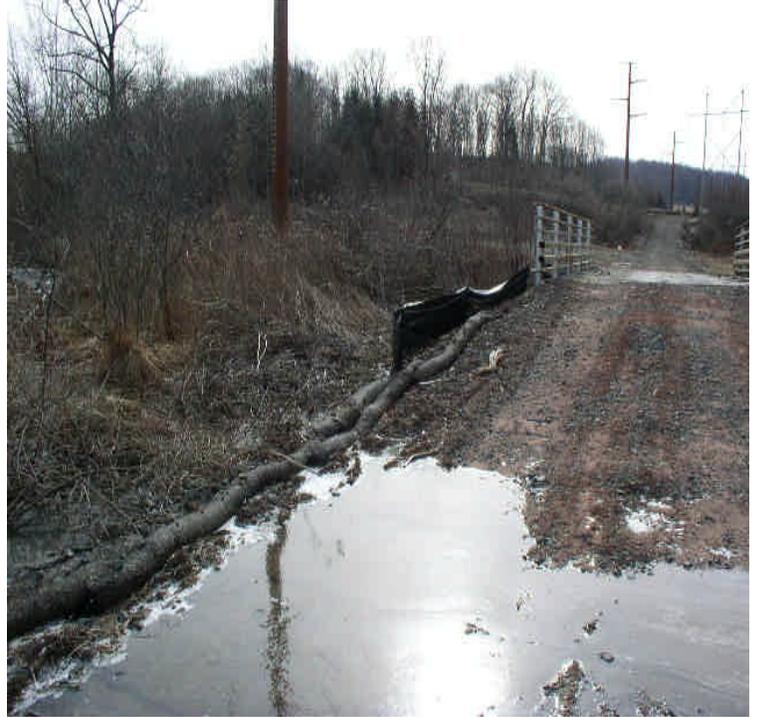
**Durham Rd: Clear run-off noted on the access road and in the wetland. Additional controls may be needed especially when area is active as water levels have the potential to overwhelm/overflow them here.**

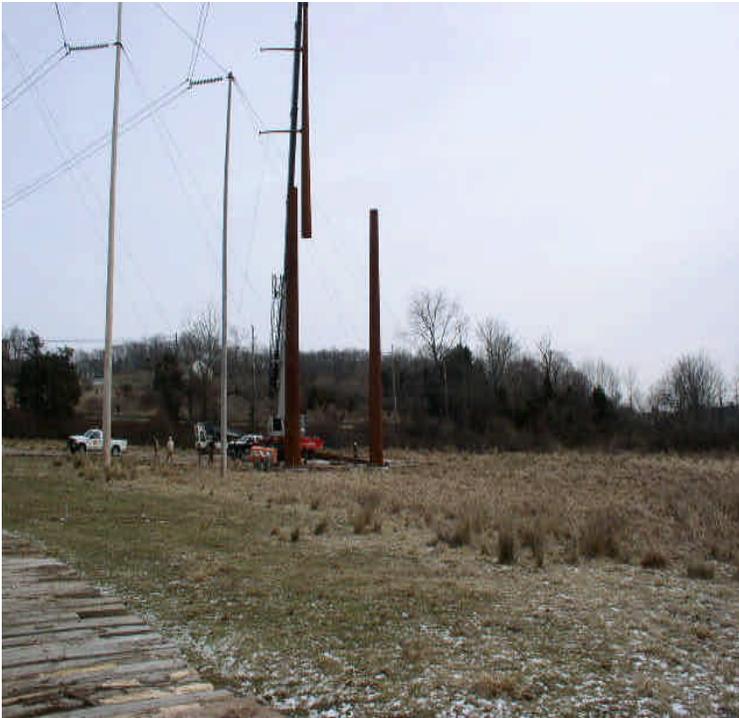
**Tamarack Swamp Rd: Crews were installing and working on structures.**

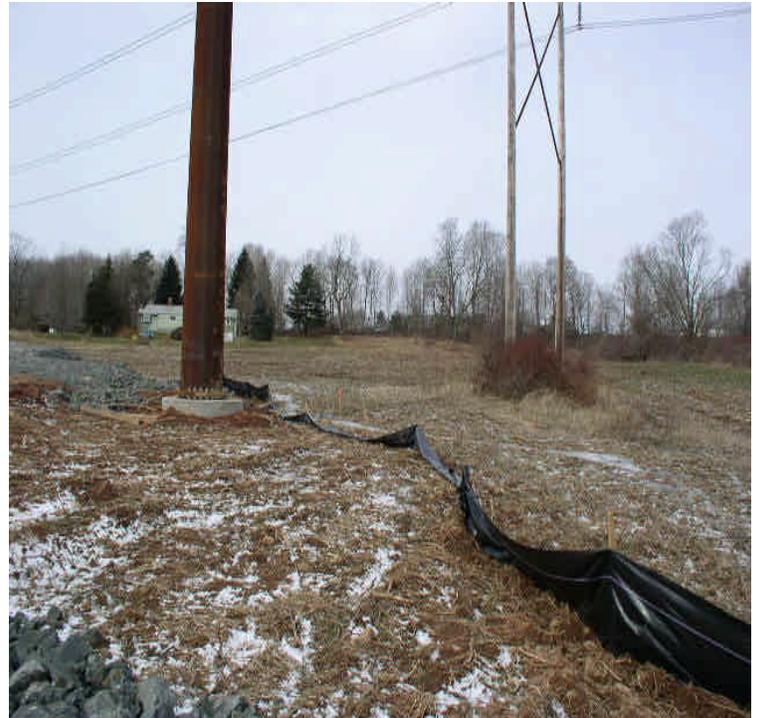
**Tamarack Swamp Rd: Small section of silt fence still needs repair.**

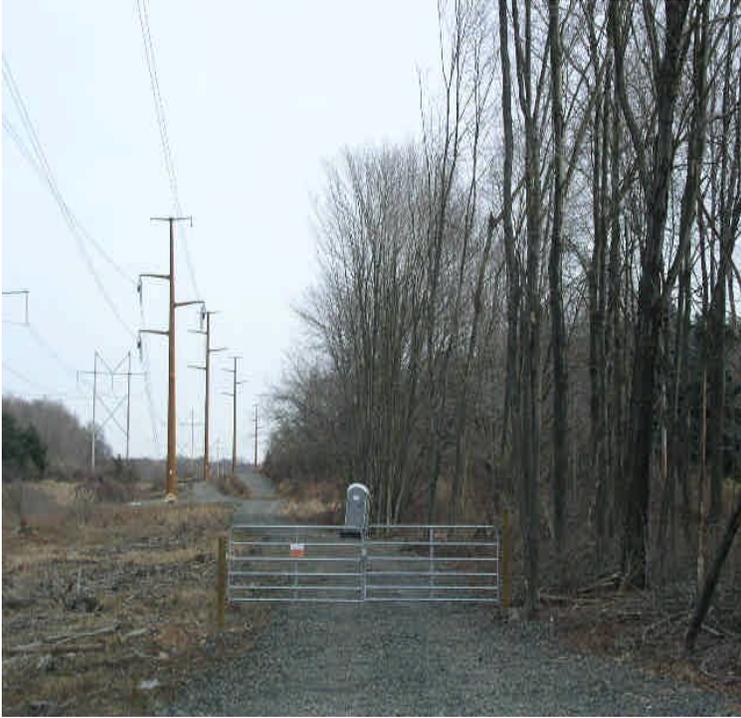
**Powers Rd: Sanitary facility located upgradient of a wetland should be relocated away from resource areas.**

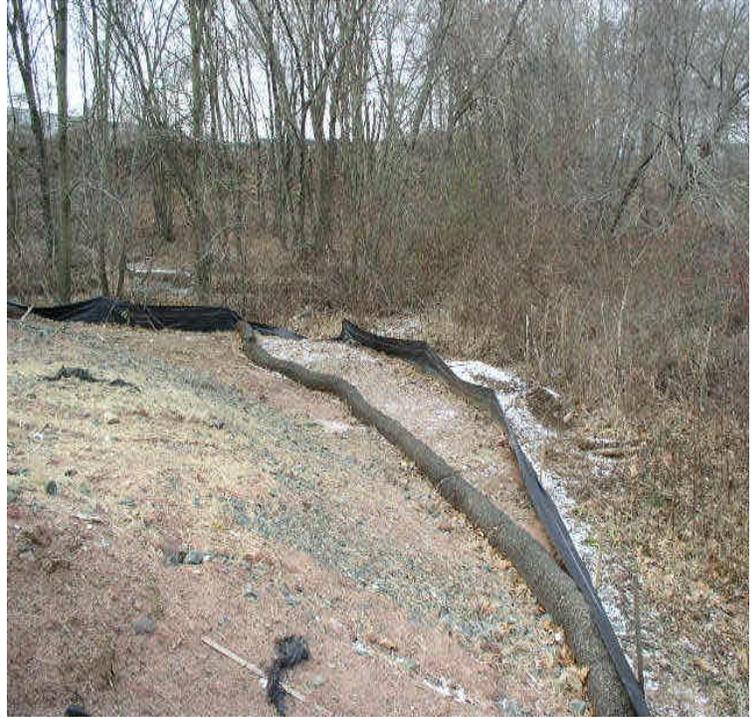
**Docker Dr: Additional controls were being installed upgradient of the wetlands and a small section of silt fence was going to be repaired.**

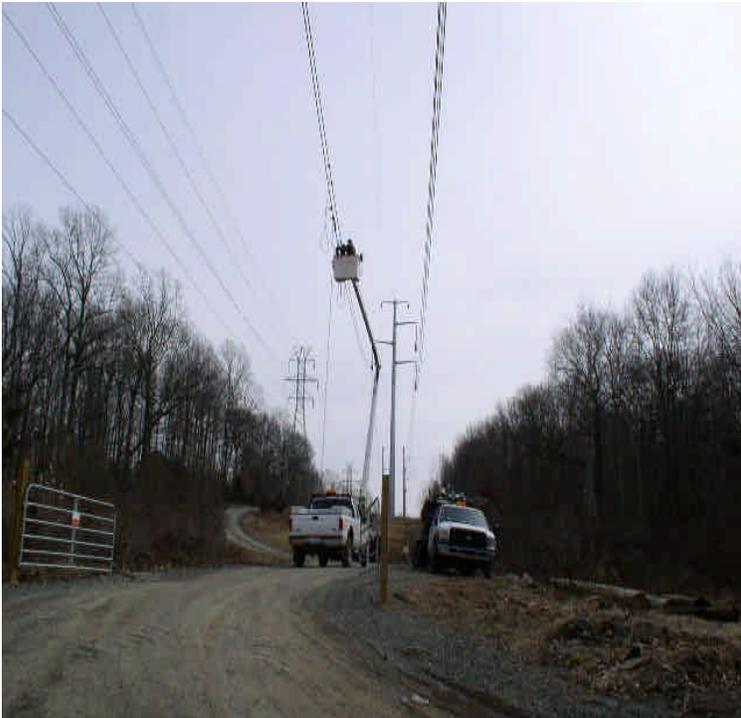
**Tuttle Ln: Line work was underway and moving east during the inspection.**

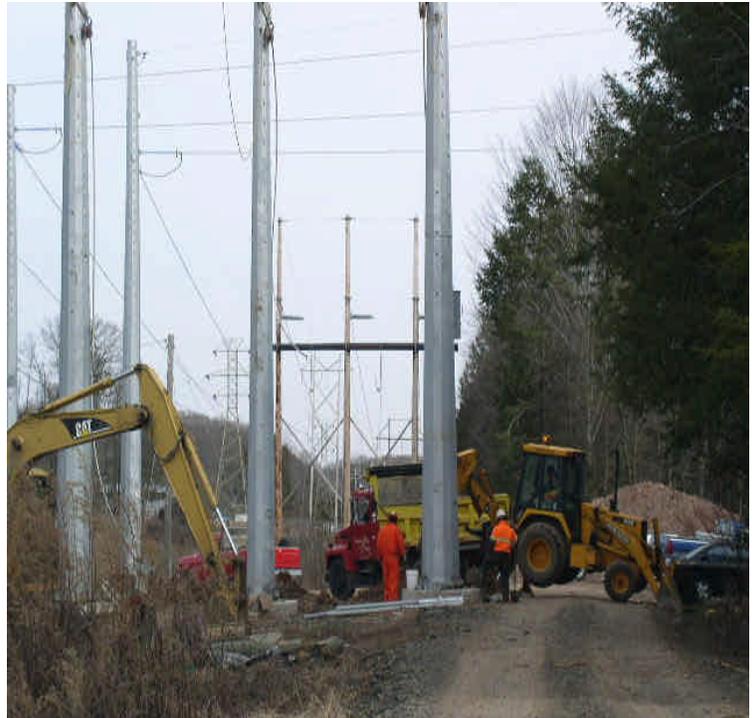
**Cook Hill Jct: Crews were grading the area and installing conduit.**
