Docket No. 272 – Development and Management Plan Inspection

Segment 2a Inspection

Date: February 26, 2008

Location: Segment 2a – Beseck Switching Station to Cheshire/Hamden Town Line

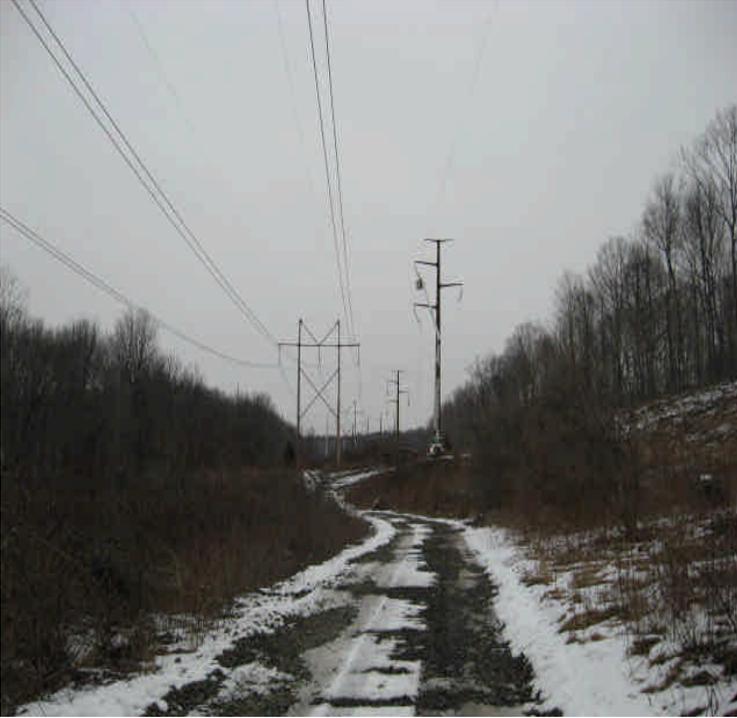
High Hill Rd: Crews were installing insulators and blocks for line pulling

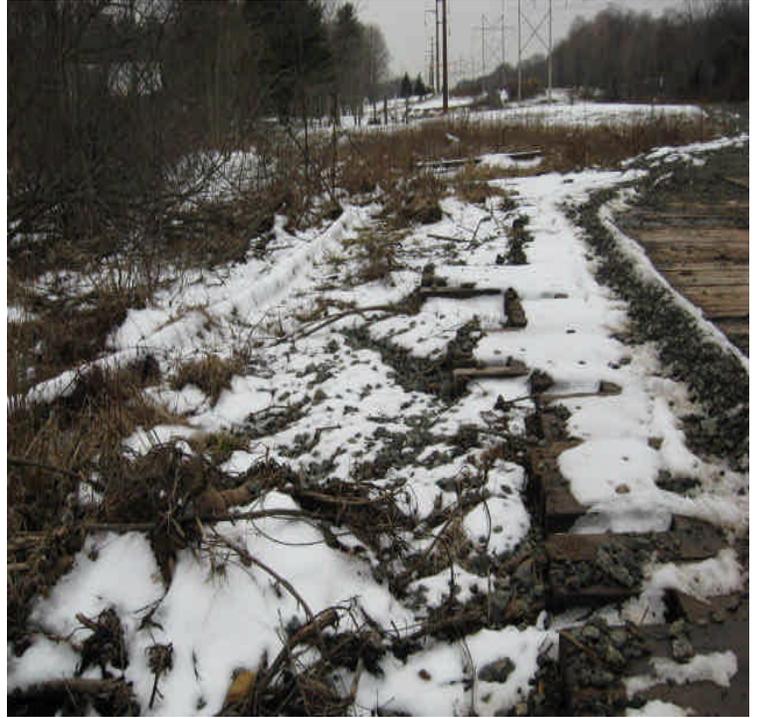
Areas of Inspection	Observation	Recommended Action	Corrected Action
Tamarack Swamp Road	<p>Snow removal activities have pushed stone onto timber mats and subsequently into wetlands off Liney Hall. 2/26/08</p> <p>Pad and adjacent controls remain within wetlands. In two separate occasions, during active work, sediment was pushed over controls into wetlands. Controls were replaced around the sediment each time but the encroachments were not removed. However, the contractor is evaluating pads with GPS to ensure limits are within what was permitted. 2/20-2/26/08</p> <p>Access road/ wetland crossings remain in place to the east. Controls are in place adjacent to the work. 2/26/08</p>	<p>Remove stone, carefully by hand, from wetlands and pull stone back from the timber mats. 2/26/08</p> <p>Area is sensitive and should be monitored closely. Pull soil back before installing new controls, do not just encompass it. 12/4-2/20/08</p> <p>The contractor stated that pads are within the proposed/permitted size limits. 2/20-2/26/08</p> <p>Continue to monitor controls. Crossings need to be removed/restored when access is complete. 2/26/08</p>	<p>Needs attention.</p> <p><i>The contractor has stated that pads are within the proposed/permitted size limits.</i></p> <p>NA at this time.</p>

Liney Hall Ln: Snow and stone were plowed onto timber mats and subsequently into wetlands. Stone material needs to be removed carefully.

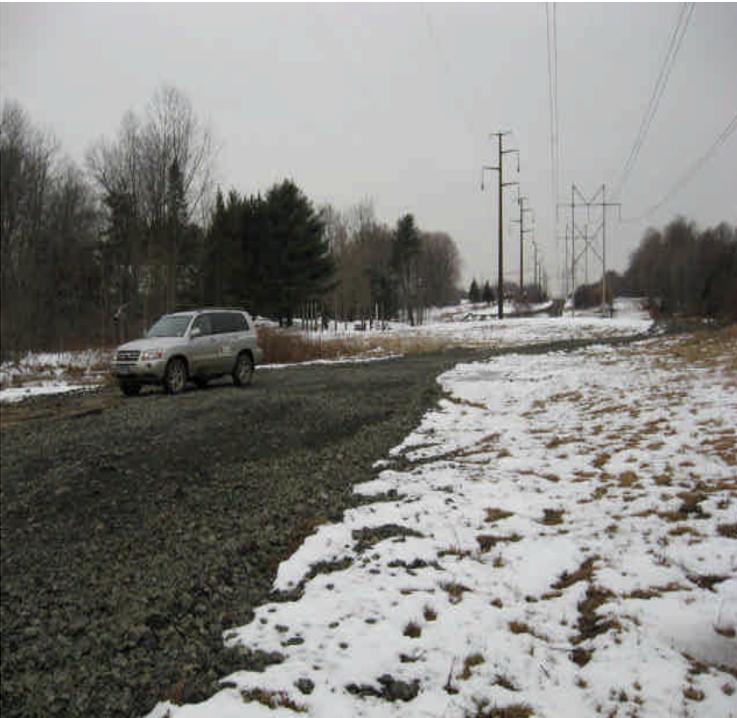
Liney Hall Ln: Additional stone was installed upgradient from/ adjacent to the timber mats.

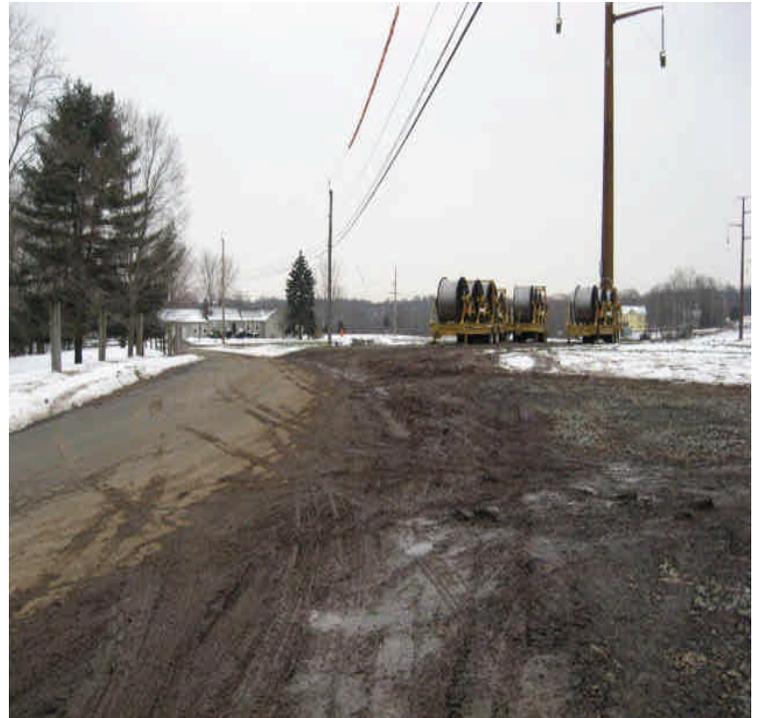
Liney Hall Ln: Sediment tracking noted on the roadway at the entrance to the ROW access road. The roadway should be cleaned/swept and additional stone may be needed at the entrance to reduce tracking.

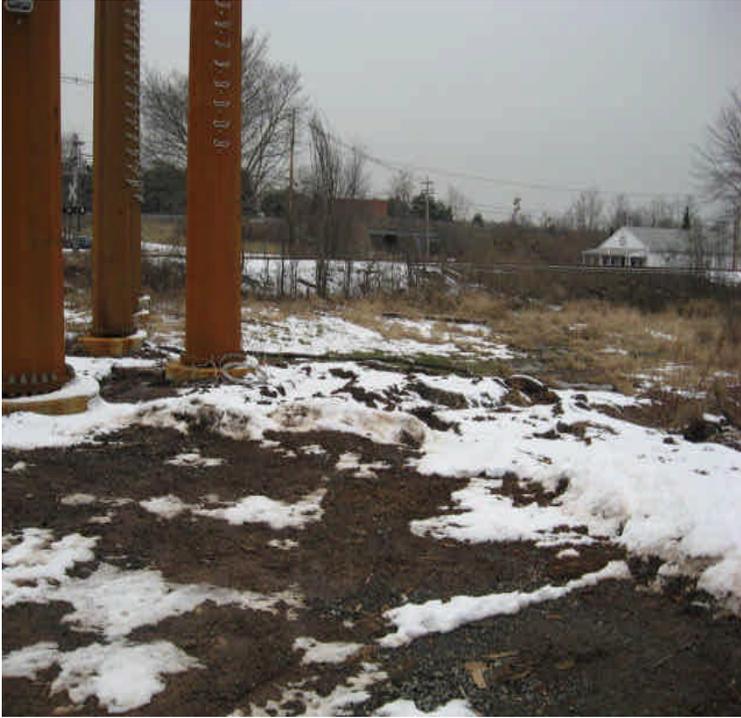
Powers Rd. & Woodhouse Ave.	<p>Soils exposed by timber mat removal were seeded, but not all stone was removed from the wetland prior to seeding. (noted 9/25) Well-established grass cover is in place. Some timber mats were removed from the wetland for use at the access road bypass. 2/26/08</p>	<p>Remove the stone from the wetlands to the extent feasible (recommended since 9/25) However, crews continue to return here for line work, potentially disturbing the area again before final stabilization. Add new controls as needed to recently exposed areas. 2/26/08</p>	<p>Some timber mats have been removed from the wetland. Monitor this area closely and add controls as needed.</p>
Mansion Rd to Tuttle Ave.	<p>Several wetland crossings are in place. 2/26/08</p>	<p>Monitor and maintain new controls. Crossings will need to be restored when access needs are complete. 2/26/08</p>	<p>NA at this time.</p>
Old Farms Rd.	<p>Wetland clearing and crossing complete via an existing bridge and culvert. Disturbed areas remain mulched and</p>	<p>Additional controls may be needed to prevent run-off from any soil disturbance. See access road and erosion control</p>	<p>NA at this time.</p>

Powers Rd: Some timber mats were removed from the wetlands. Controls were in place.

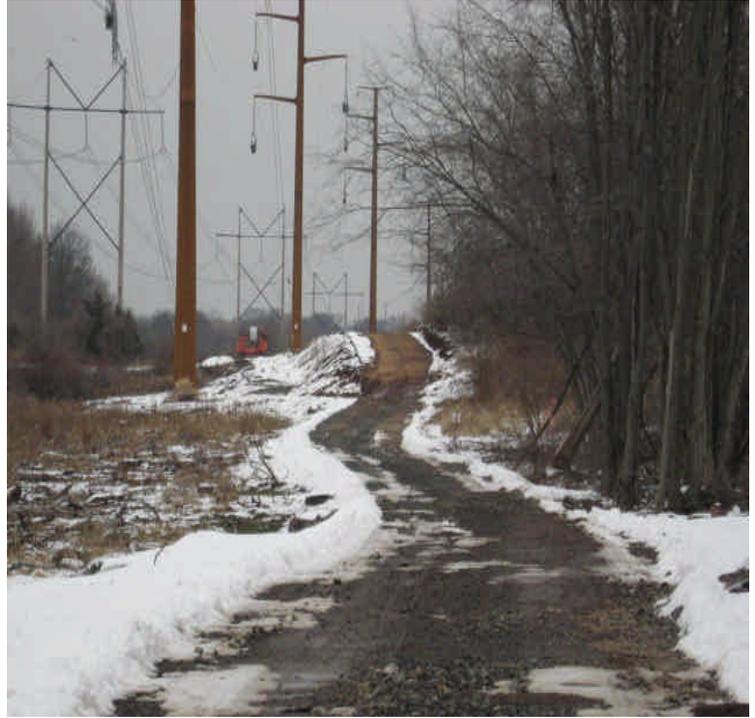
Powers Rd: The rutted tracks noted at the access road by-pass last week were covered with the timber mats taken from the wetlands. The sanitary facility previously located near wetlands has also been removed.

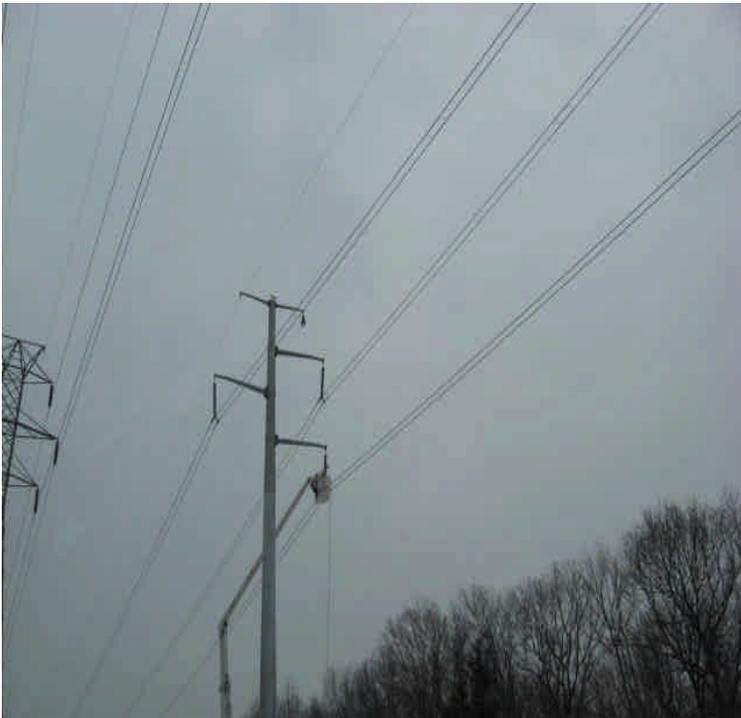
Tuttle Ln: Line work was underway from Old Farms Rd.

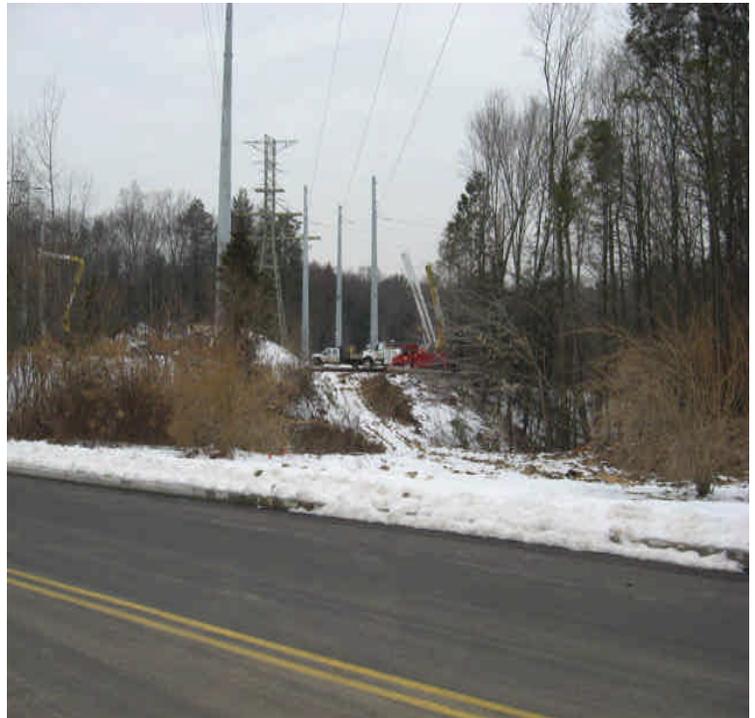
Old Farms Rd: Line work was underway at several structures along the roadway. Continue to monitor controls and wetland boundaries during the line work.
