Docket No. 272 – Development and Management Plan Inspection

Segment 2a Inspection

Date: March 4, 2008

Location: Segment 2a – Beseck Switching Station to Cheshire/Hamden Town Line

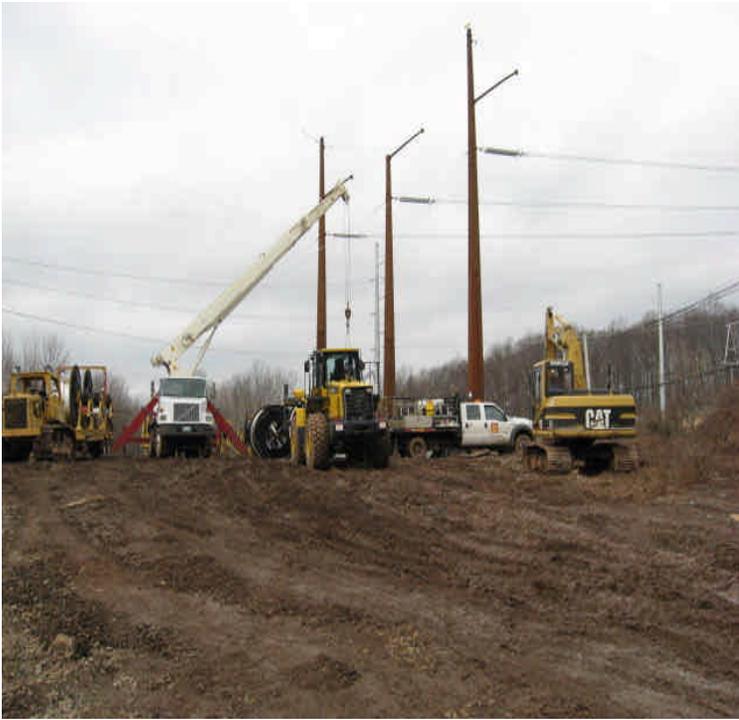
Carpenter Ln: Crews preparing for line pulling. Large exposed area will need controls upon completion of work. Carpenter Lane should be swept.

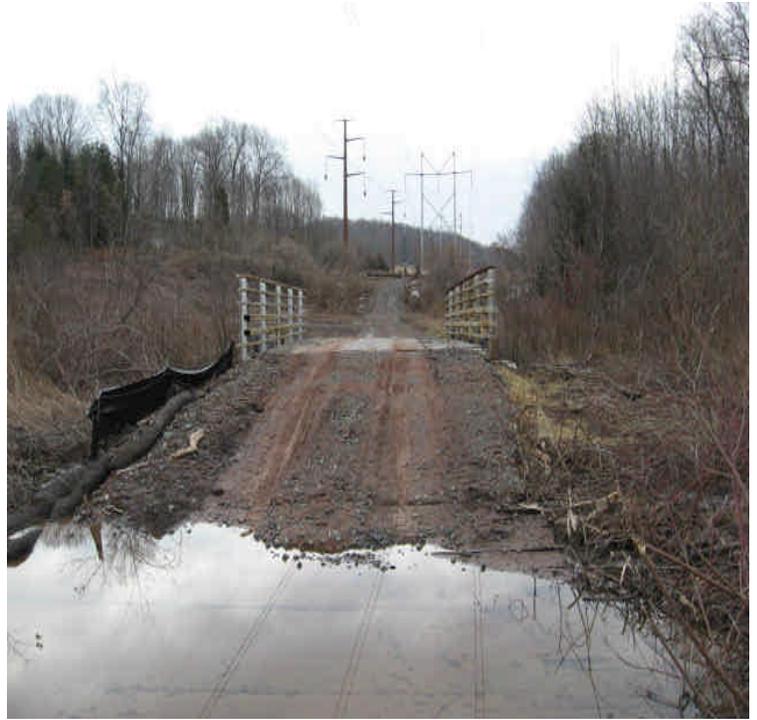
Durham Rd: Access road is flooded. If feasible, keep equipment off access road until water subsides.

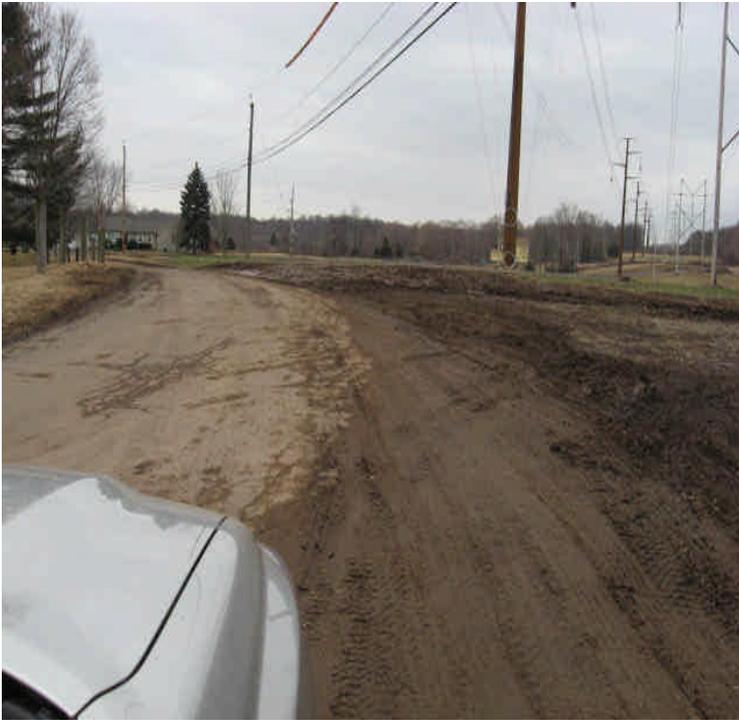
Liney Hall Ln.: Stone entrance pad should be installed to reduce sediment tracking. The roadway needs to be swept.

Heavy sediment tracking was still noted from the ROW access on Liney Hall Ln. 2/26-3/4/08	Clean/sweep roadway and install more stone in the tracking pad as needed. 2/26-3/4/08	Needs attention
	Snow and stone had been plowed onto the timber mats and subsequently into the wetlands. 2/26-3/4/08	Carefully remove stone from the wetlands. When plowing snow, monitor wetland boundaries and place snow in upland areas 2/26-3/4/08	Needs attention

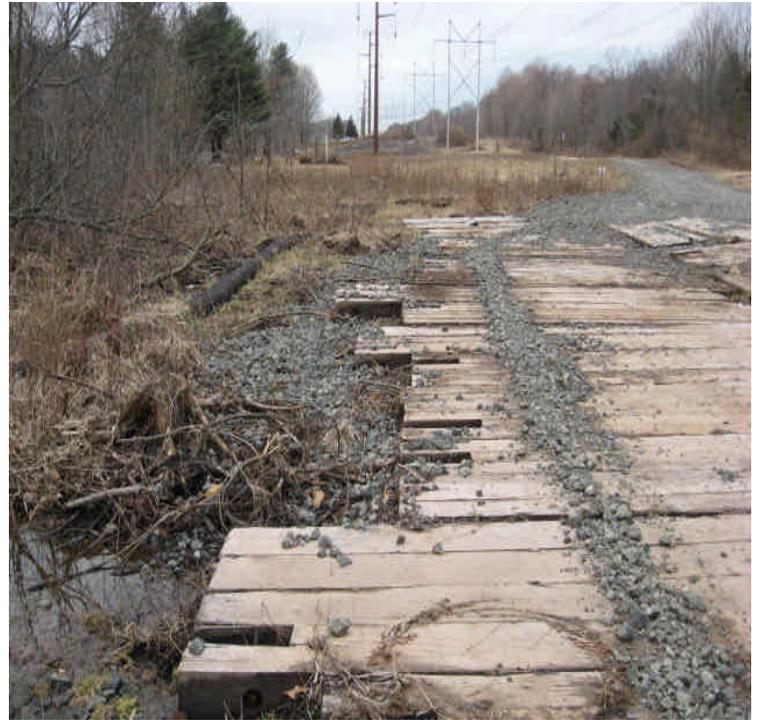
Liney Hall Ln: Plows have pushed stone onto timber mats and into the wetlands.

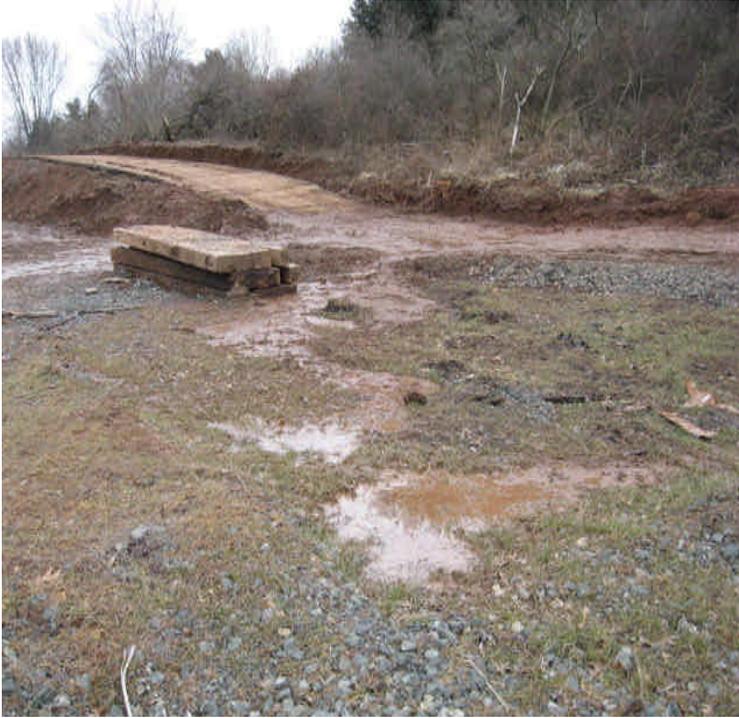
Powers Rd.	<p>Timber mats had been placed over the access road bypass last week for stabilization and structure. However, mats are now compressing into the soft ground and turbid run-off is flowing into the wetland boundary. 3/4/08</p>	<p>Additional controls are needed downgradient of the timber mats to prevent run-off to wetlands.</p> <p>Monitor the exposed pad site in the wetlands where the mats were taken from. 3/4/08</p>	<p>Needs attention.</p>
Williams; S. Turnpike + Merritt Parkway; Mansion Rd.; Durham Rd.; Stony Brook; Pent Rd.; Oliver Creek Rd.	<p>No sediment tracking was noted on any of these roadways and the adjacent areas appear stable. Stone construction entrance pads remain in place at entrances. 3/4/08</p>	<p>Continue to monitor entrances and sweep as needed. 3/4/08</p>	<p>NA</p>
Pond Hill Rd. Docker Dr.	<p>Exposed soils remain mulched and seeded off Pond Hill Rd. However, controls were not installed at wetlands. Additional controls were installed above the wetland off Docker. ATVs have been causing ruts and disturbance in areas between Pond Hill Rd and Docker Dr. 12/4</p>	<p>Contractors have made efforts to stabilize the area several times but ATV traffic is high in this area. Evaluate ways to keep ATVs out. Return for final stabilization when the ground thaws. 3/4/08 See erosion control section for more details. 3/4/08</p>	<p>Needs attention during thaw conditions.</p>

Powers Rd. Woodhouse Ave. Harrison Rd.	<p>Turbid run-off was noted from the bypass access road off Powers Rd. Timber mats are compressing into the mud and turbid run-off is flowing into the wetland boundary. 3/4/08</p>	<p>Additional controls are needed to stabilize the area and filter run-off. If sediment has accumulated, it should be removed by hand. 3/4/08.</p>	<p>Needs attention.</p>

Powers Rd: New timber mats on the bypass road are compressing into the soft soil. Turbid run-off is flowing into the wetland boundary.

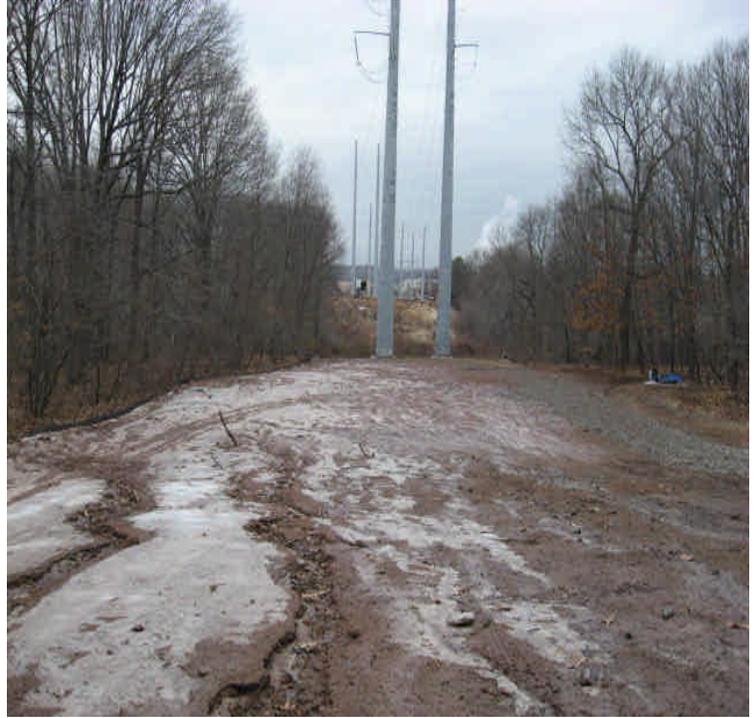
Docker Dr: Several eroded gullies/rills noted along the slope within the ROW. Additional controls/stabilization measures are needed to prevent erosion.

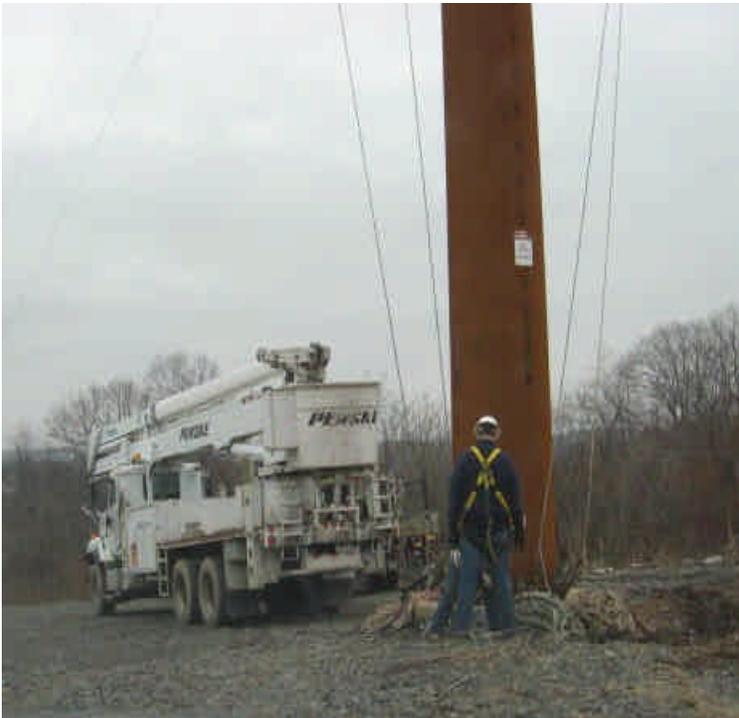
Blue Hills Orchard: Line installation underway from Pent Rd through the orchard.

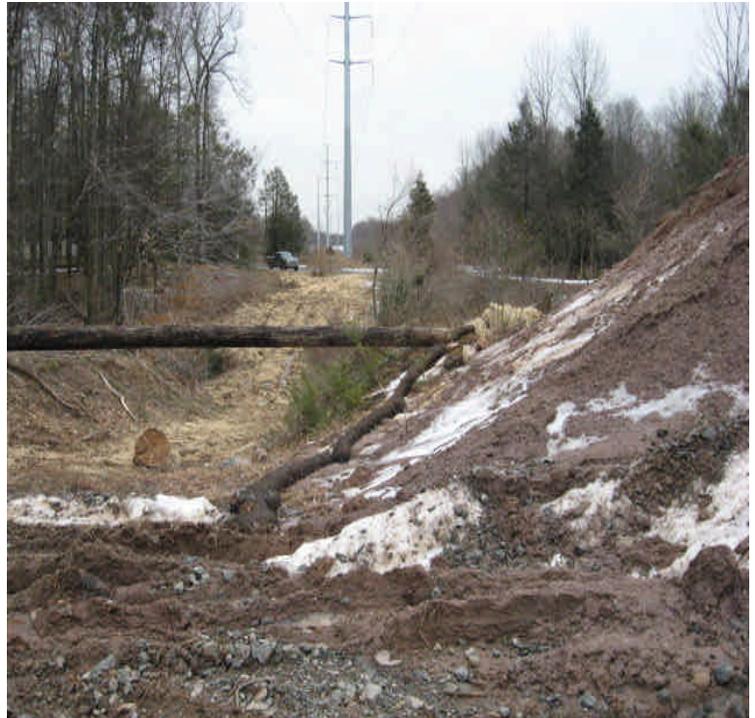
Cook Hill Jct: Soil stockpile and wetland crossing. Sediment from the stockpile is migrating under the controls on the slope upgradient from the wetland.
