**Docket No. 272 – Development and Management Plan Inspection**

**Segment 2a Inspection**

**Date:** March 11, 2008

**Location:** Segment 2a – Beseck Switching Station to Cheshire/Hamden Town Line

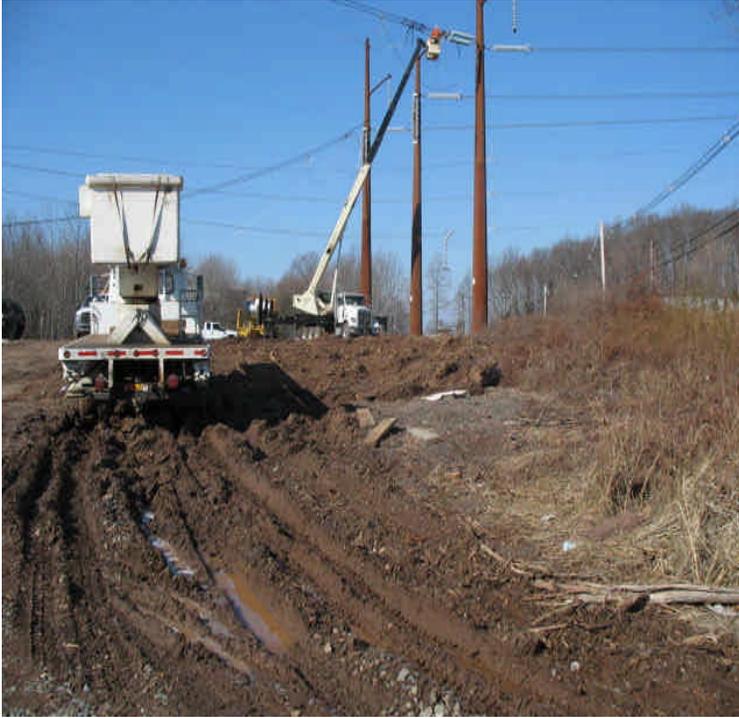
**Carpenter Ln:** Crews preparing for line pulling. Large, exposed area will need controls upon completion of work.

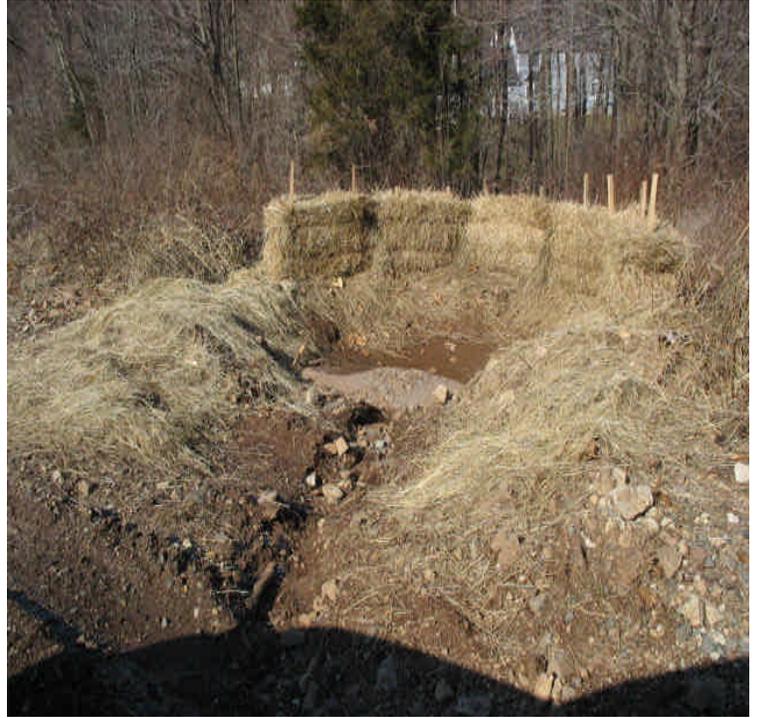
**High Hill Rd:** New water bars were installed with haybale basins to filter stormwater flowing down the access road on the slope near Rte 68.

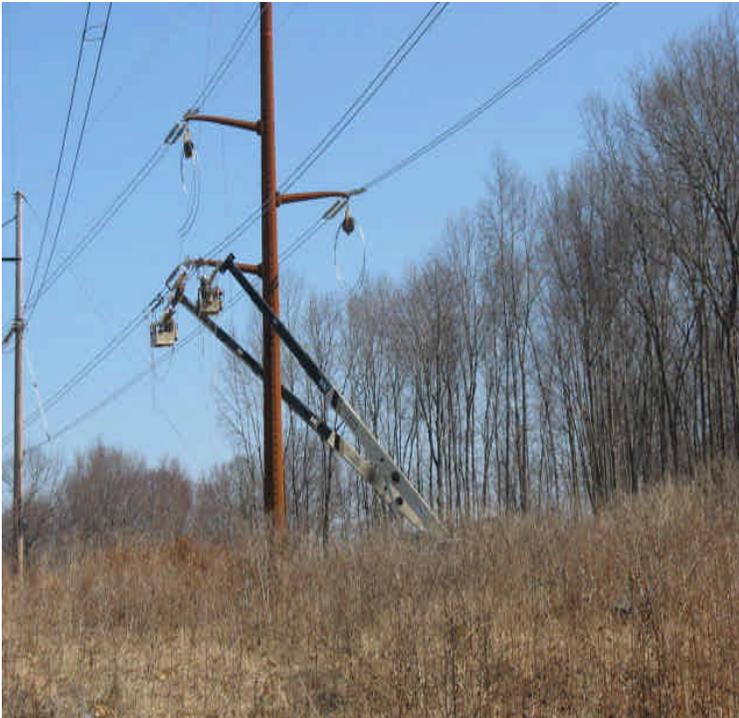
**Stony Brook Rd:** Line work was underway at several poles towards Williams Rd.

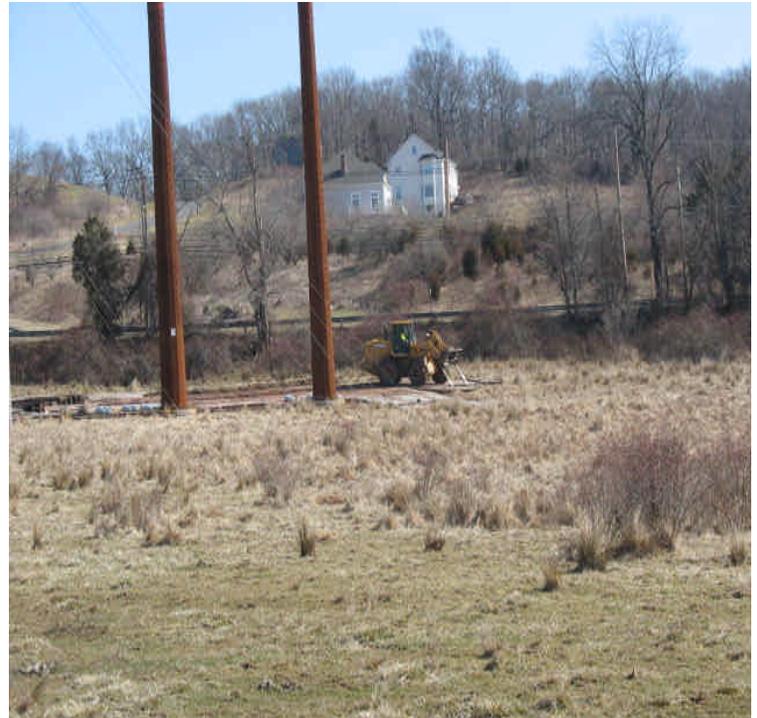
**Tamarack Swamp Rd:** Timber mats being relocated before the crossing to Stony Brook.

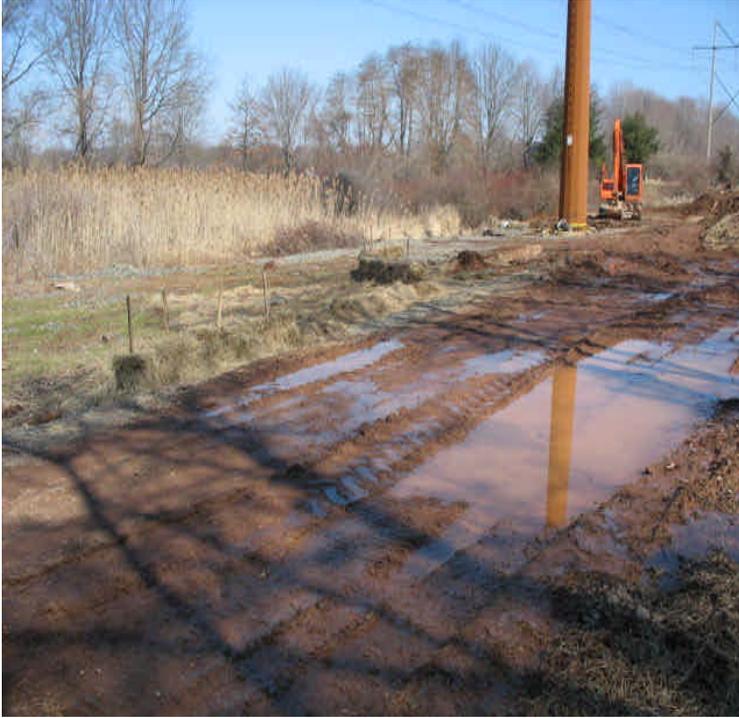
<p><b>Powers Rd.</b></p>	<p><b>Timber mats had been placed over the access road bypass for stabilization and structure. However, mats are now compressing into the soft ground and turbid run-off is flowing into the wetland boundary (since 3/4) 3/11/08</b></p>	<p><b>Additional controls are needed downgradient of the timber mats to prevent run-off to wetlands. If sediment has accumulated more than 2" here, it should be removed from the wetlands by hand, not to disturb the natural vegetation. 3/11/08</b></p>	<p><b>See erosion control section.</b></p>
<p><b>Williams; S. Turnpike + Merritt Parkway; Mansion Rd.; Durham Rd.; Stony Brook; Pent Rd.; Oliver Creek Rd.</b></p>	<p><b>No sediment tracking was noted on any of these roadways and the adjacent areas appear stable. Stone construction entrance pads remain in place at entrances. 3/11/08</b></p>	<p><b>Continue to monitor entrances and sweep as needed. 3/11/08</b></p>	<p><b>NA</b></p>

**Powers Rd:** New timber mats on the bypass road are compressing into the soil and turbid run-off is flowing into the wetland boundary.

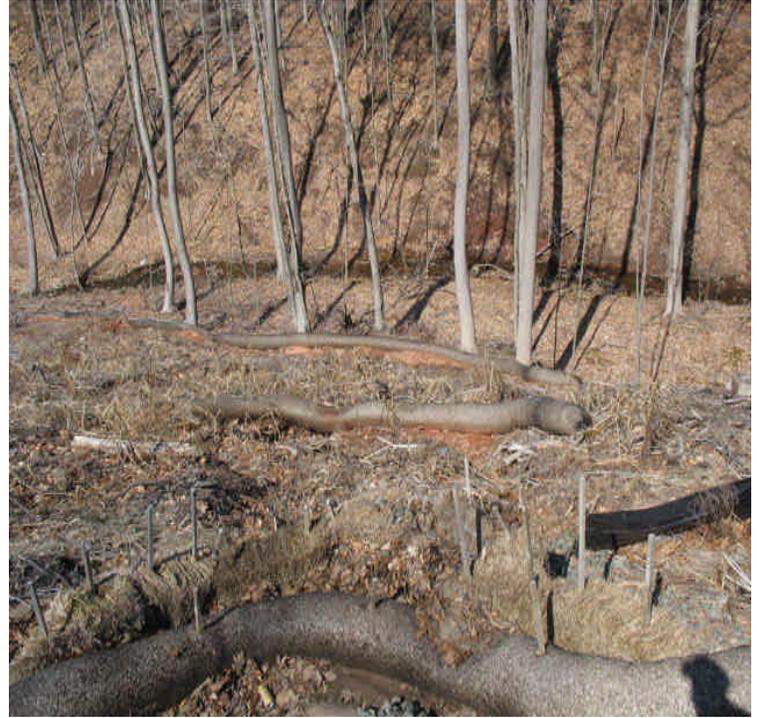
**Harrison Rd:** Stormwater has eroded soils and undermined controls where the gully has been noted on the slope for several months. Additional controls are needed and a long-term solution needs to be discussed.

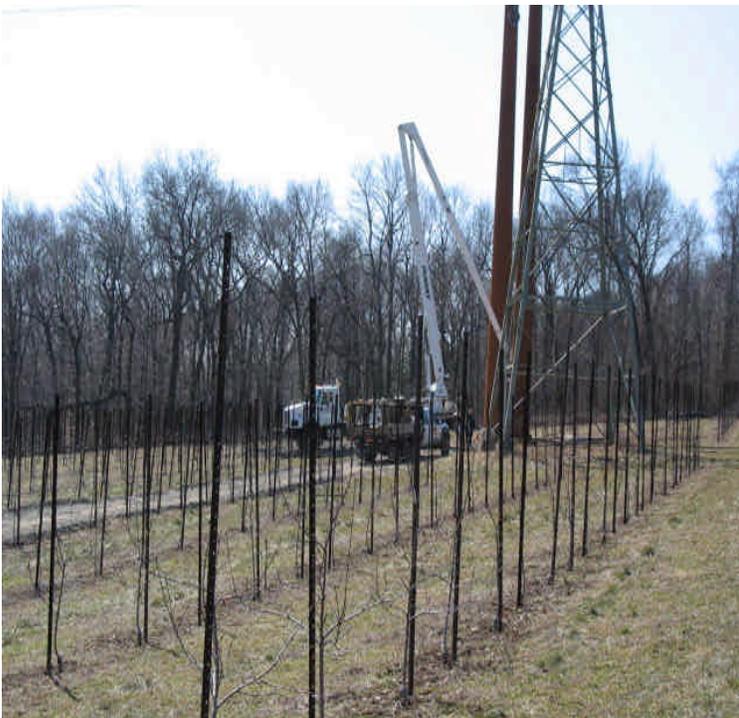
**Blue Hills Orchard:** Line installation underway from the orchard to Tuttle Ln.

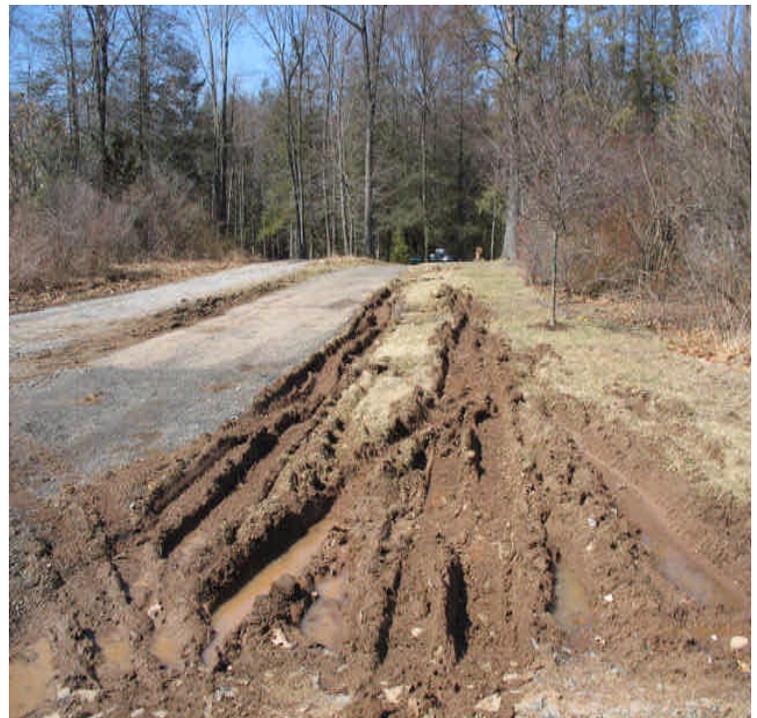
**Old Farms Rd:** Ruts noted from vehicles at the ROW access for Cook Hill Jct. Regrade and temporarily stabilize the area as needed.
