Docket No. 272 – Development and Management Plan Inspection

Segment 2a Inspection

Date: March 18, 2008

Location: Segment 2a – Beseck Switching Station to Cheshire/Hamden Town Line

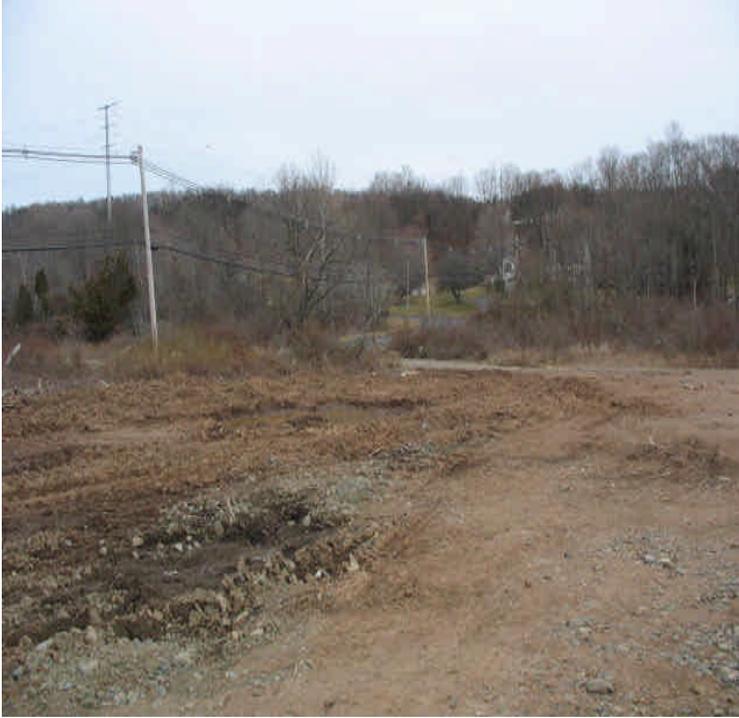
Carpenter Ln: Large, recently exposed area needs stabilization.

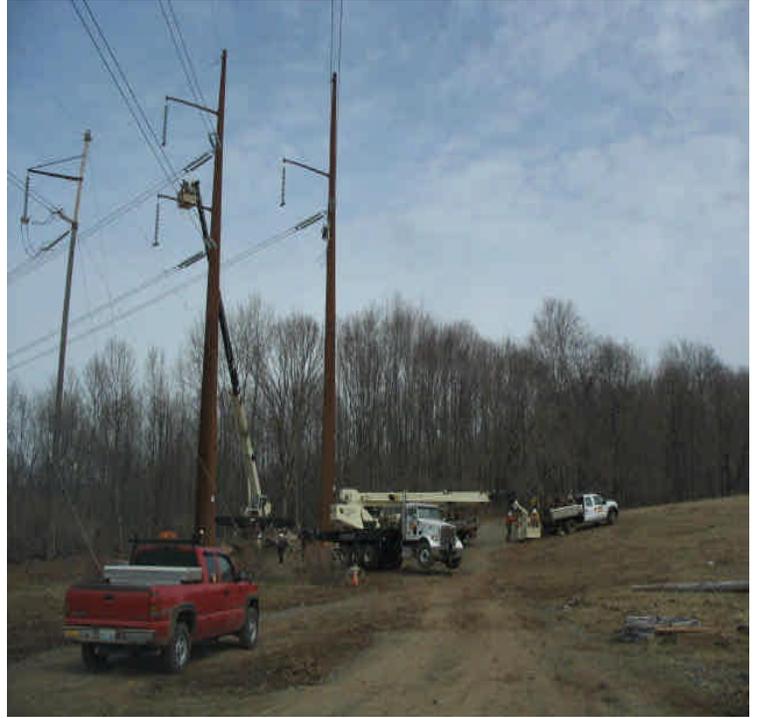
Liney Hall Ln: Line work was underway.

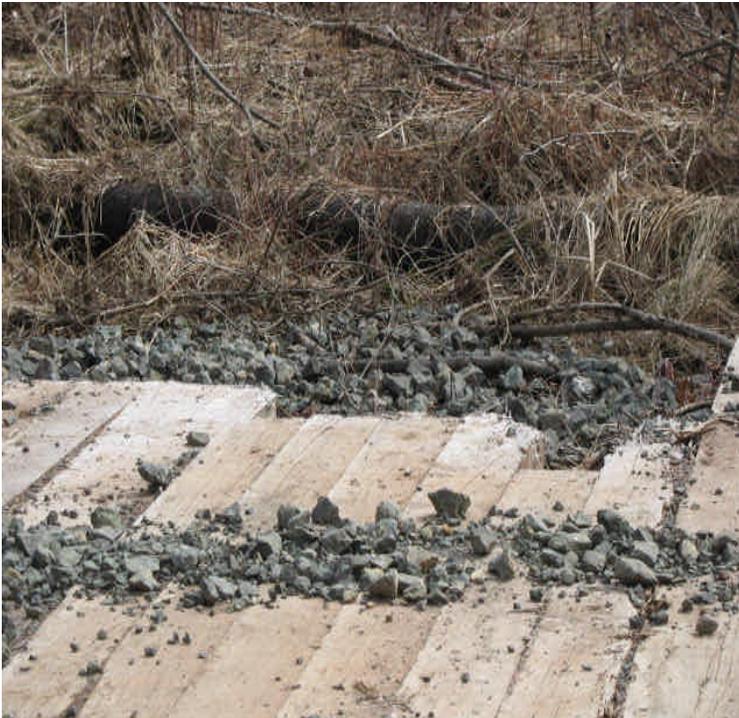
Liney Hall Ln: View of the stone that was plowed on the timber mats and within the wetlands during snow removal.

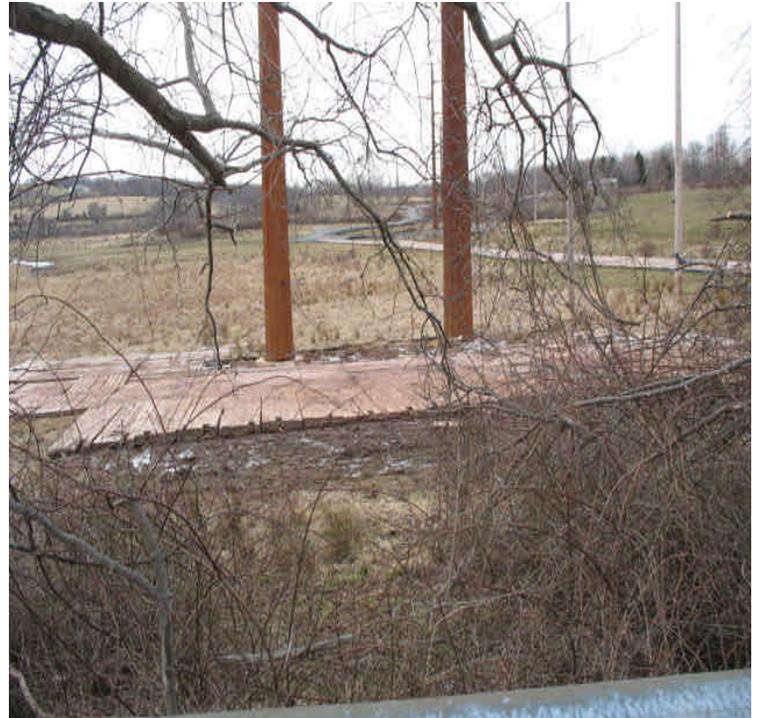
Tamarack Swamp Rd: Timber mats were relocated to the structure before the Stony Brook crossing.

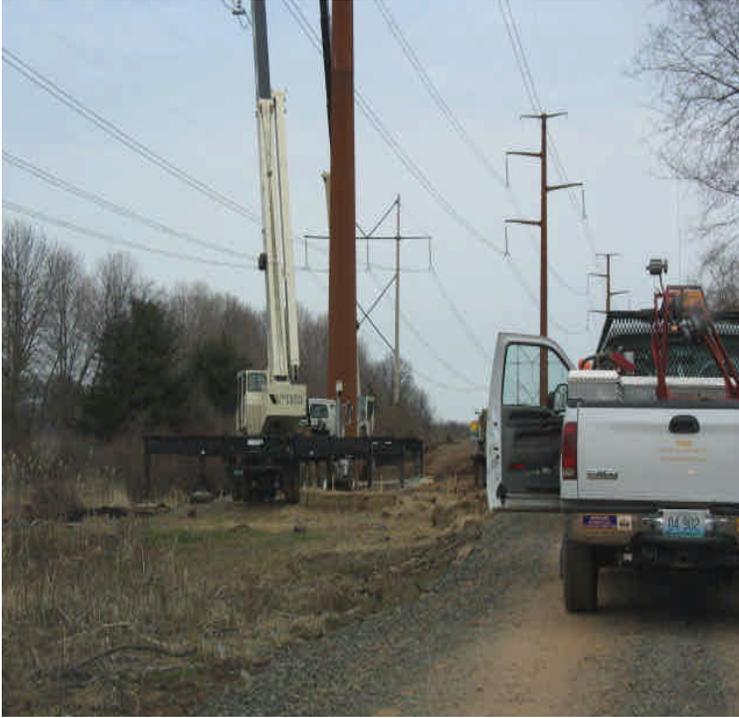
Powers Rd: The new bypass road and timber mats are stable. Additional controls were installed along the wetland boundary.

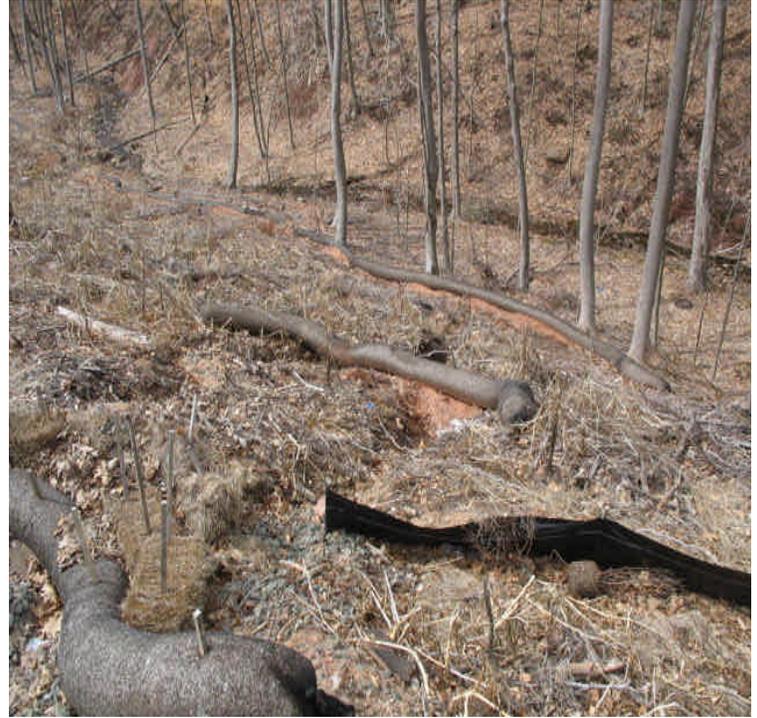
Harrison Rd: Stormwater has eroded soils and undermined controls where the gully had been noted on the slope for several months. Additional controls are needed and a long-term solution needs to be discussed.

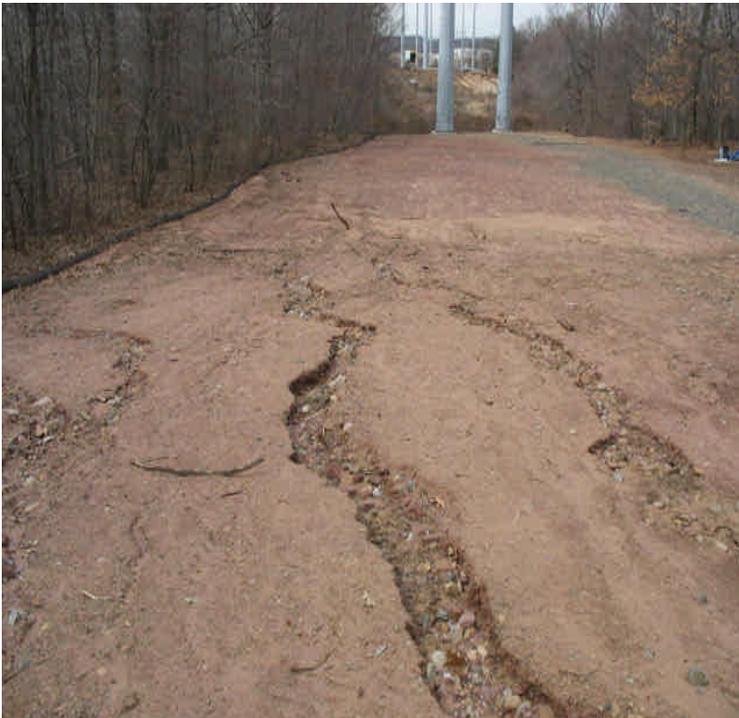
Docker Dr: Eroded rills/gullies had worsened along the slope due to heavy rain. Mulch/seed have washed away. Contractors are scheduled to return here with heavy mulch in an attempt to stabilize the area.

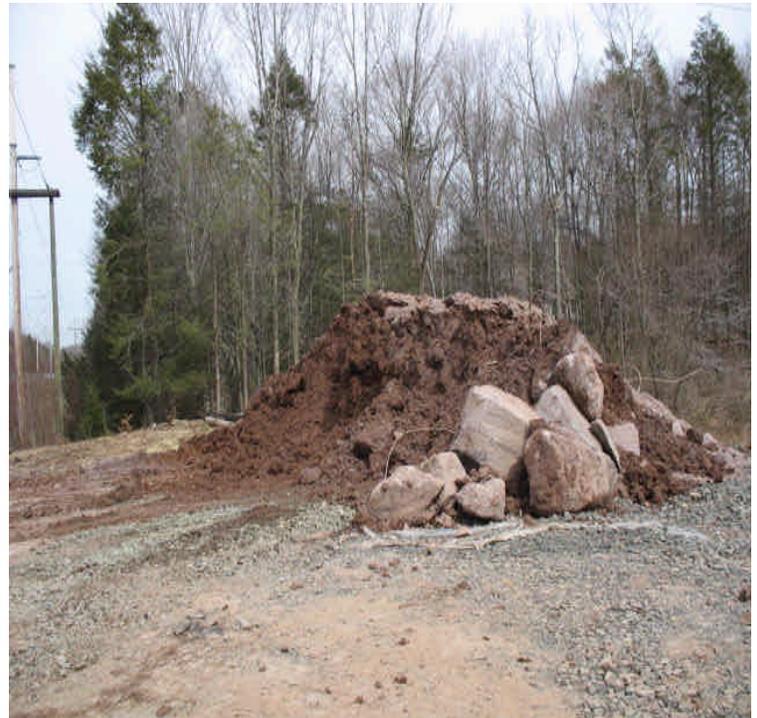
Old Farms Rd: The soil stockpile at Cook Hill Jct. had been partially removed. Continue to remove the material and stabilize the area.
