**Docket No. 272 – Development and Management Plan Inspection**

**Segment 2a Inspection**

**Date:** April 22, 2008

**Location:** Segment 2a – Beseck Switching Station to Cheshire/Hamden Town Line

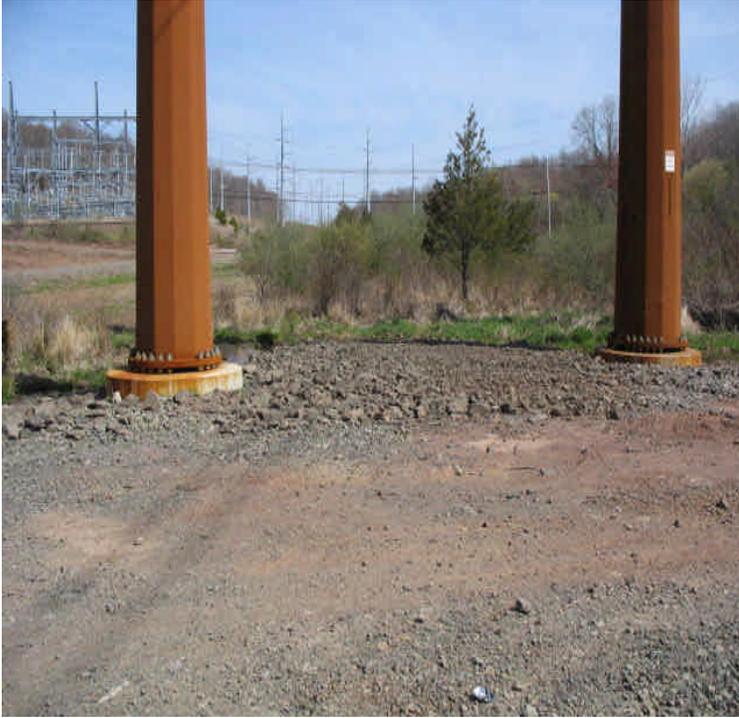
**Carpenter Ln:** New areas of stone installed were within the wetlands. Crews are reducing the overall wetland impacts by eliminating one of the proposed access roads to the structures but they are working on an access connection between the sets.

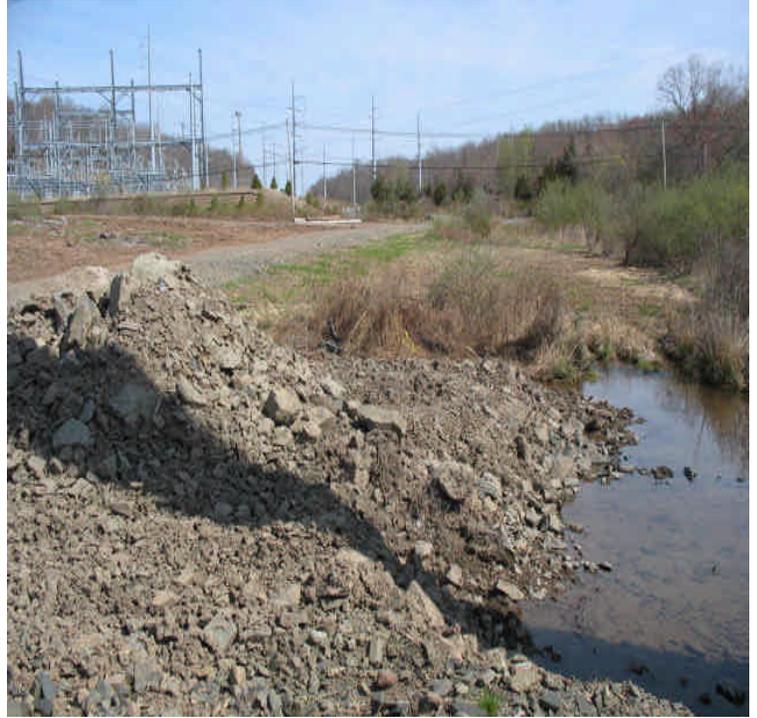
**Carpenter Ln:** Stone/sediment stockpile from the work was located upgradient from wetlands. Relocate or remove the stockpile greater than 100 feet from wetlands. Also, controls at the outlet did not appear to be repaired following the observation of turbidity on 4/8.

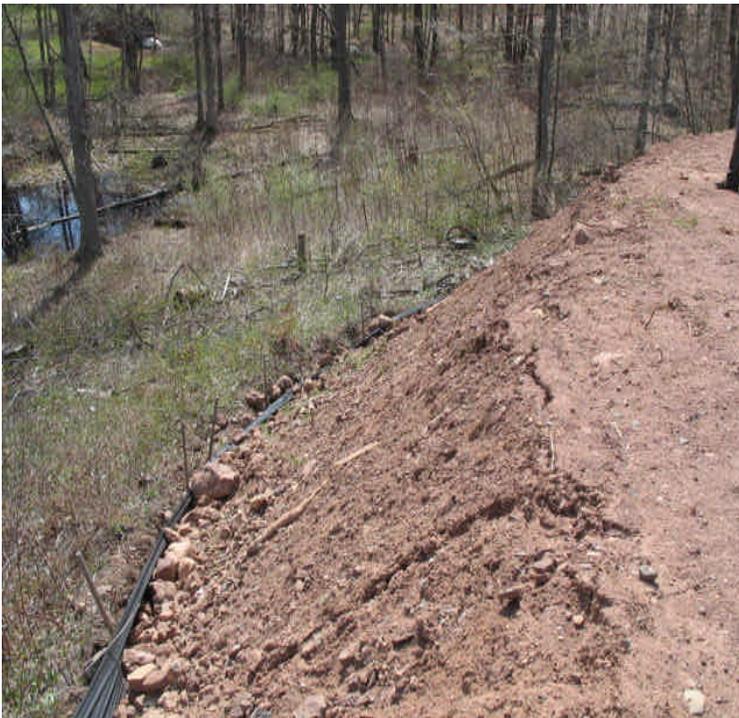
**Durham Rd:** Exposed soils & slope noted upgradient of wetlands north of Durham Rd. Silt fence has been knocked down by wind, large stones and material from the slope. Repair the controls.

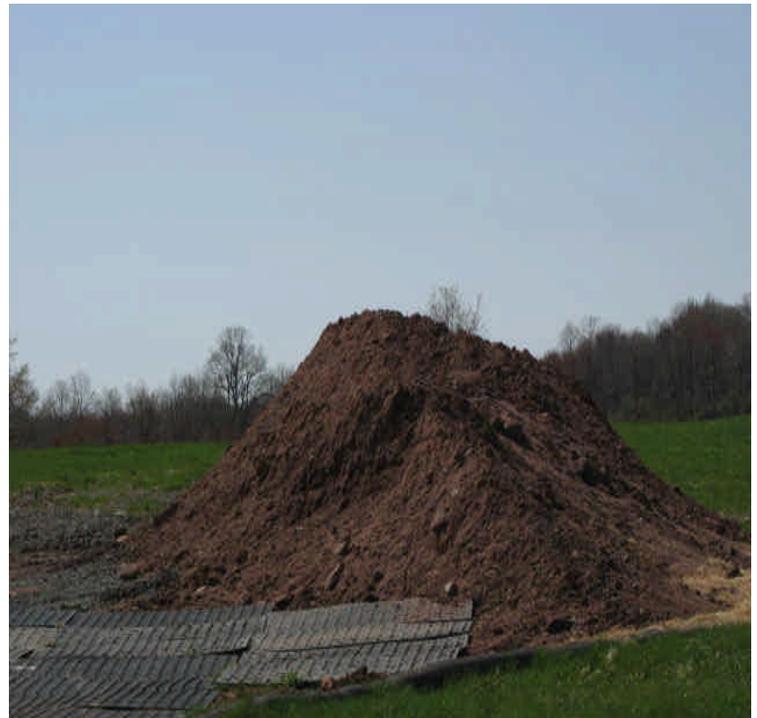
**Tamarack Swamp Rd.:** Stockpile located east of the roadway is not fully contained with controls. Add controls and stabilize or remove the stockpile.

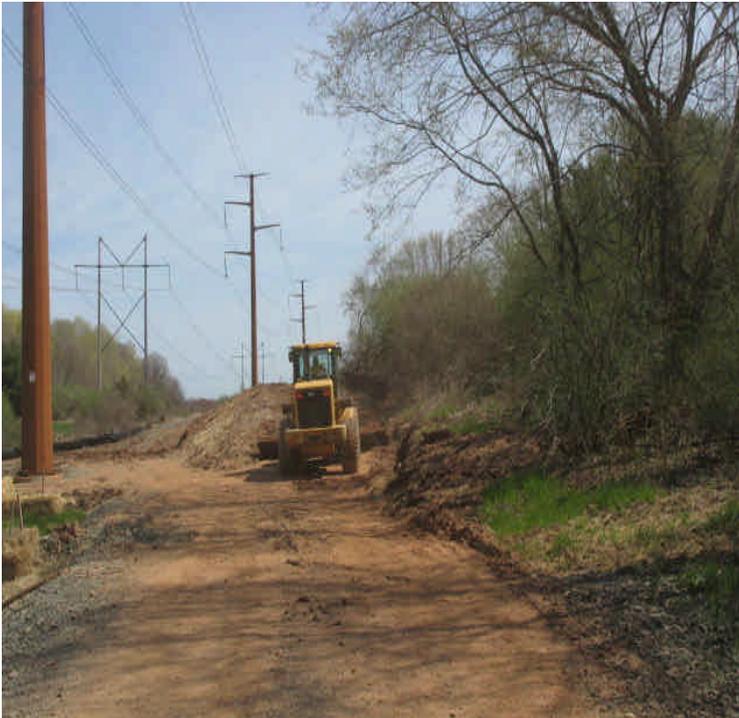
**Powers Rd: Timber mat removal underway at the saturated crossing.**

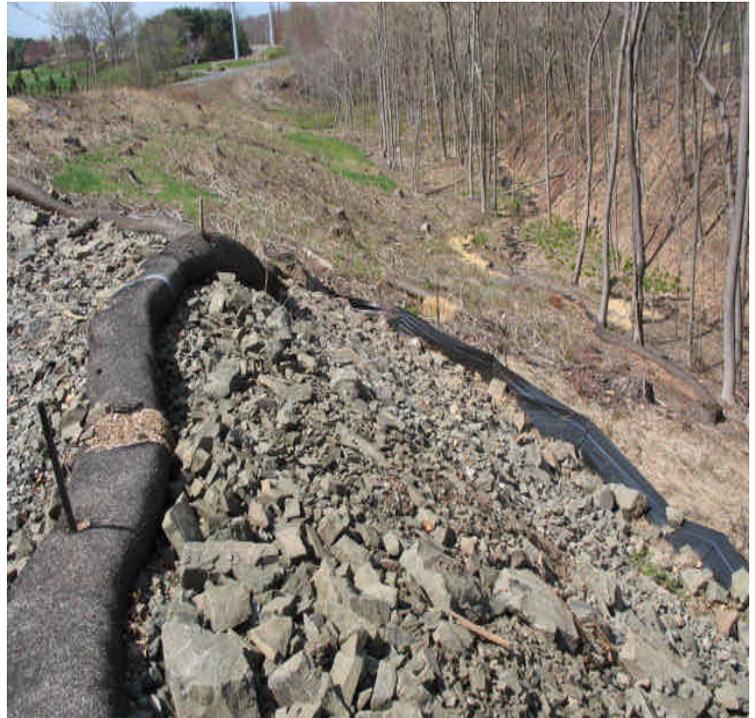
**Harrison Rd: The top terrace of the slope below the newly installed detention area has been covered in riprap for stabilization. The pad here will remain, as requested by the golf club, for maintenance crew parking.**

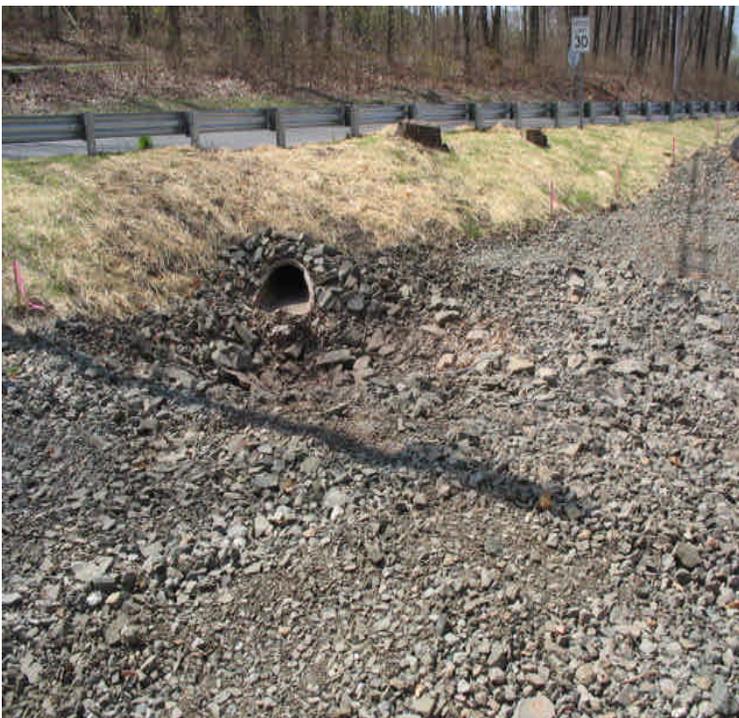
**Harrison Rd: Crews installed a more permanent solution to filter and slow the stormwater from the roadway that outlets to the ROW. A detention area "surge pool" was constructed to allow water to flow over a flat grade prior to heading downslope.**

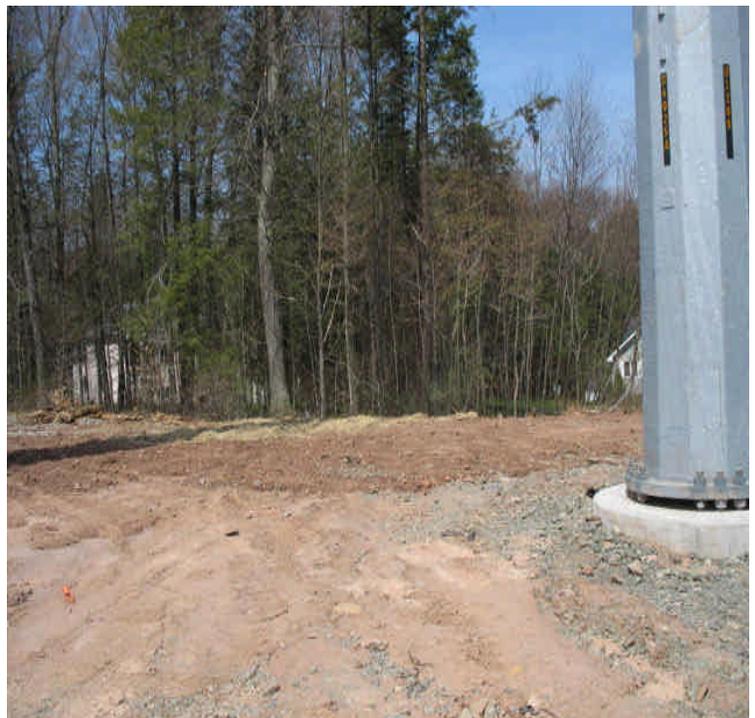
**Old Farms Rd: Old foundations have been removed from the site and some hay/seed have been applied. Continue to stabilize exposed soils.**
