**Docket No. 272 – Development and Management Plan Inspection**

**Segment 2a Inspection**

**Date:** April 29, 2008

**Location:** Segment 2a – Beseck Switching Station to Cheshire/Hamden Town Line

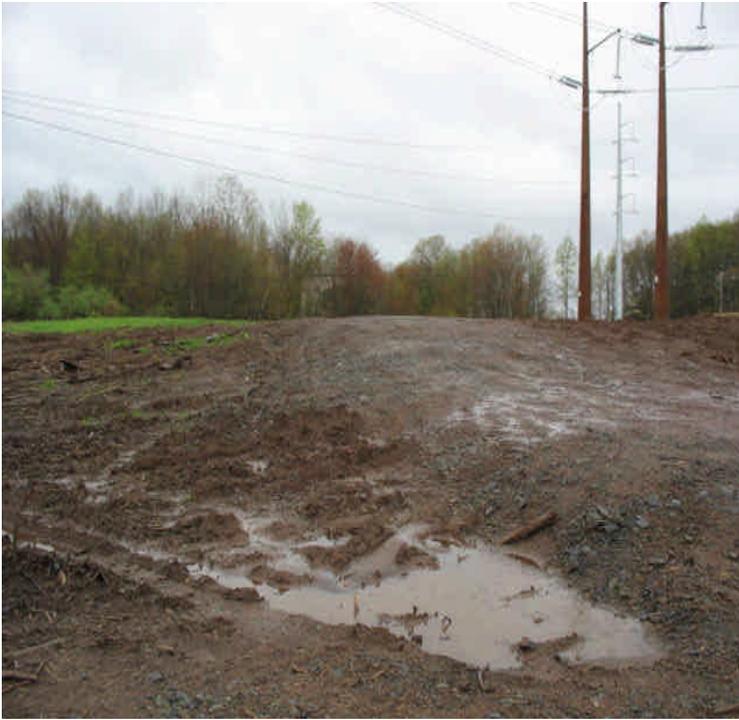
**Carpenter Ln:** Large area disturbed/exposed during line crew work remains upgradient from wetlands. Final grade and stabilize this area which has remained inactive for several weeks.

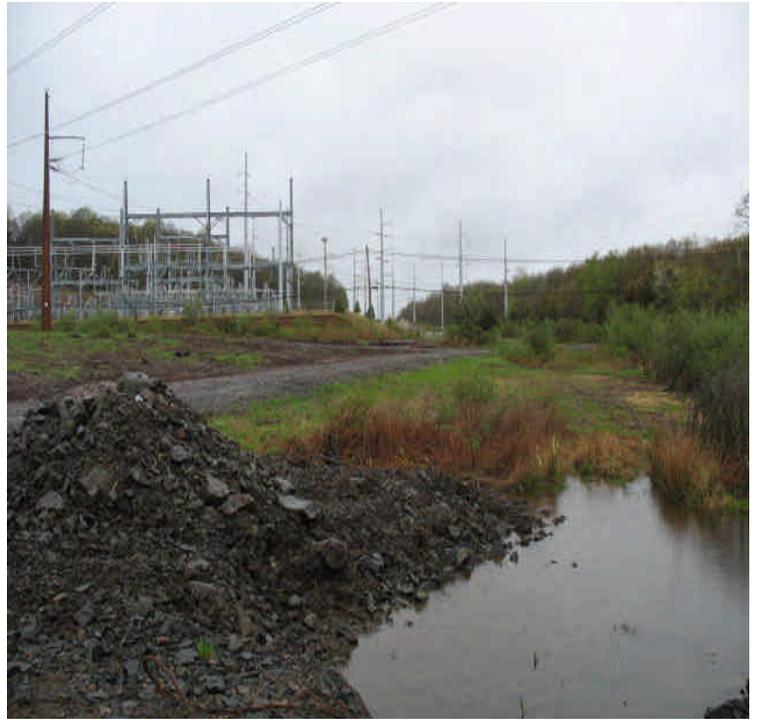
**Carpenter Ln:** Stone/sediment stockpile from pad work was located in/adjacent to wetlands. Relocate or remove the stockpile greater than 100 feet from wetlands. Also, controls at the outlet should be repaired prior to additional work.

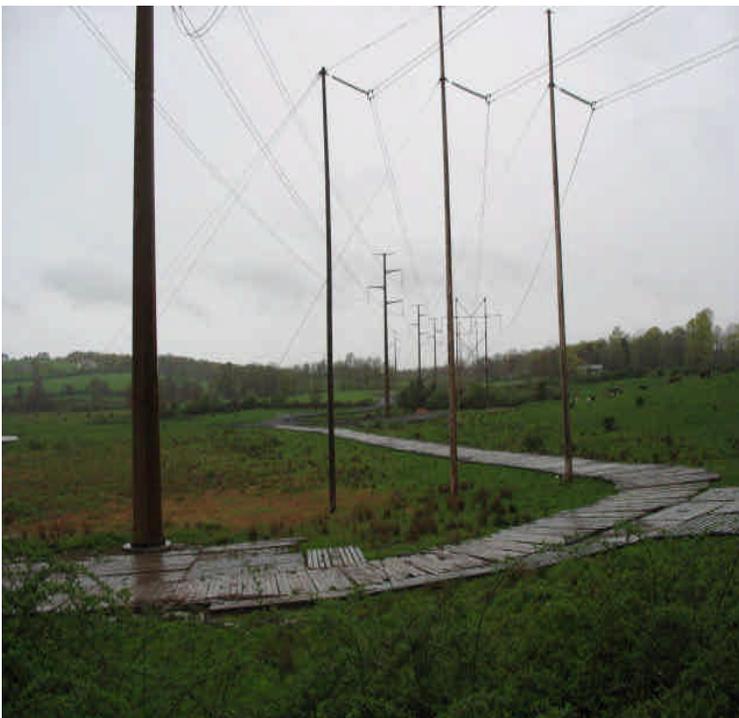
**Tamarack Swamp Rd:** View of timber mat access road through the farm fields and wetlands.

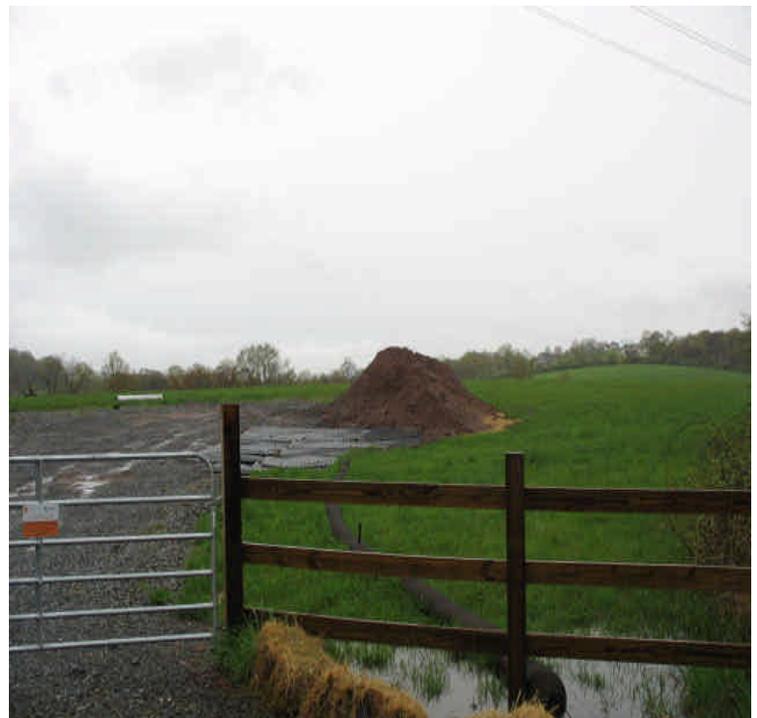
**Tamarack Swamp Rd.:** Stockpile located east of the roadway is not fully contained with controls. Add controls and stabilize or remove the stockpile.

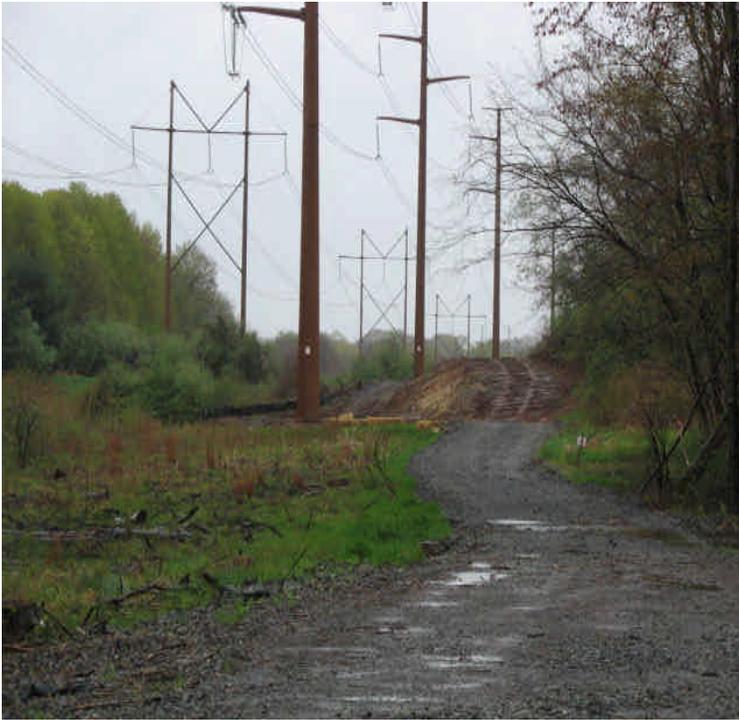
**Powers Rd: Timber mat removal complete at the saturated crossing. Controls remain in place at the wetland.**

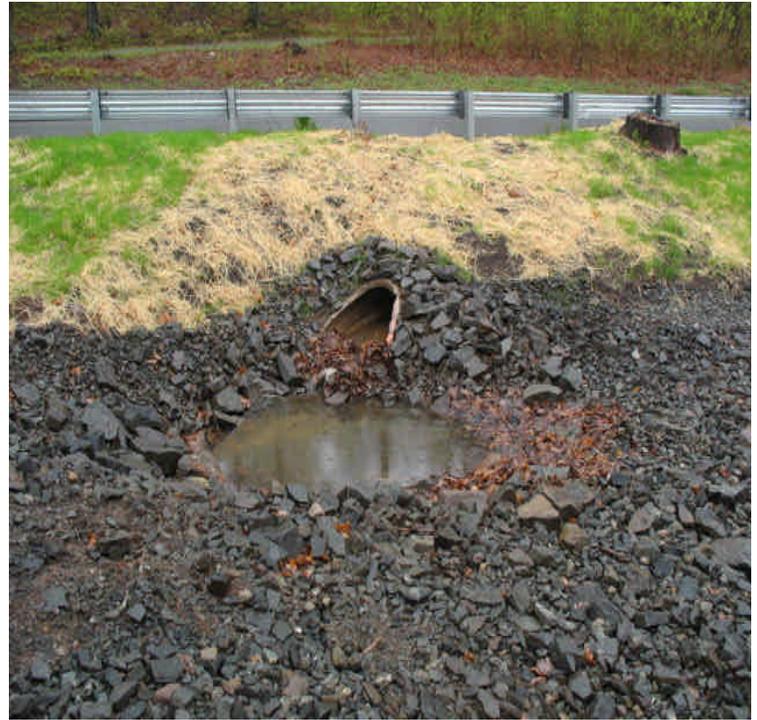
**Harrison Rd: View of the recently installed stormwater solution for run-off from the roadway. The detention area had some pooled water and stormwater was percolating through the stone during heavy rain. Continue to evaluate.**

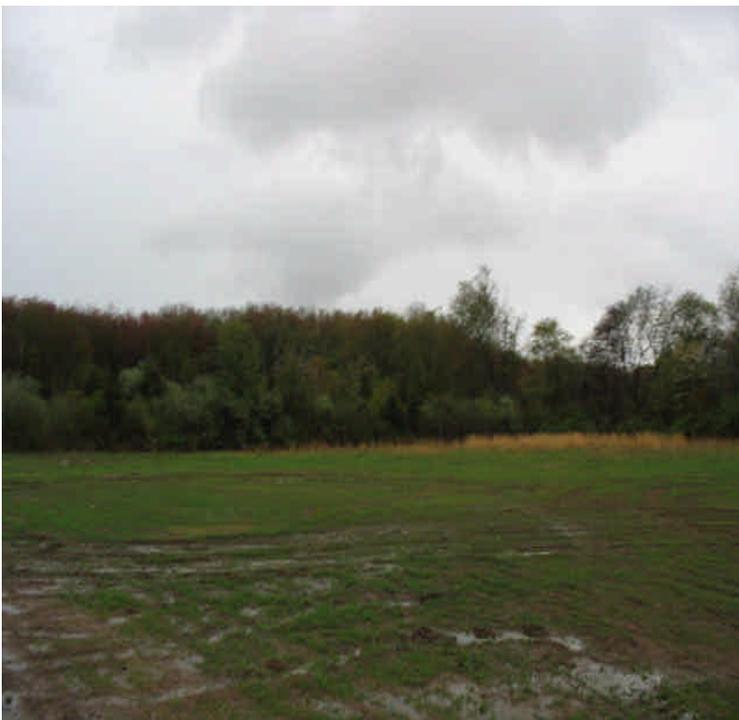
**Pond Hill Rd: Grass growth noted at exposed soils graded and seeded over winter. Continue to monitor for full stabilization.**

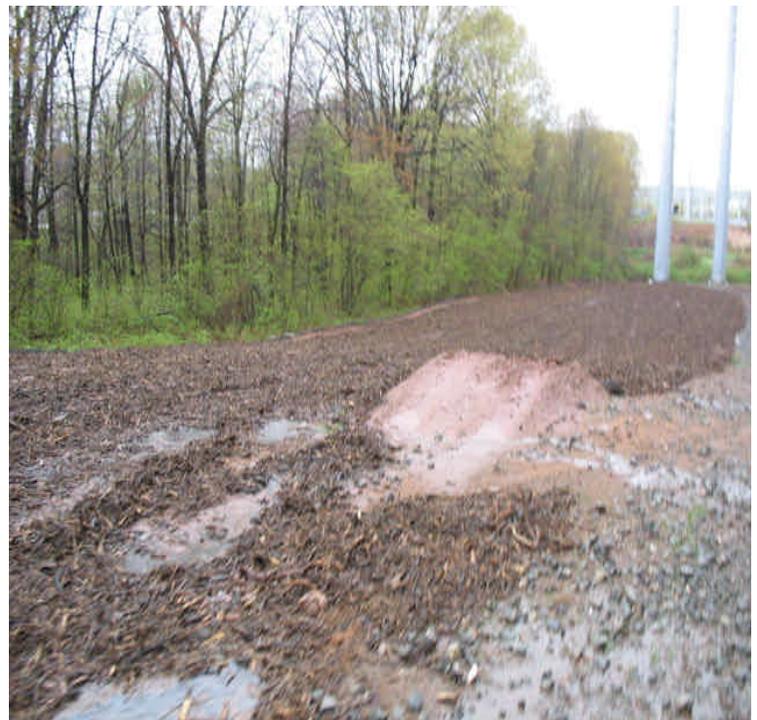
**Docker Dr: Heavy mulch was applied over exposed soils for stabilization from stormwater/ erosion and ATV traffic.**
