Docket No. 272 – Development and Management Plan Inspection

Segment 2a Inspection

Date: July 15, 2008

Location: Segment 2a – Beseck Switching Station to Cheshire/Hamden Town Line

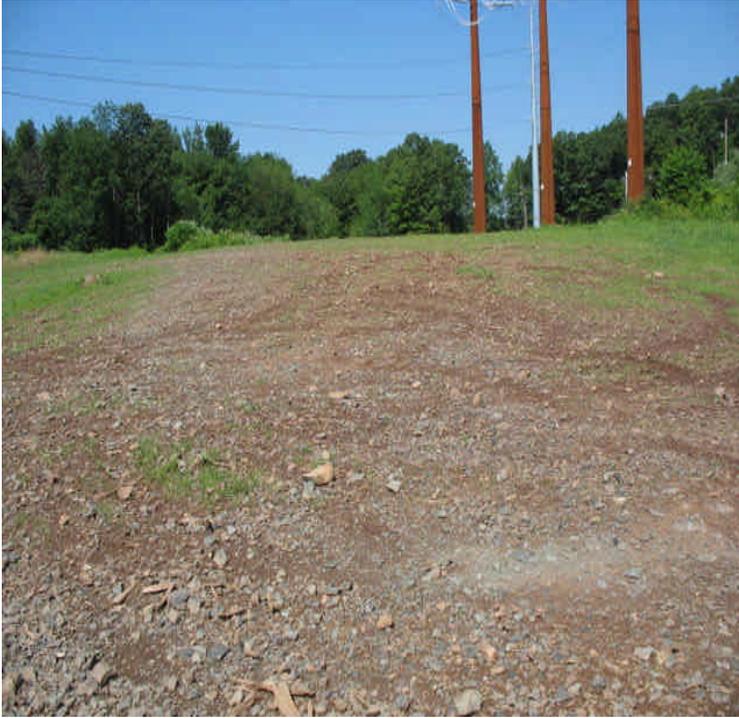
Carpenter Ln: The disturbed area remains graded and seeded but vegetative growth is still fairly sparse. Additional seed may be needed during more favorable conditions.

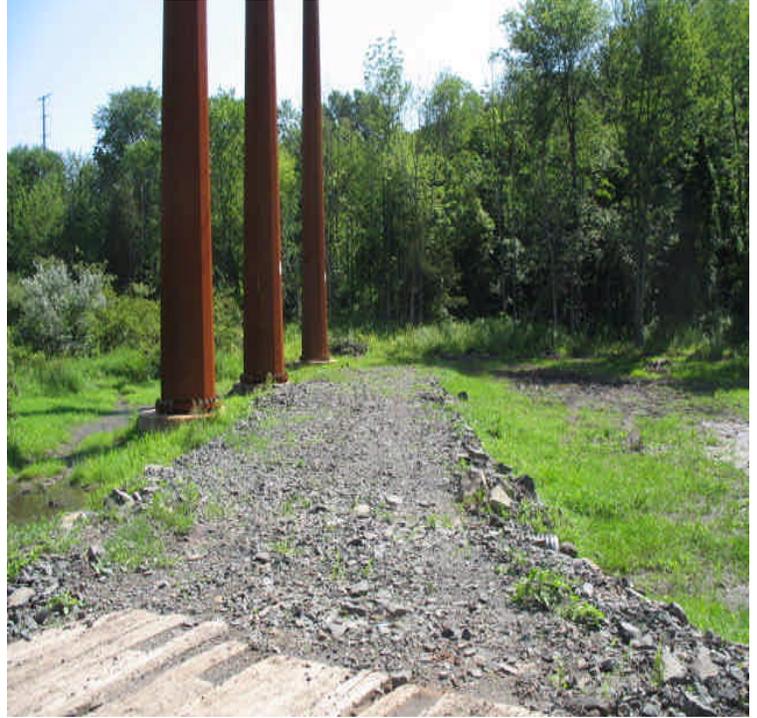
Carpenter Ln: Restoration work is complete within the wetlands. Minor seeding will be done when water subsides. Impacts were reduced from original permitted numbers and narrowed to a spur road.

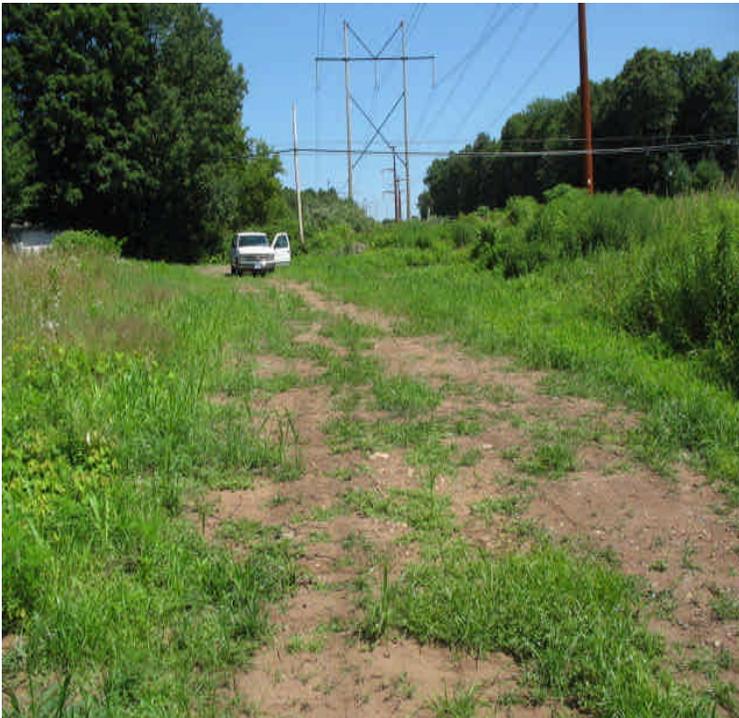
Durham Rd (South): Exposed access road sloping toward the wetlands. Needs minor controls to prevent run-off from entering the wetlands. The noted increase in vegetation will also help filter run-off.

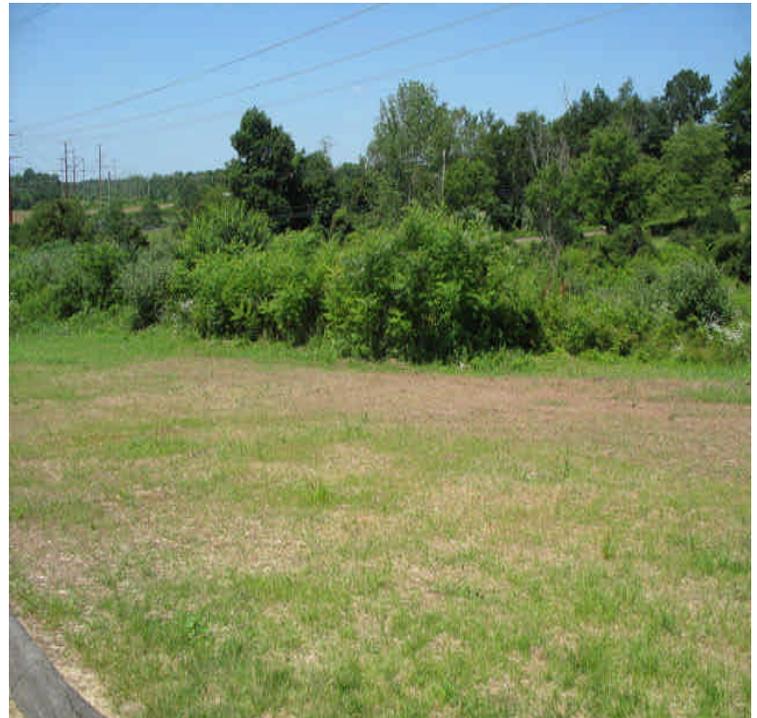
Stony Brook: Final grading/restoration complete. Topsoil, hay and seed remain in place. Additional seed may be needed during more favorable conditions.

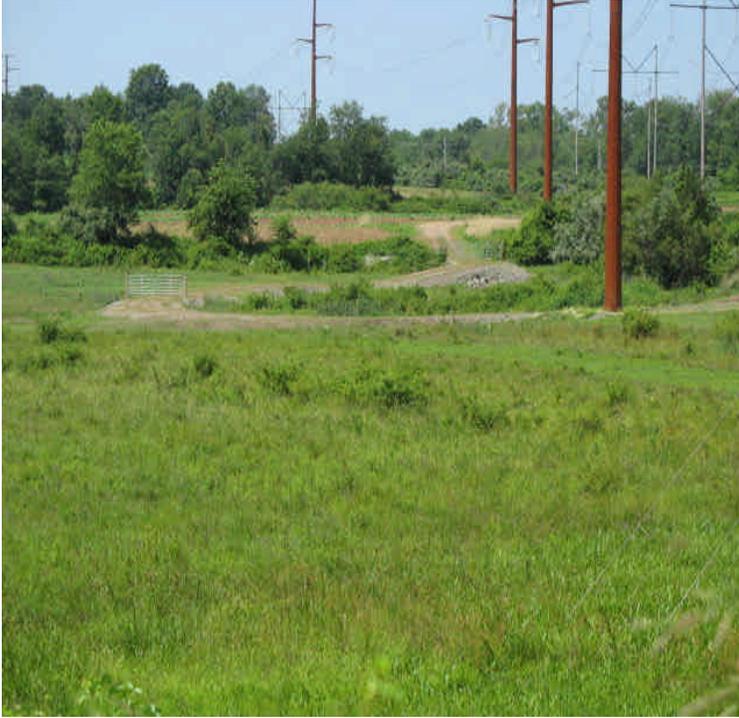
Tamarack Swamp: Access road pads remain narrowed and graded. Adjacent areas have good vegetative growth.

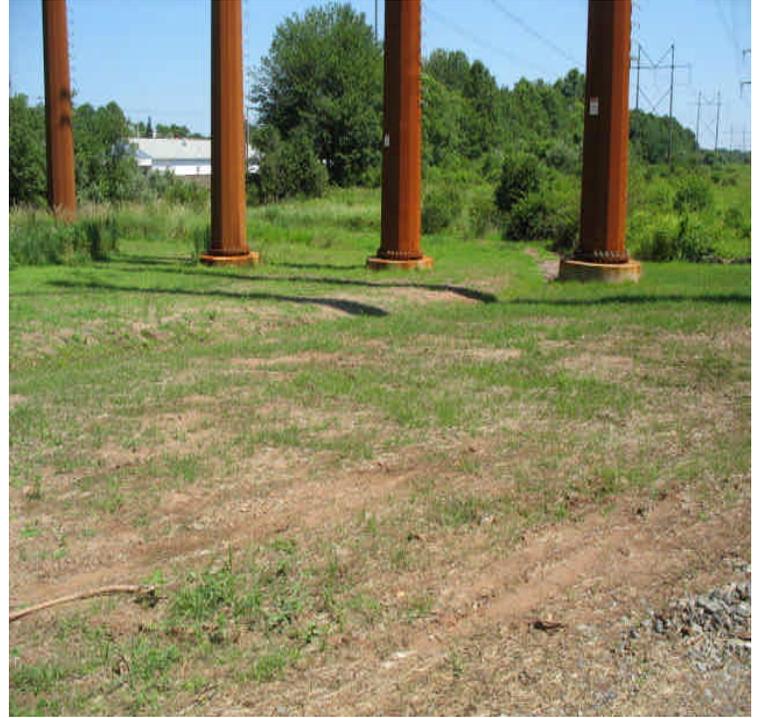
Powers Rd: Final restoration complete. Some grass growth noted. Additional seed may be needed along the banks. Continue to monitor

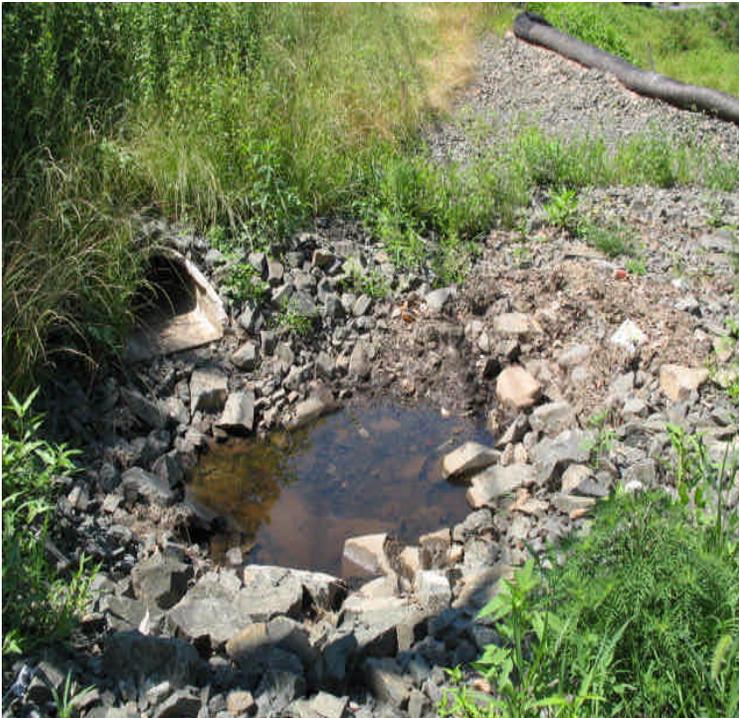
Harrison Rd: Stormwater from roadway run-off was settling out in the detention basin.

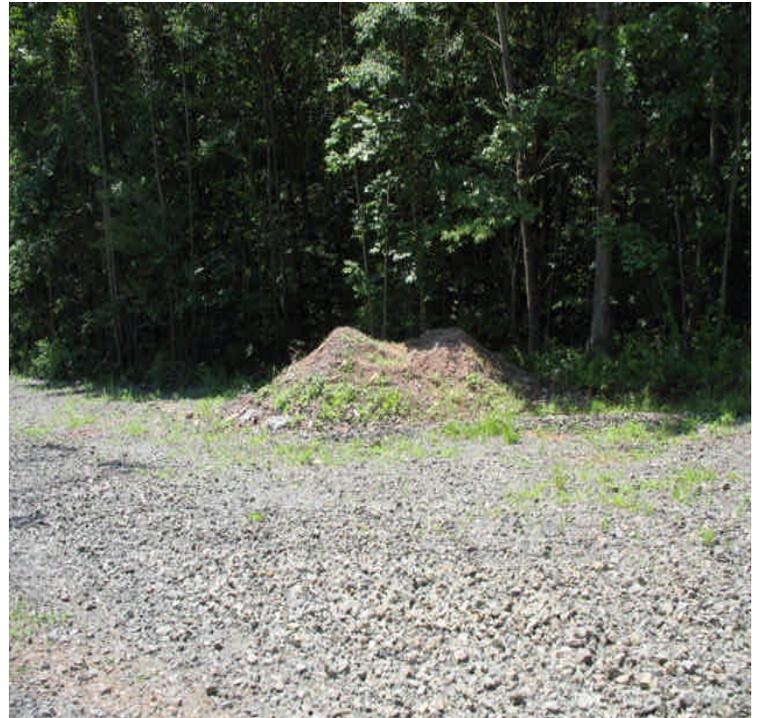
Tuttle Rd: Small stockpile left at Tuttle Ln. Final restoration has not been performed in this area.
