Docket No. 272 – Development and Management Plan Inspection

Segment 2a Inspection

Date: July 29, 2008

Location: Segment 2a – Beseck Switching Station to Cheshire/Hamden Town Line

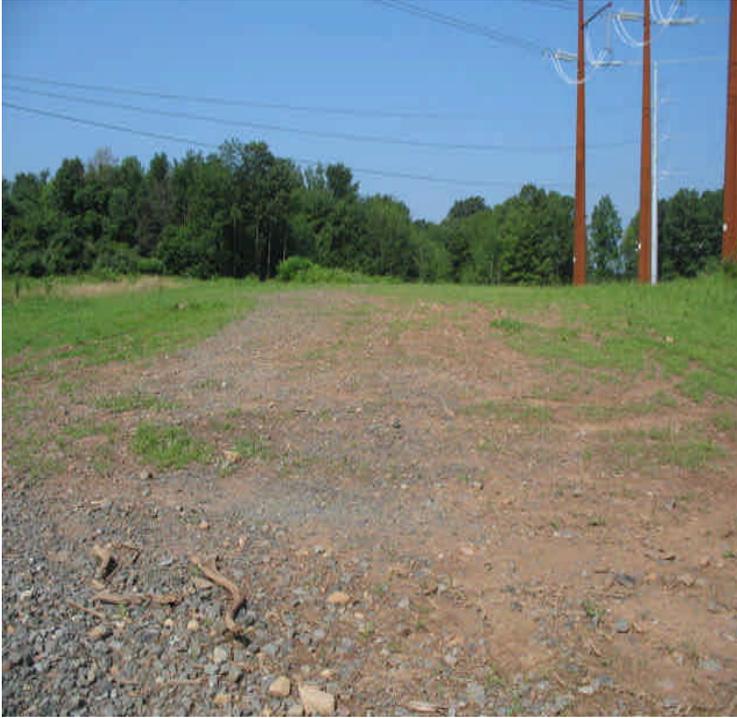
Carpenter Ln: The disturbed area remains graded and seeded but vegetative growth is still fairly sparse. Additional seed may be needed during more favorable conditions.

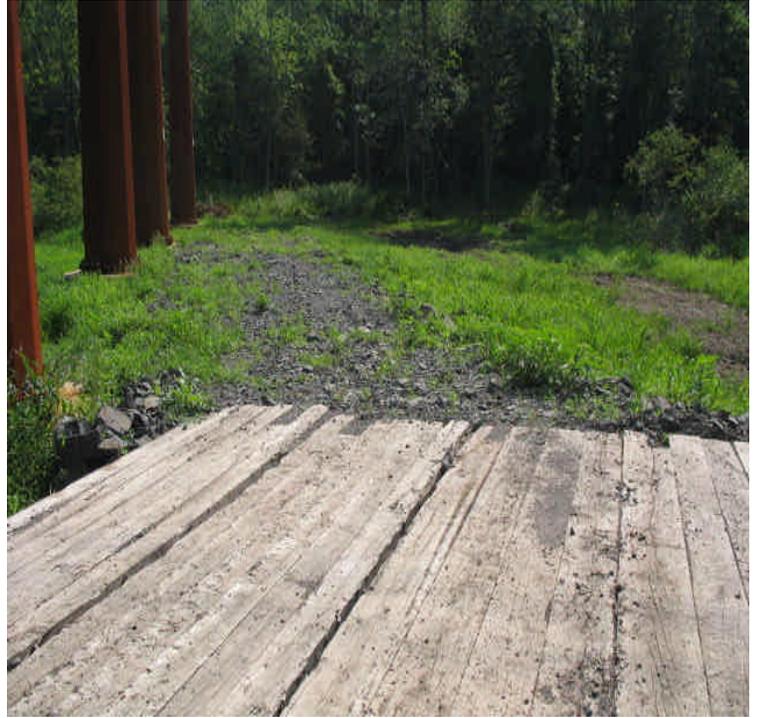
Carpenter Ln: Restoration work is complete within the wetlands. Impacts were reduced from original permitted numbers and narrowed to a spur road. The span timber bridge will remain.

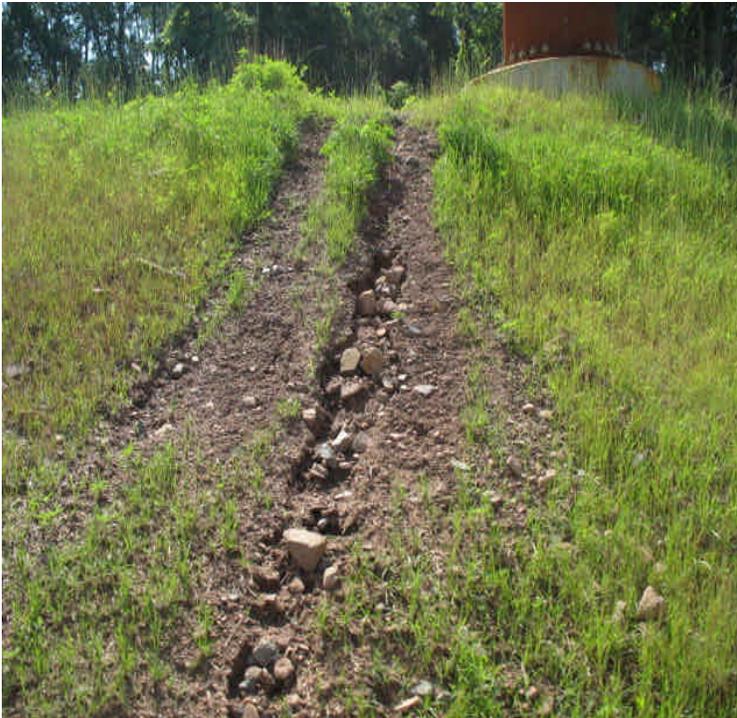
High Hill Rd: Previously stabilized slope is being disturbed by ATVs.

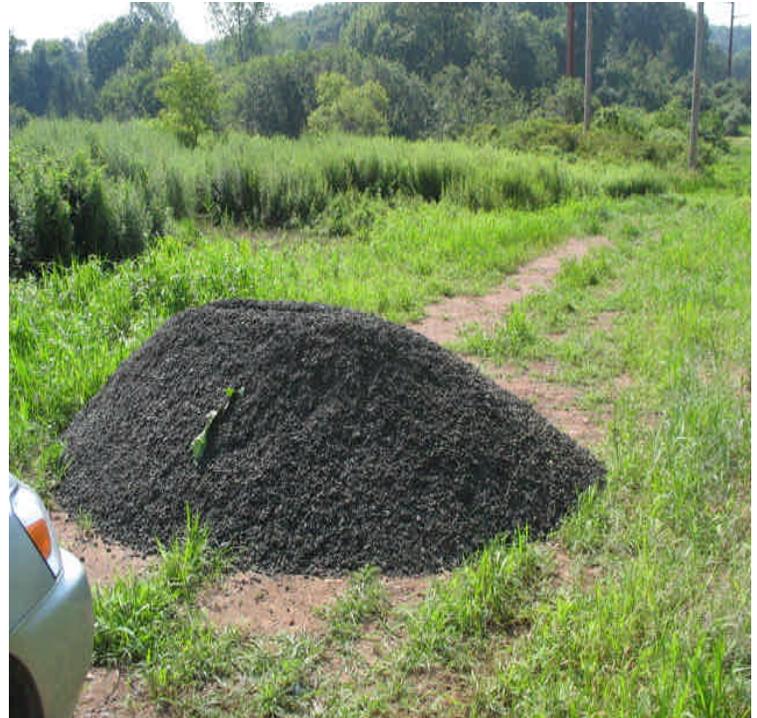
Durham Rd: Small roadbase stockpile was left by roadwork crews; the stockpile is not associated with the M/N project.

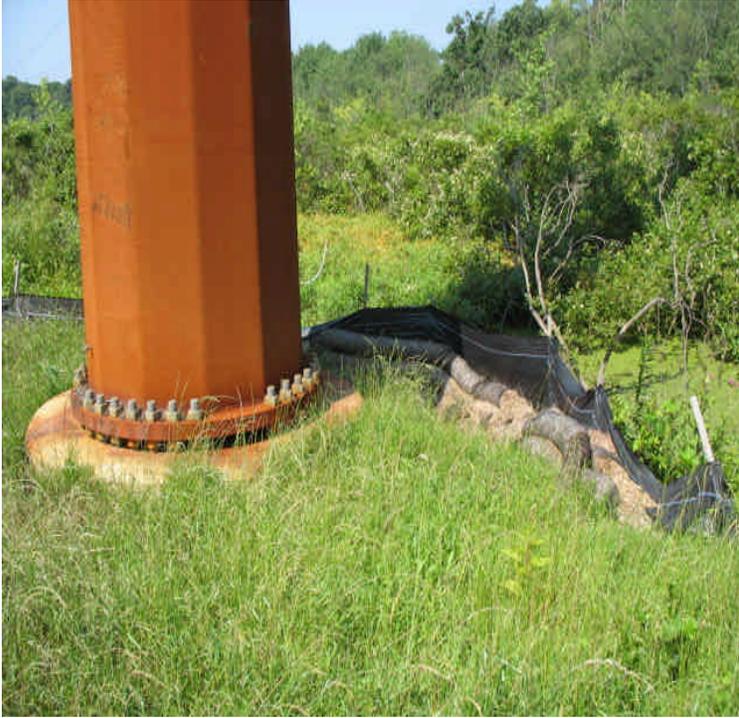
Tamarack Swamp: Vegetation has grown in around the pole within the wetlands on the west side of the roadway.

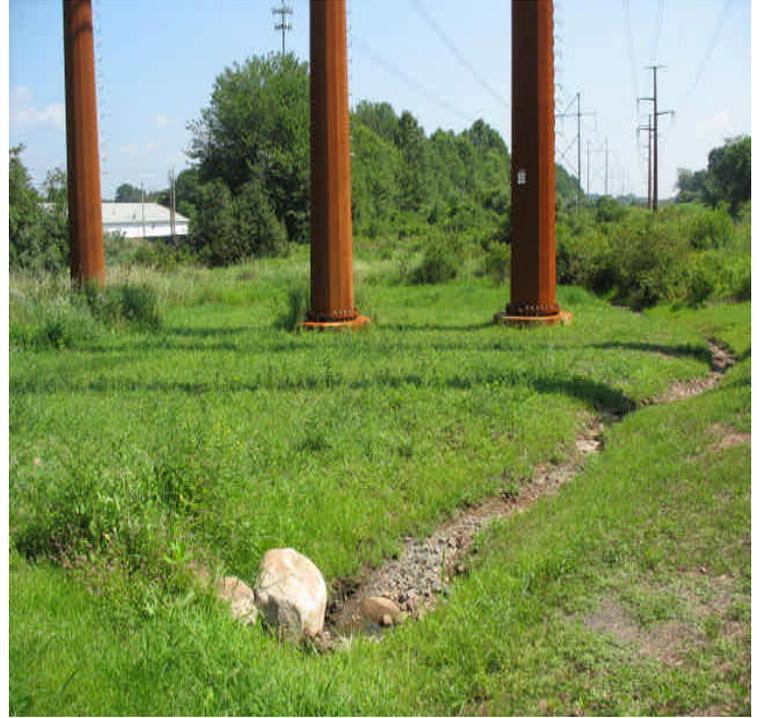
Powers Rd: Final restoration complete. Additional grass growth noted along the channel banks.

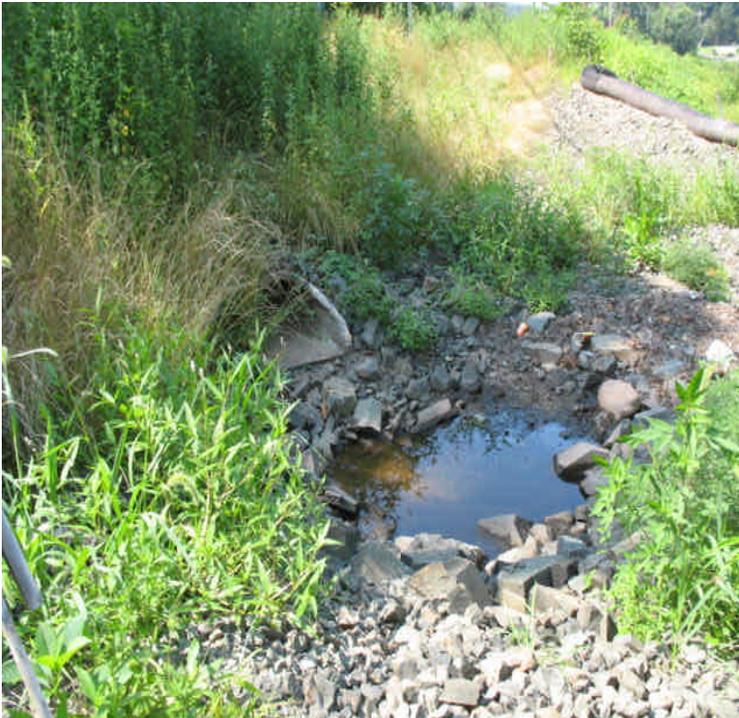
Harrison Rd: The riprap stormwater collection and dispersal area is working well. No further erosion was noted on the slope.

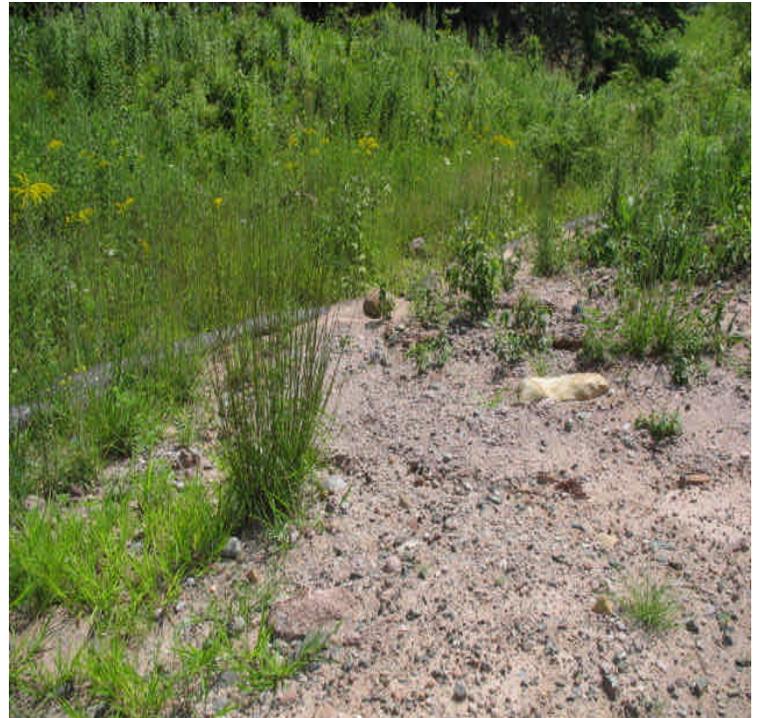
Cook Hill Jct: Some sediment has started to wash over the filter sock sock upgradient from the wetlands. Sediment removal is needed.
