Docket No. 272 – Development and Management Plan Inspection

Segment 2a Inspection

Date: August 5, 2008

Location: Segment 2a – Beseck Switching Station to Cheshire/Hamden Town Line

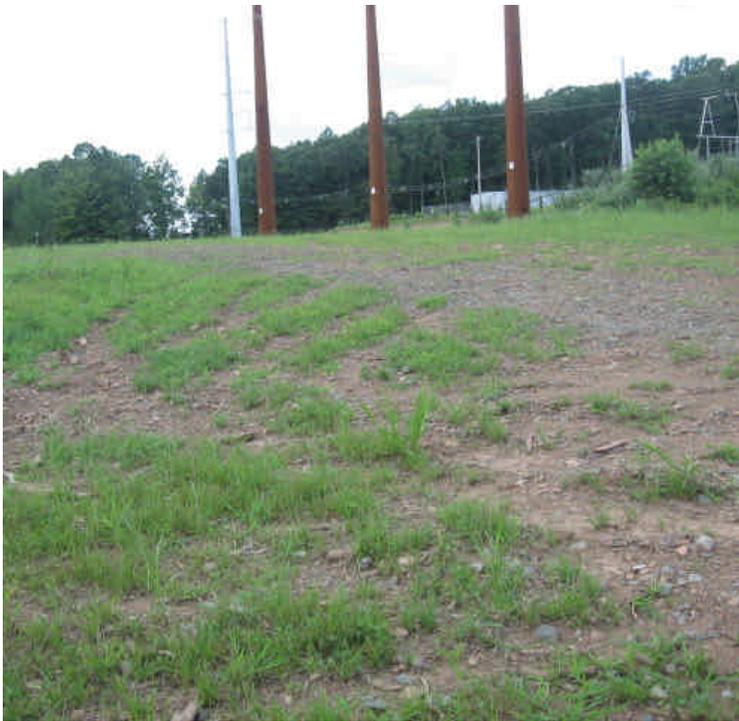
Carpenter Ln: The disturbed area remains graded and seeded but vegetative growth is still fairly sparse. Additional seed may be needed during more favorable conditions.

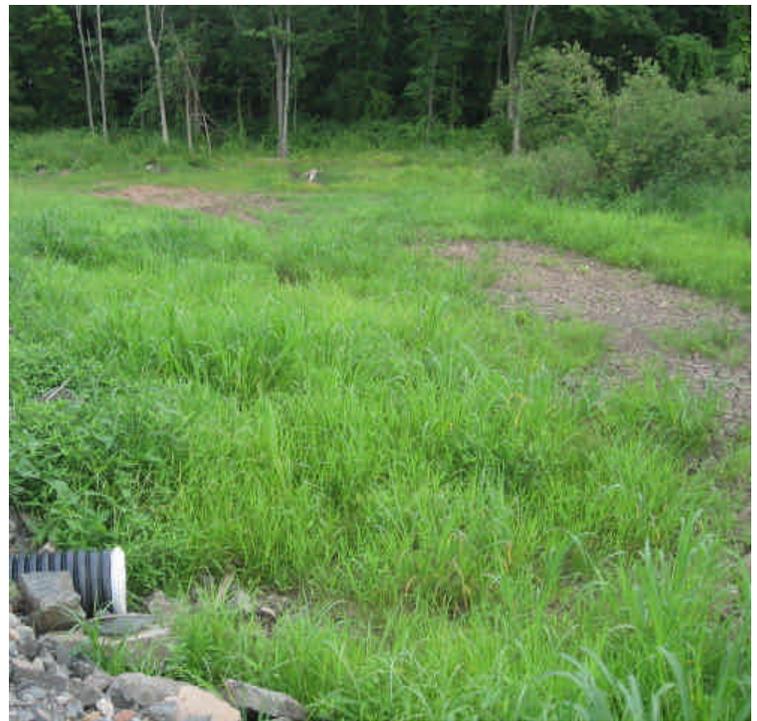
Carpenter Ln: Restoration work is complete within the wetlands. View of one of the permanent culverts and the established vegetative cover, consisting of wetland species.

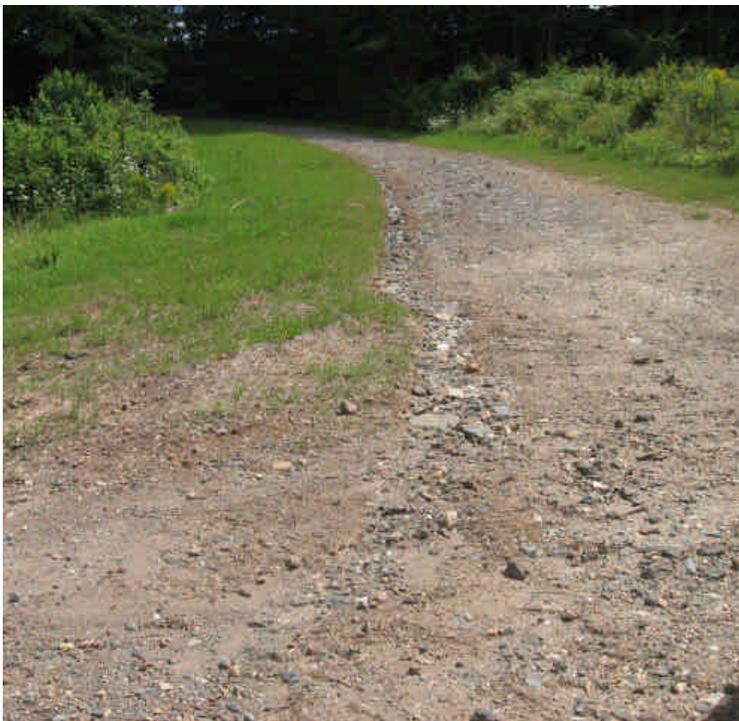
High Hill Rd: Small gully noted along the access road slope. The slight sedimentation at the base was not affecting resource areas. A few haybales may be placed at the base of slope proactively. Continue to monitor.

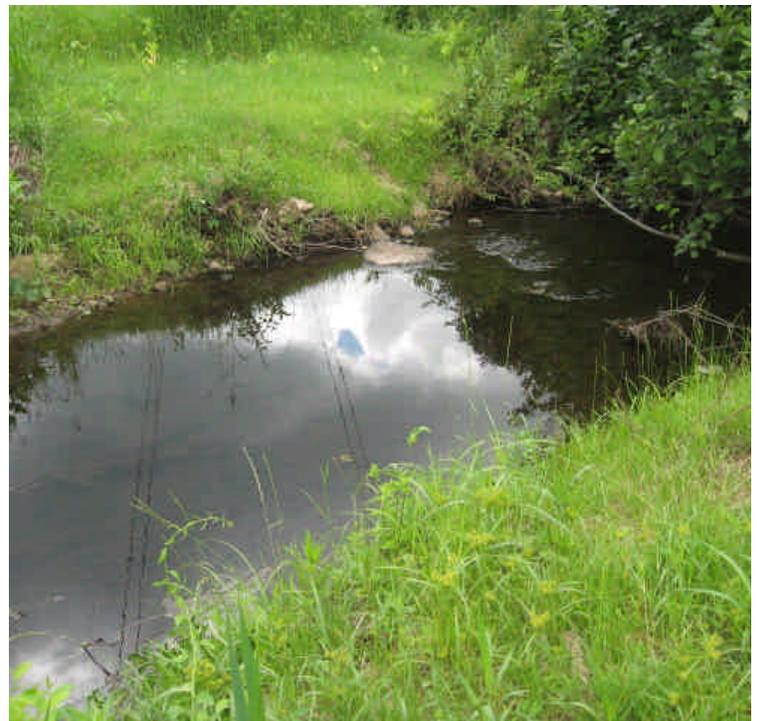
Durham Rd: The banks of the stream previously crossed with the equipment bridge are fully vegetated and stable. ATV tracks were noted in the adjacent wetland despite the gate. The adjacent access is slowly re-vegetating.

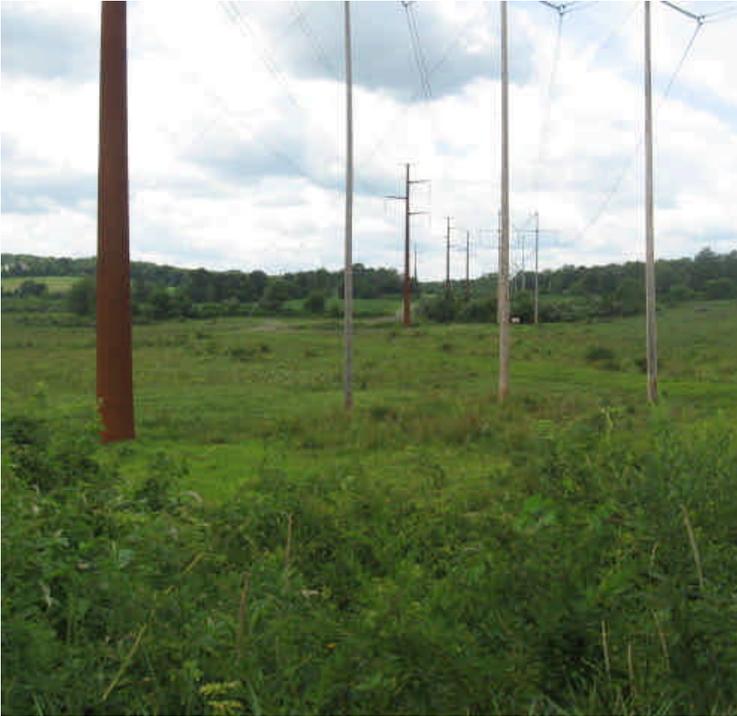
East Center St: View of the ROW from the roadway looking towards Tamarac Road. The restored access road is re-vegetating well.

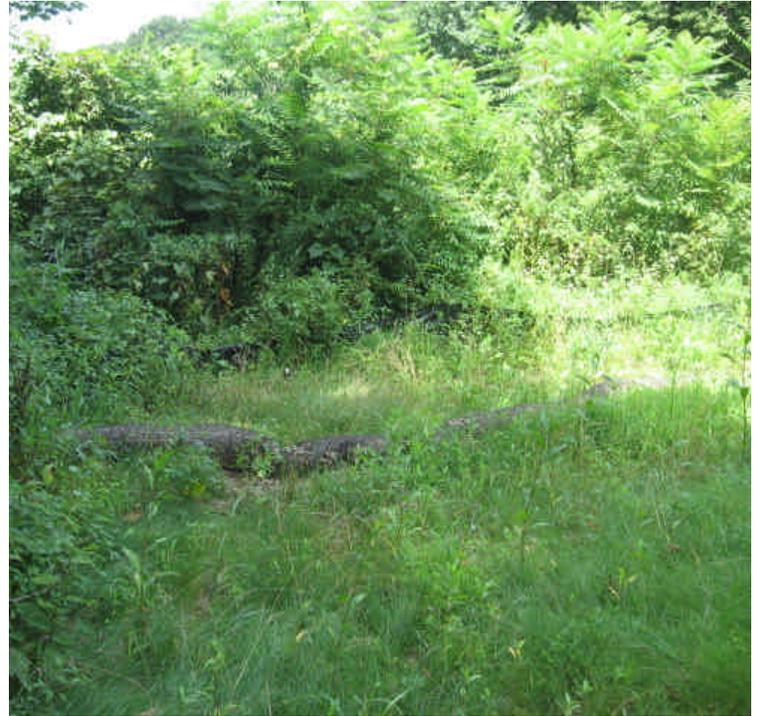
Docker Dr: Filter socks and silt fence remain at the bank of the stream. Areas immediately adjacent are well vegetated but the thick bark remains on the slopes upgradient.

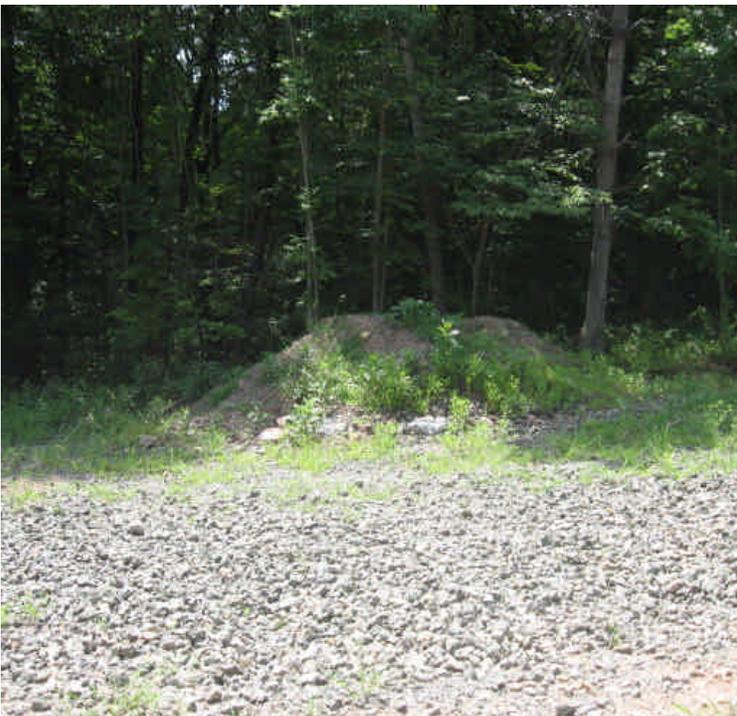
Tuttle Ave: The access roads and pads remain along this section of the ROW. Small leftover stockpiles are associated with most of the pads. BSC was informed that the landowner requested that the pad and road materials remain in place.

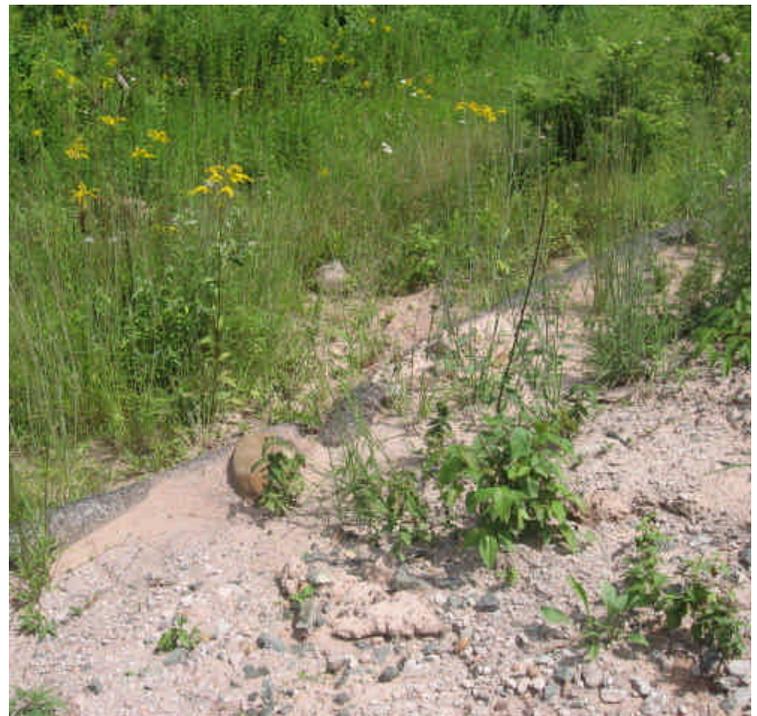
Cook Hill Jct: Some sediment has started to wash over the controls above the wetlands. Sediment removal is needed.
