Docket No. 272 – Development and Management Plan Inspection

Segment 2a Inspection

Date: August 12, 2008

Location: Segment 2a – Beseck Switching Station to Cheshire/Hamden Town Line

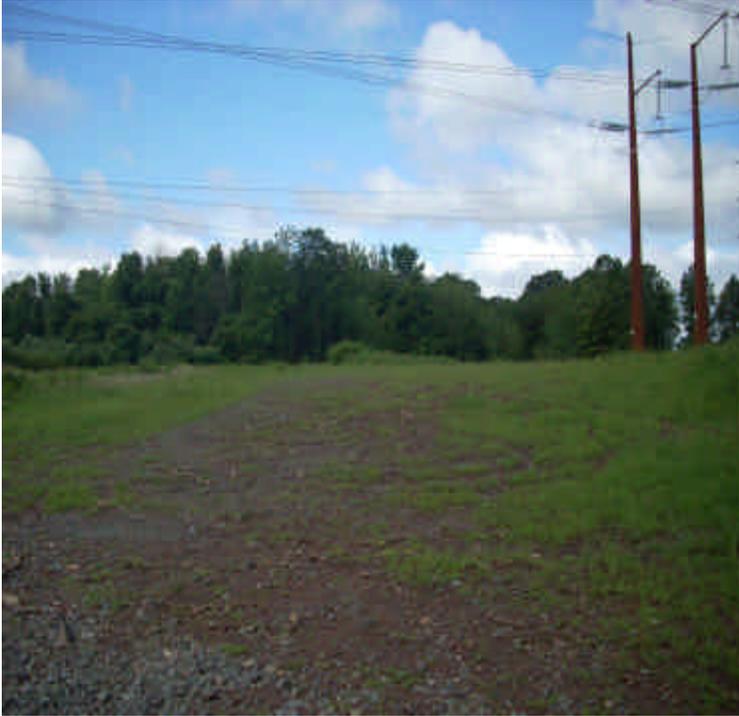
Carpenter Ln: The disturbed area remains graded and seeded but vegetative growth is still fairly sparse. Additional seed may be needed during more favorable conditions.

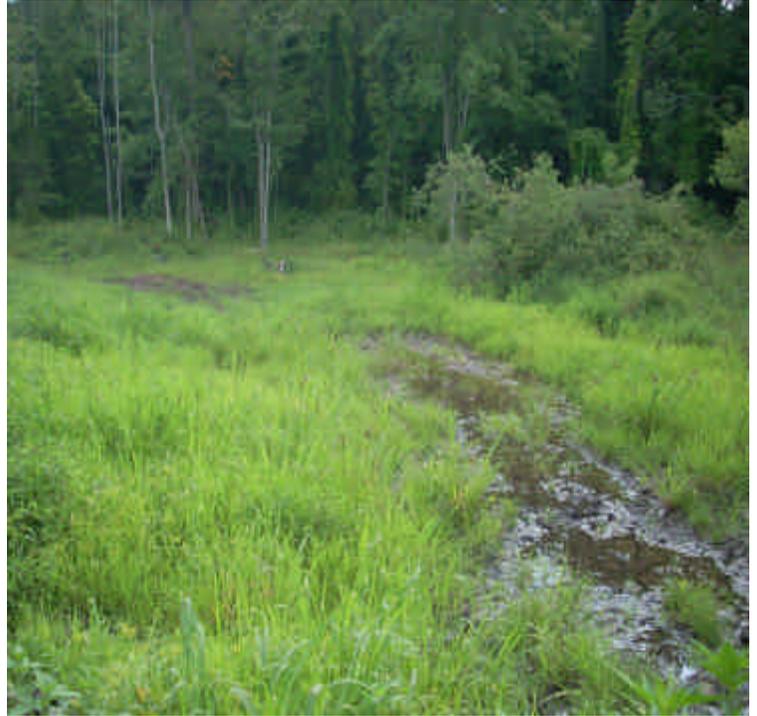
Carpenter Ln: Restoration work is complete within the wetlands. Areas were stabilizing with vegetative cover consisting mainly of native wetland species.

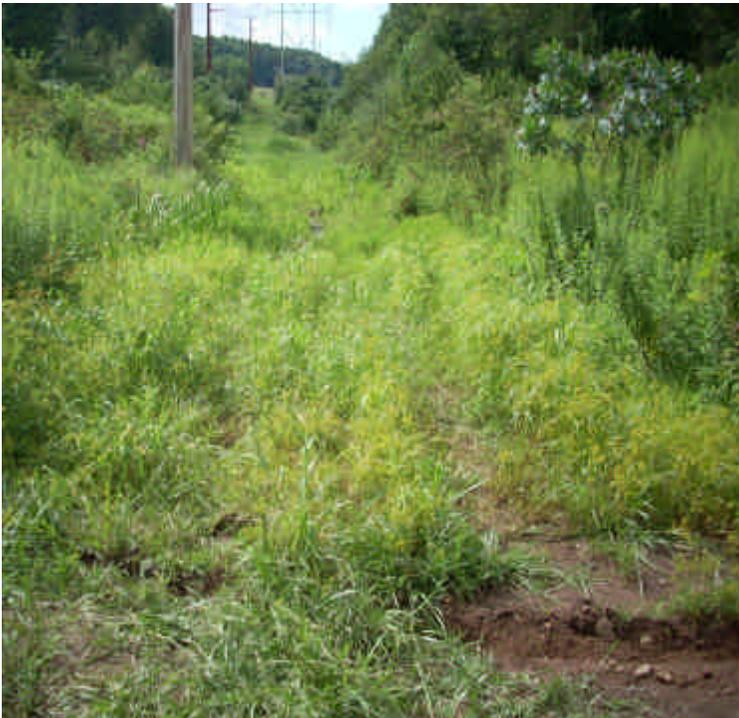
Durham Rd: A small drainage ditch was dug across the access road upgradient from the stabilizing wetland crossing in order to divert run-off.

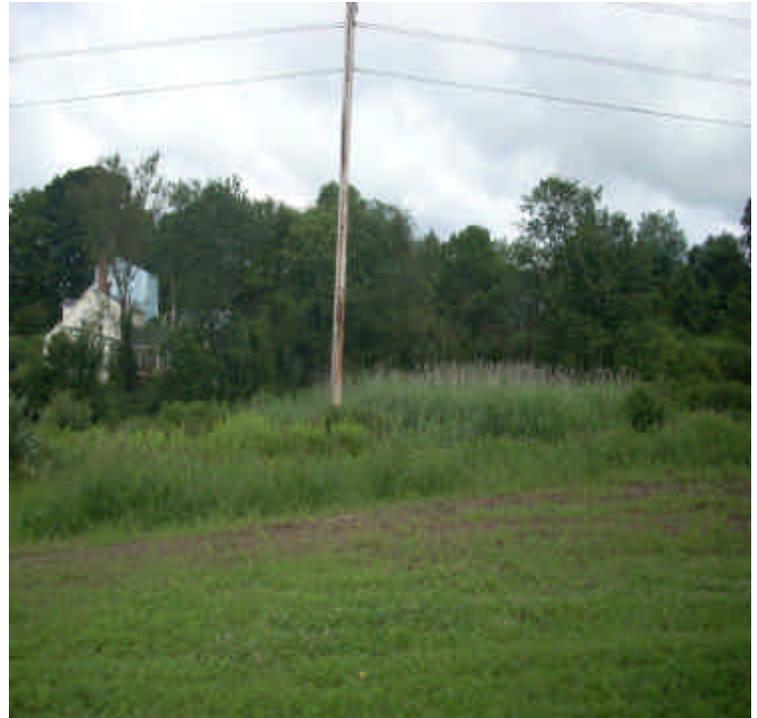
Stony Brook Rd: Small sparsely vegetated areas at the entrance to the ROW need minor attention/reseeding.

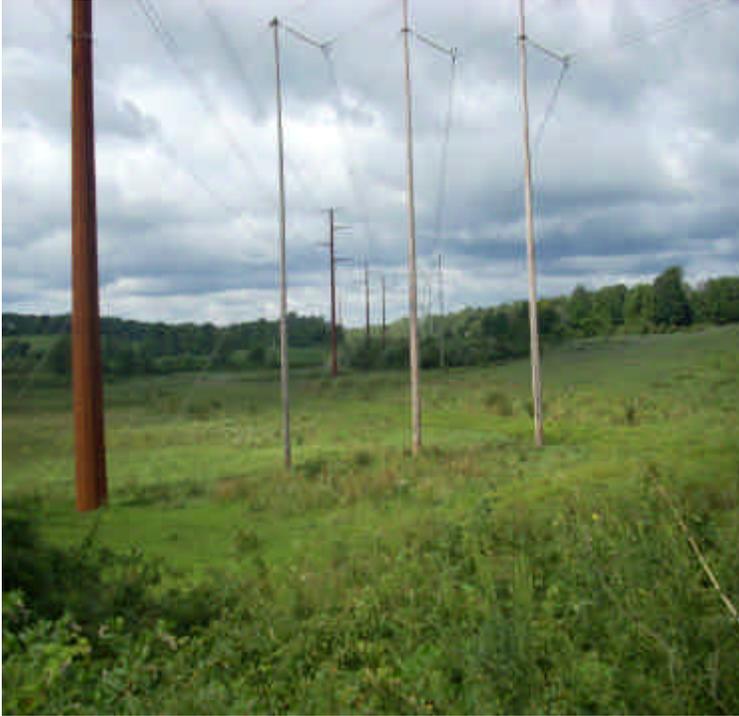
Tamarack Rd: Vegetation has established around the structure within the wetlands on the east side of the roadway.

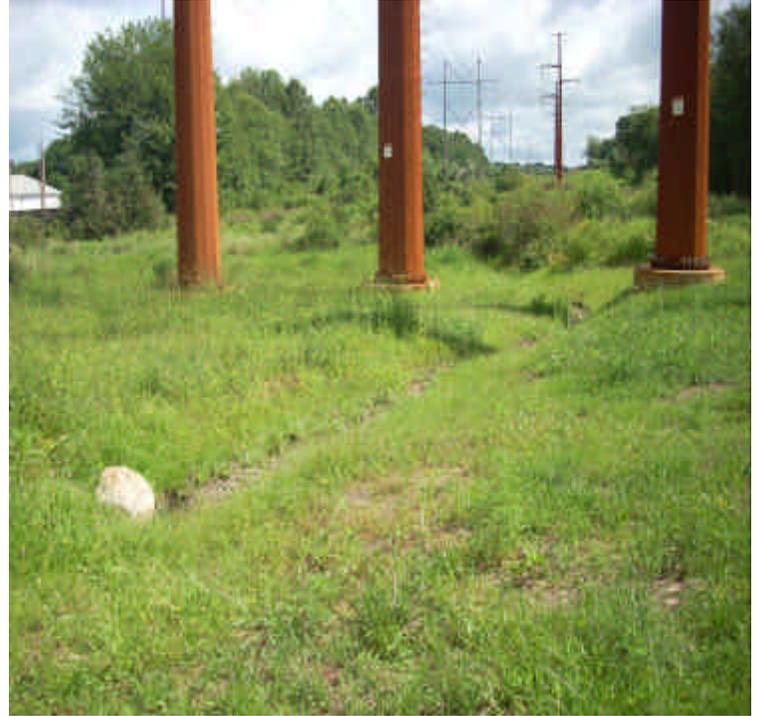
Powers Rd: Final restoration complete. Additional grass growth continues to establish along the channel banks.

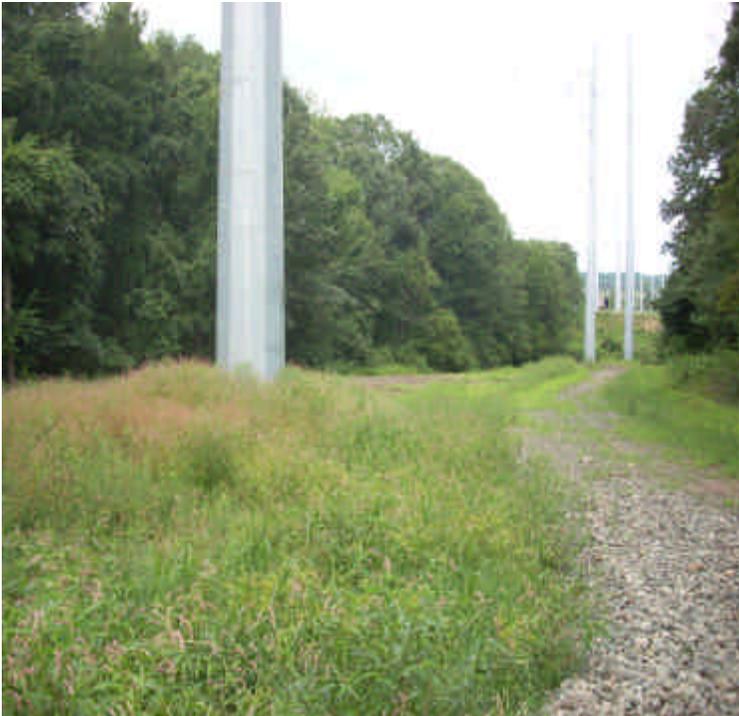
Docker Dr: ATV traffic has been reduced, resulting in additional vegetative growth along with the thick mulch cover.

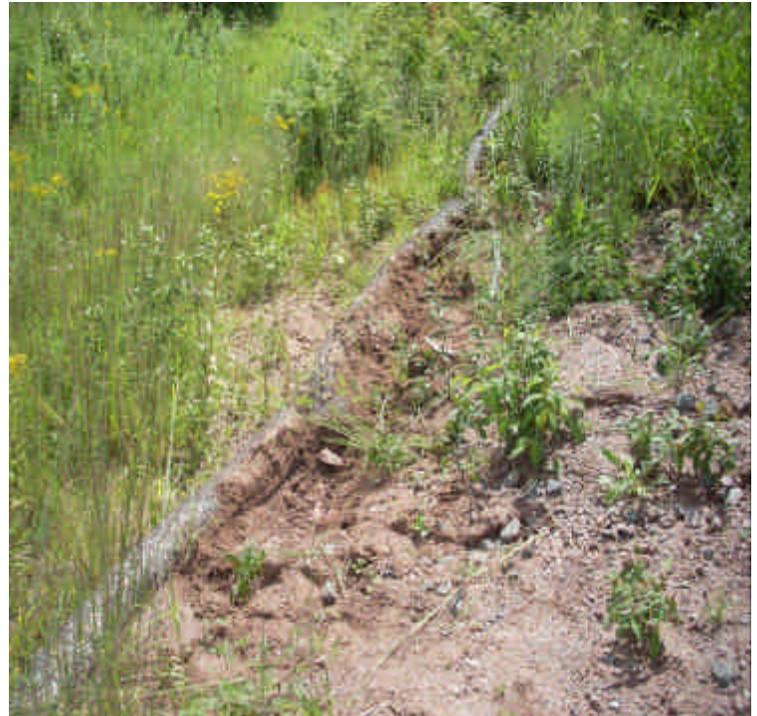
Cook Hill Jct: Some of accumulated sediment has been removed from the edge of the controls upgradient from the wetlands.
