Docket No. 272 – Development and Management Plan Inspection

Segment 2a Inspection

Date: August 25, 2008

Location: Segment 2a – Beseck Switching Station to Cheshire/Hamden Town Line

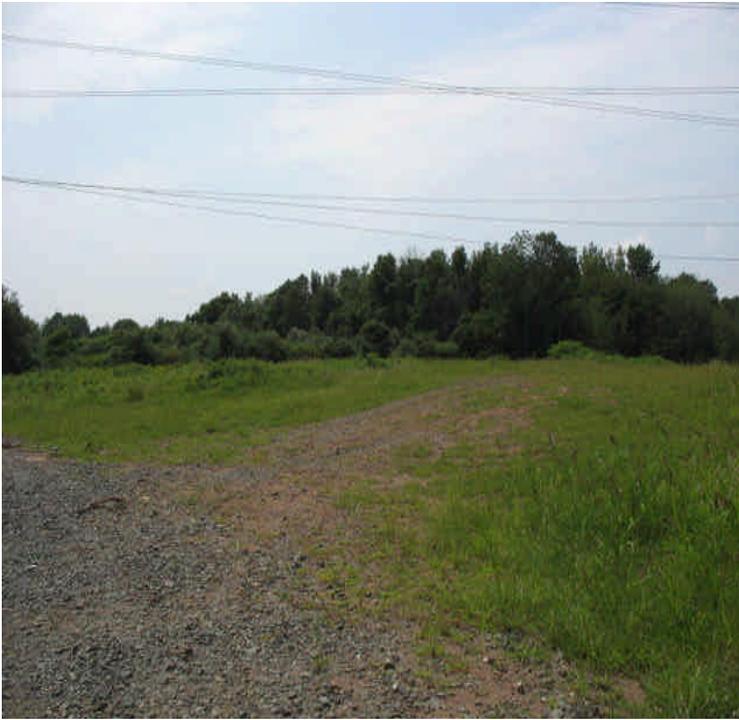
Carpenter Ln: The disturbed area remains graded and seeded but vegetative growth is still fairly sparse in areas. Additional seed may be needed during more favorable conditions.

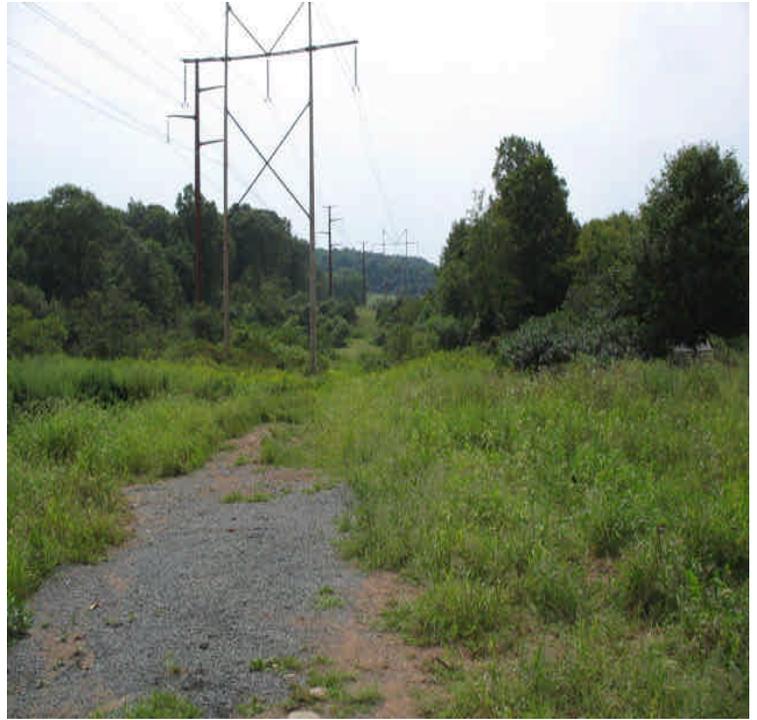
Durham Rd: Restoration work is complete within the wetlands. Small area of upland is still sparse however; wetlands are stable. It will be evaluated if there is 70% cover overall.

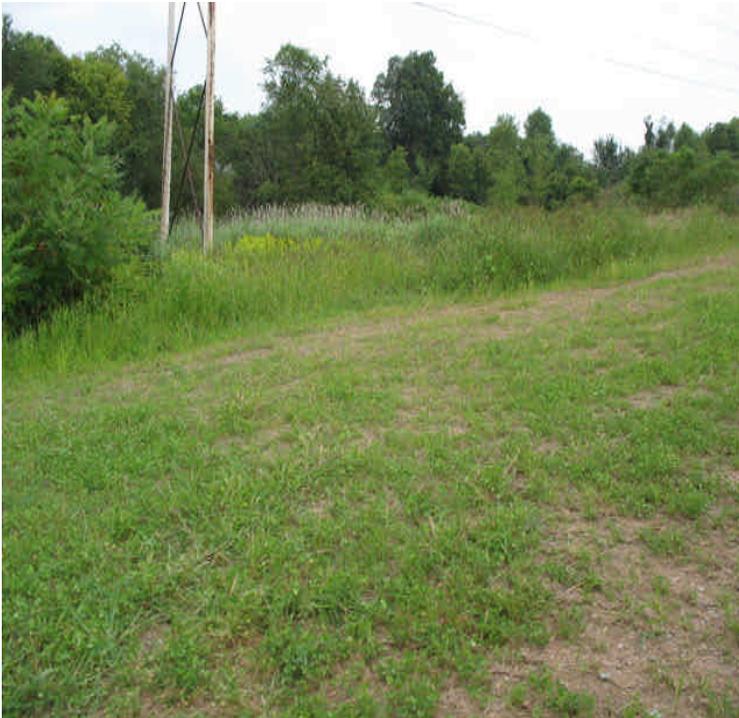
Stony Brook Rd: Sparse area of vegetation located at the site entrance. It will be evaluated if there is 70% cover overall.

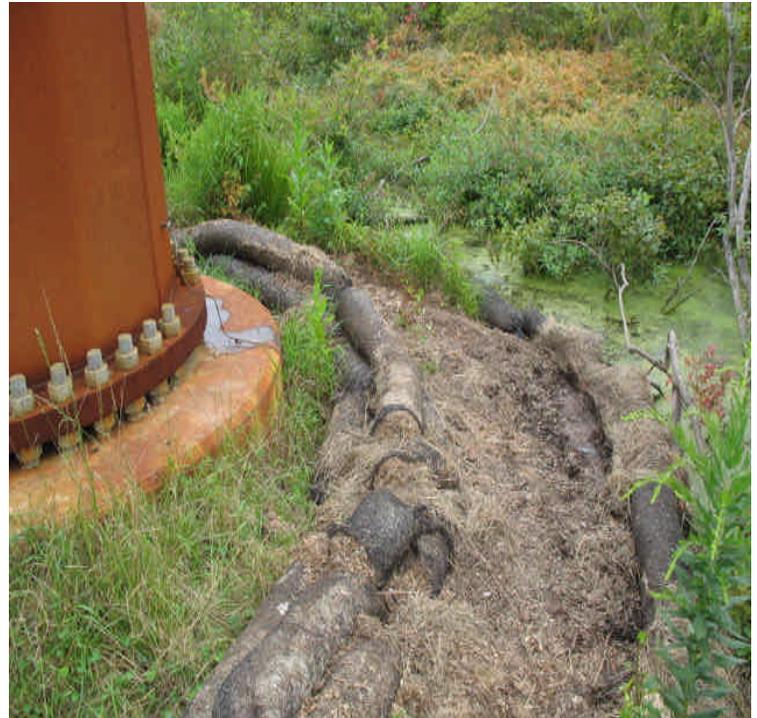
Tamarack Swamp (west): Haybales have been removed and fiber roll were pulled slightly upgradient, away from the wetland. One fiber roll will remain until stable.

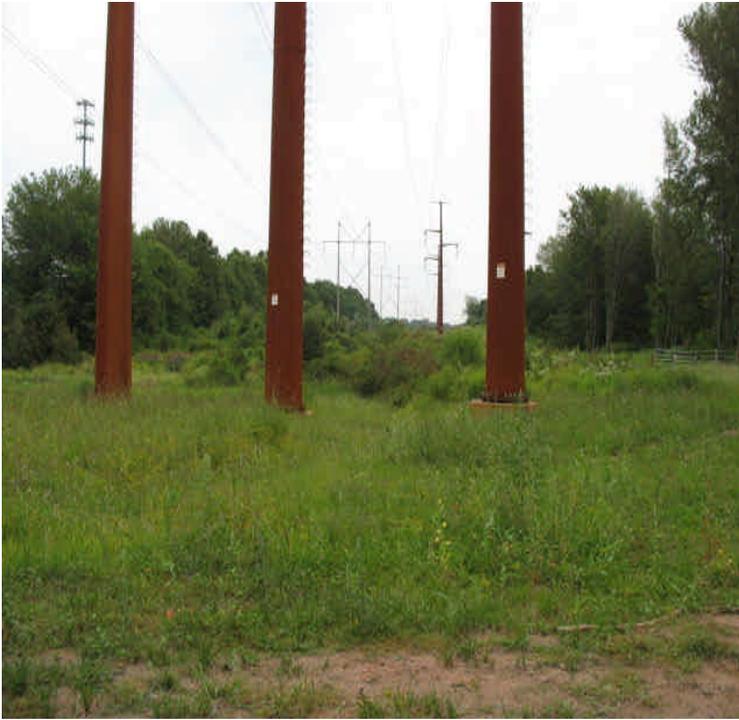
Powers Rd: Wetlands are stable. Small area of uplands may need additional seed.

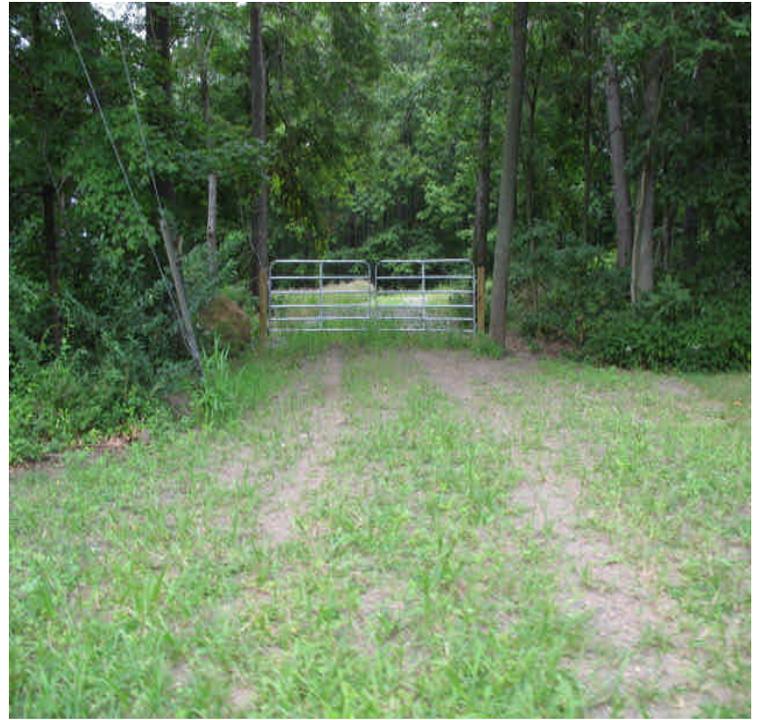
Docker Dr: Somewhat sparse vegetative cover at the site entrance. Add seed if necessary.

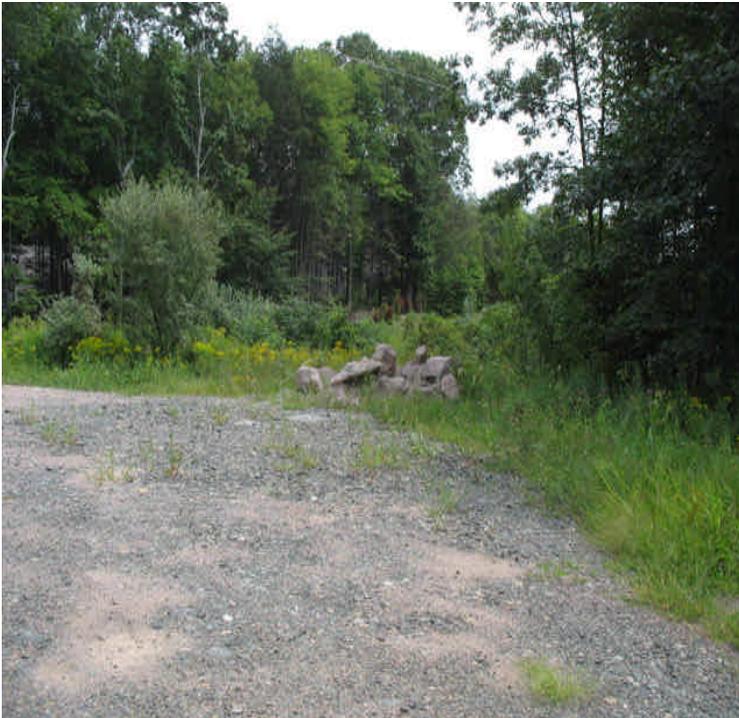
Cook Hill Jct: One small material stockpile remains.

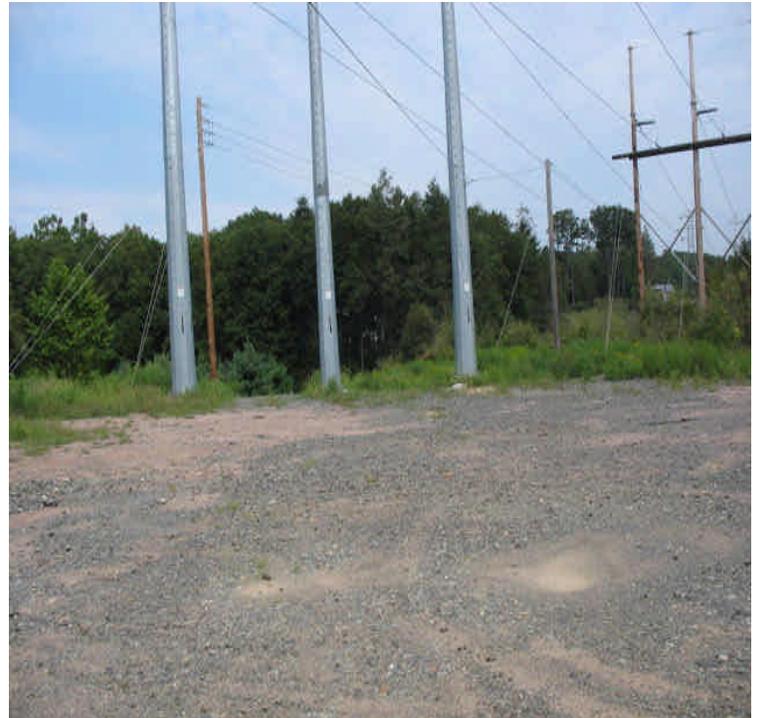
Cook Hill Jct: Final restoration still needed from Cook Hill Jct to 2B. BSC was informed this would be one of the last sections restored.
