**Docket No. 272 – Development and Management Plan Inspection**

**Segment 2a Inspection**

**Date:** September 2, 2008

**Location:** Segment 2a – Beseck Switching Station to Cheshire/Hamden Town Line

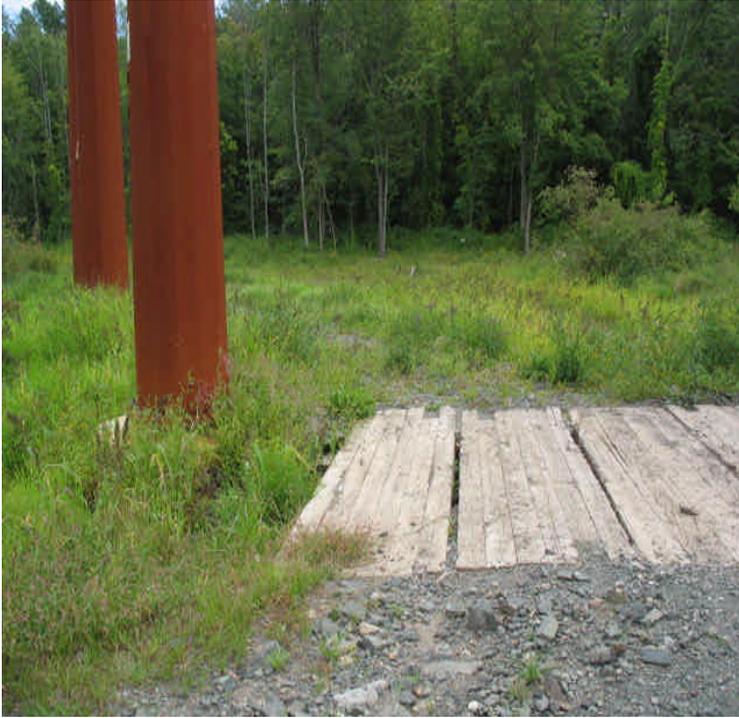
**Carpenter Ln: Wetland crossing (including permanent access road within the wetlands) is stable with over 70% cover of native species.**

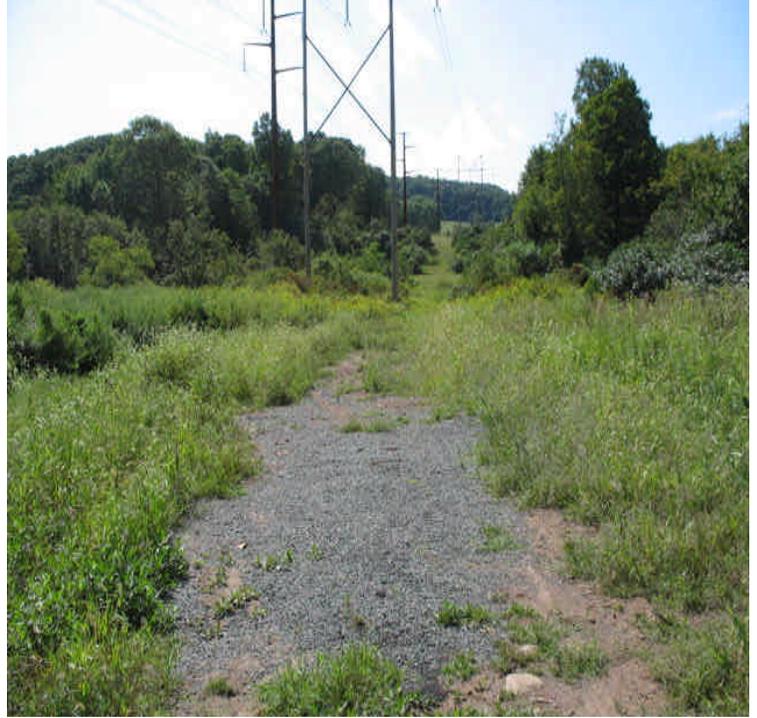
**Durham Rd: Restoration work is complete within the wetlands and the area is stable. However, a small area of upland still has sparse cover. It will be evaluated if there is 70% cover overall.**

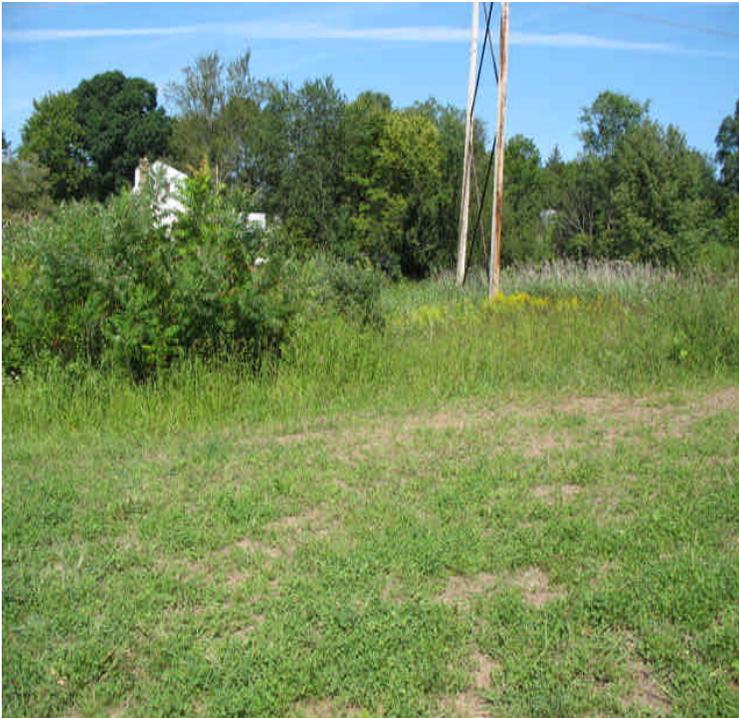
**Stony Brook Rd: Sparse area of vegetation located at the site entrance. It will be evaluated if there is 70% cover overall.**

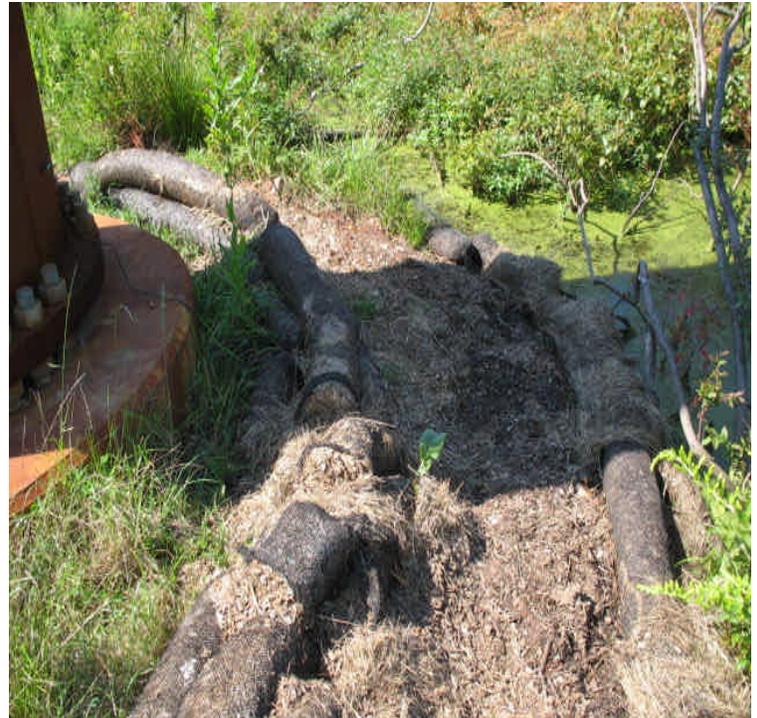
**Tamarack Swamp (west): Haybales have been removed and fiber roll were pulled slightly upgradient, away from the wetland. One fiber roll will remain until stable.**

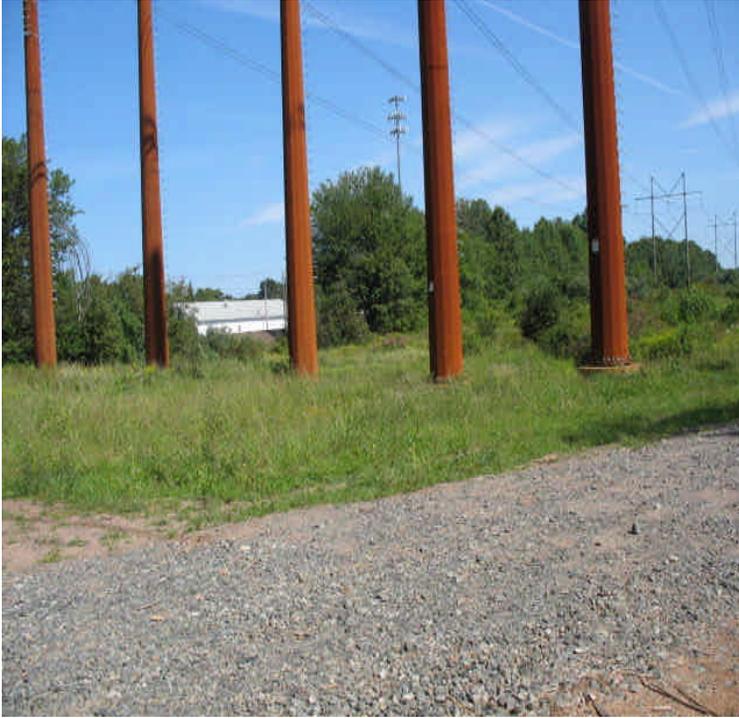
**Powers Rd: Wetlands are stable. Small area of uplands may need additional seed.**

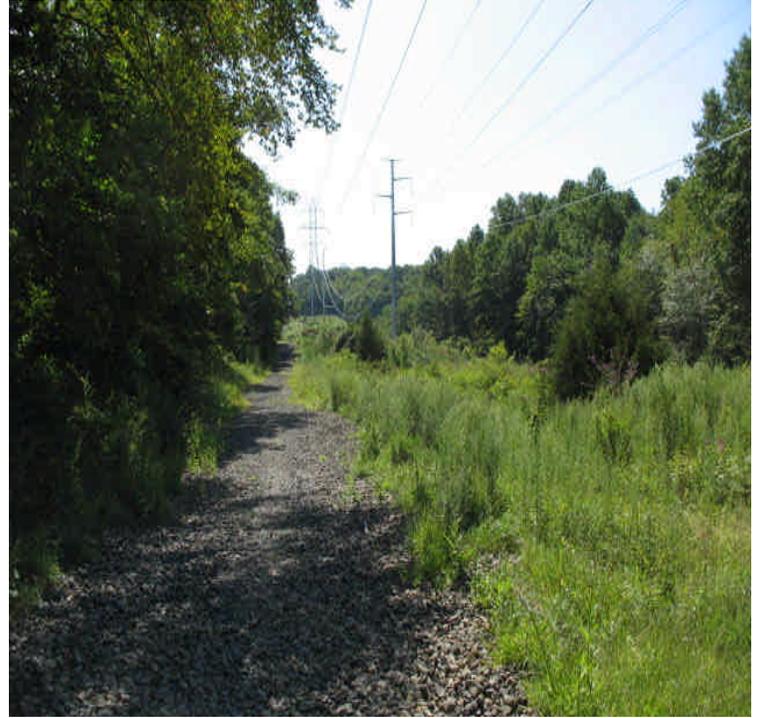
**Tuttle Ln: Wetland crossing adjacent to the permanent access road is stable and vegetated.**

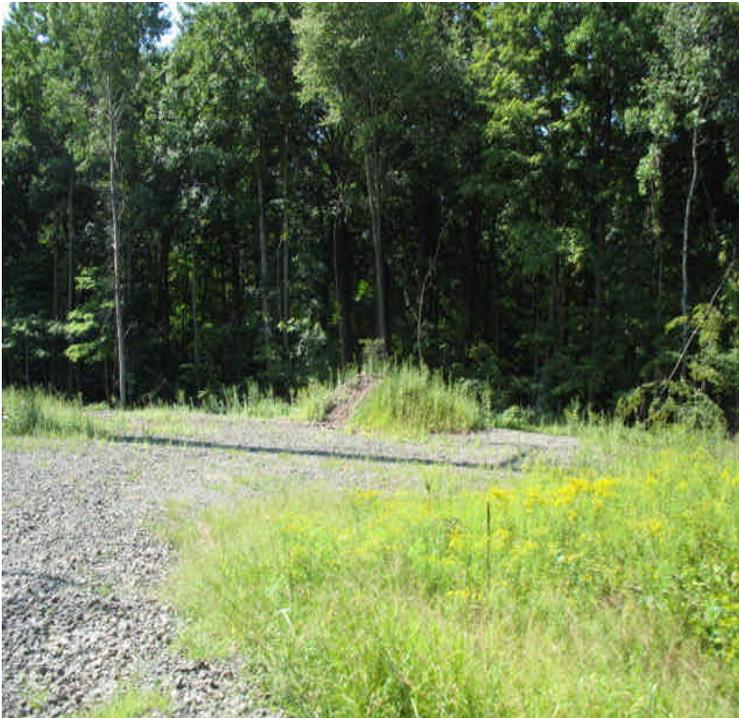
**Tuttle Ln: Several small stockpiles exist at pad sites along the ROW. BSC was informed that the landowner requested these materials remain in place.**

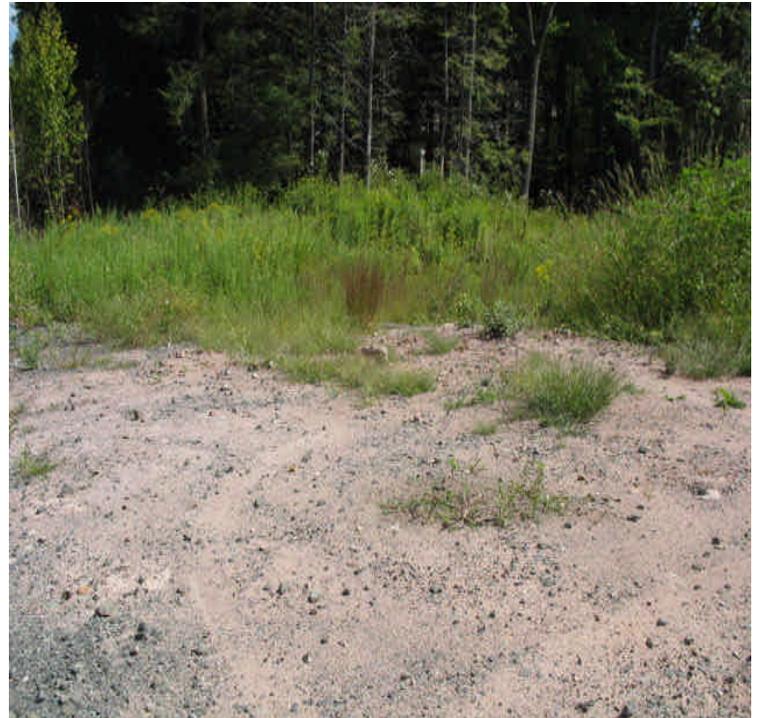
**Cook Hill Jct: Final restoration still needed from Cook Hill Jct to 2A. BSC was informed this would be one of the last sections restored.**
