**Docket No. 272 – Development and Management Plan Inspection**

**Segment 2b Inspection**

**Date:** March 21, 2008

**Location:** Segment 2b – Cheshire/Hamden Town Line to East Devon Substation

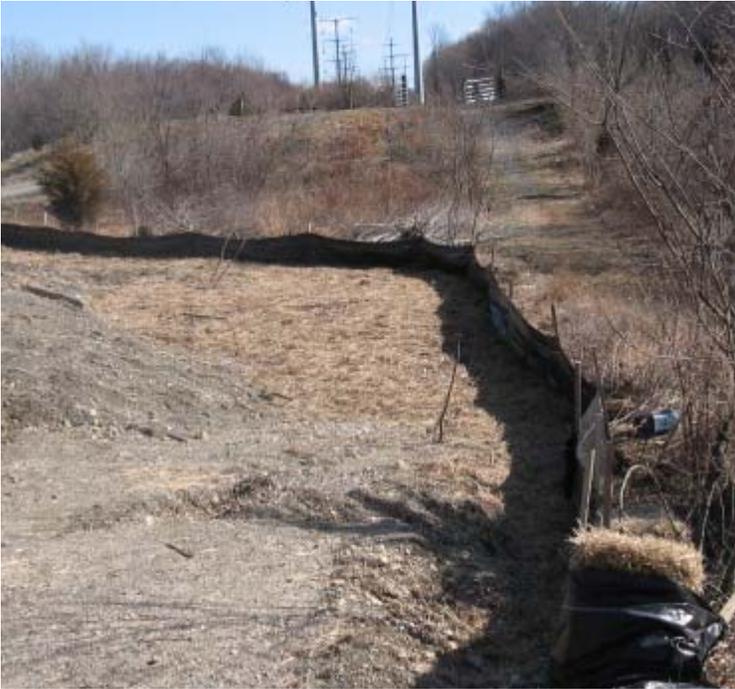
Eisenhower Park (Milford): Silt fence controls have been repaired and excess sand from foundation installation has been removed from the base of structure #24027.

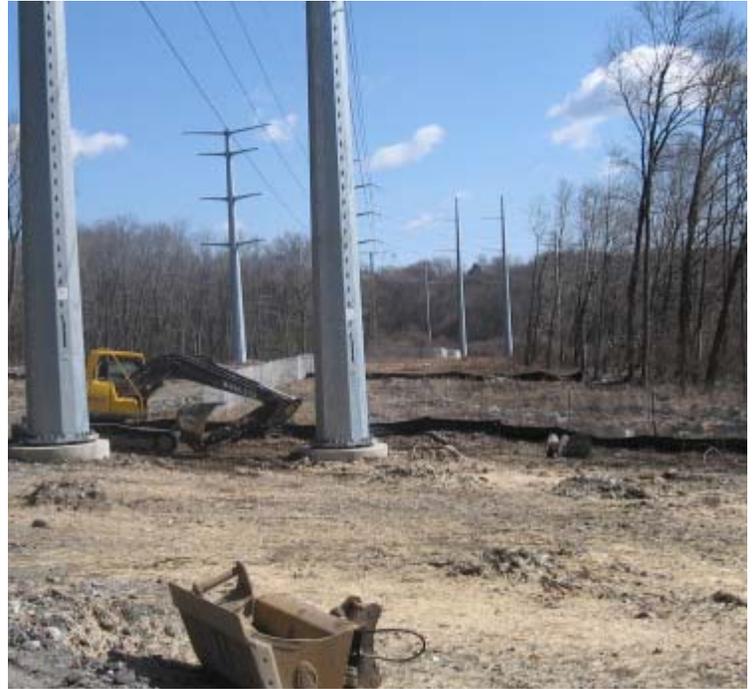
Rimmon Rd (Woodbridge): Construction equipment is parked in the wetland buffer near structure #3919.

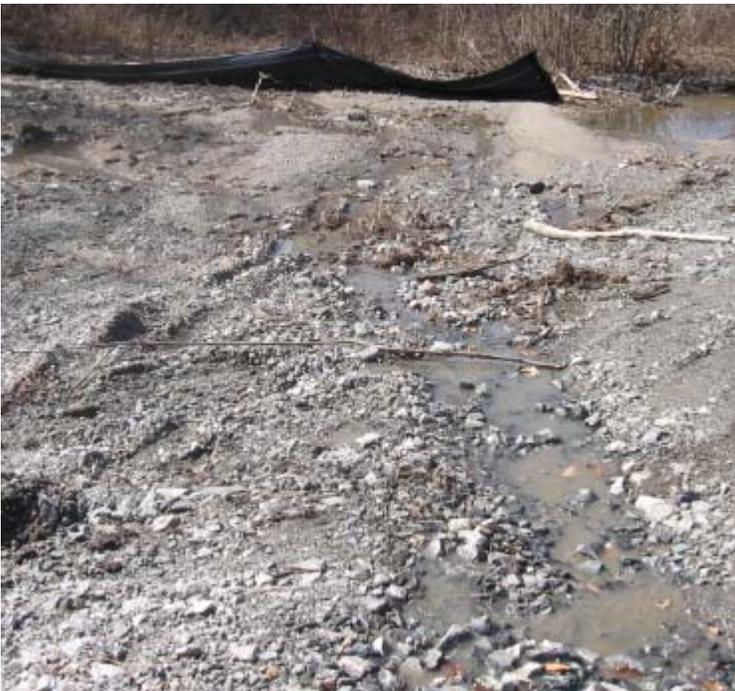
Rimmon Rd (Woodbridge): Stormwater runoff is flowing across the access rd/crane pad near structure #3922.

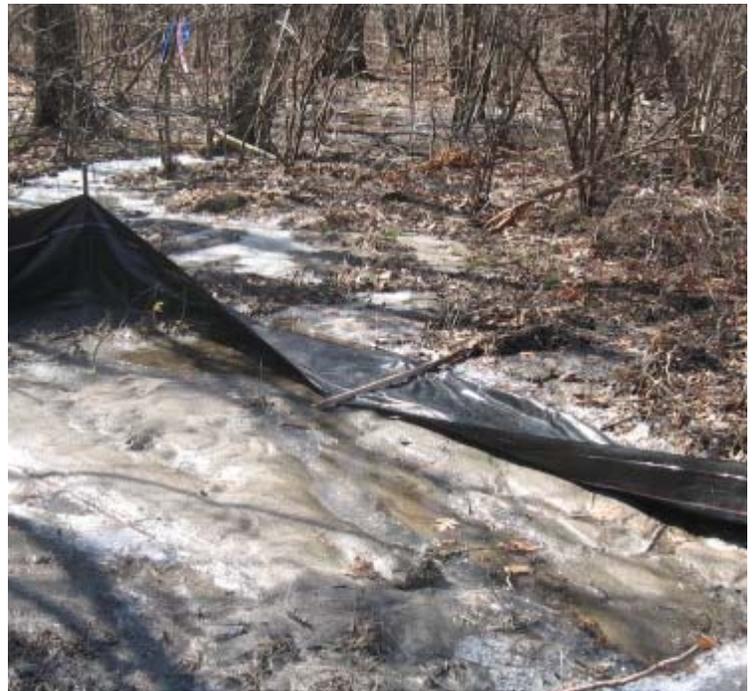
Rimmon Rd: Sediment laden stormwater has breached the silt fence controls near structure #3922. Sediment was noted in the wetlands here.

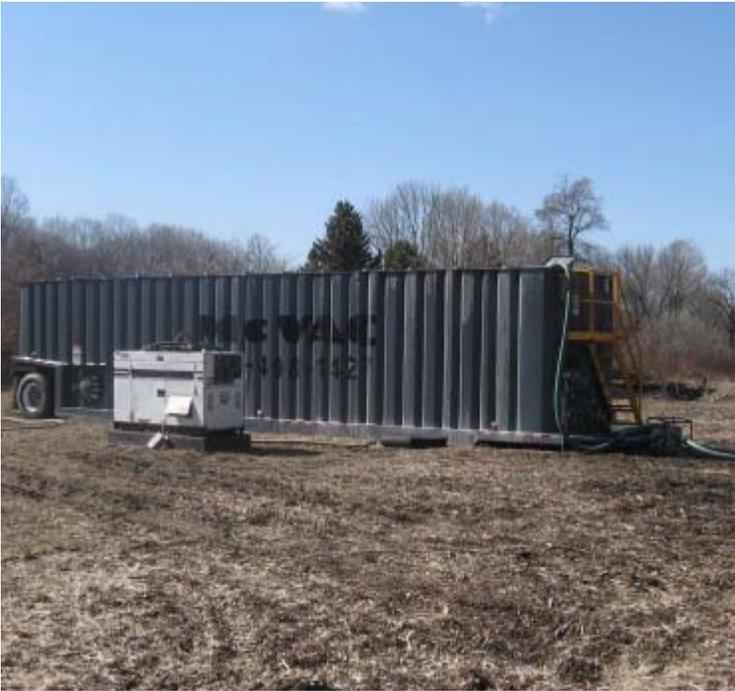
Pease Rd (Woodbridge): Frac tanks containing water from nearby sites are being hauled to Pease Road for dewatering.

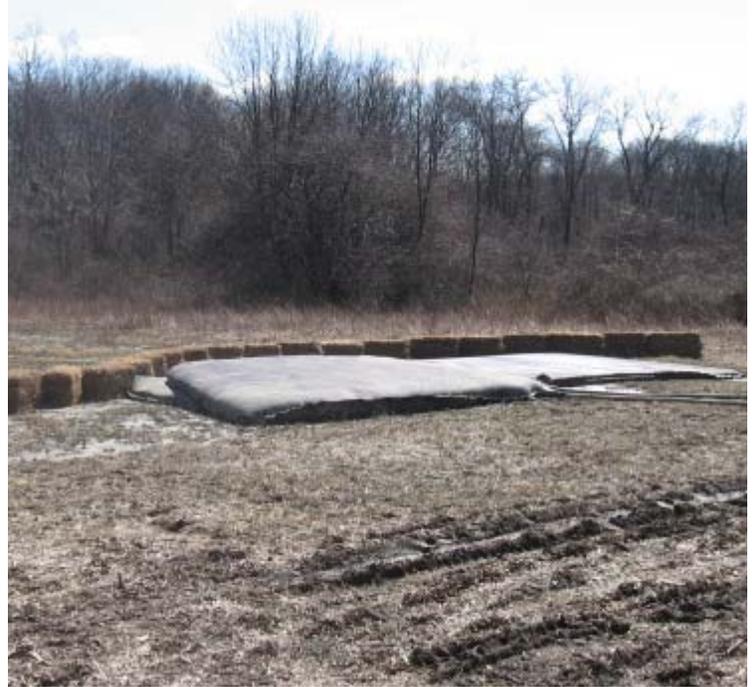
Pease Rd: Water is being pumped from frac tanks into a filter bag equipped with a line of haybales for detention and filtering purposes.

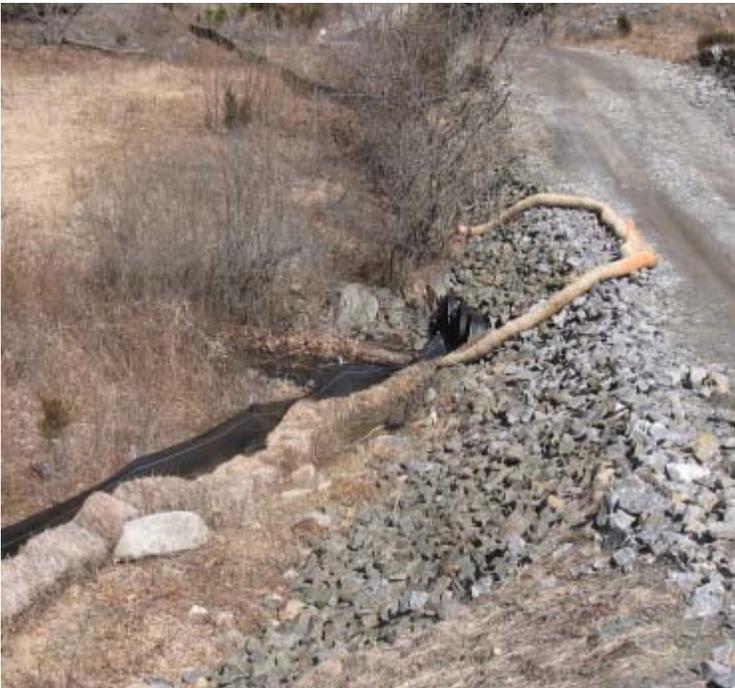
Areas of Inspection	Observation	Recommended Action	Corrected Action
Clearview Ln	Spoils remain within the wetland buffer in the ROW near structure #24090. Controls were installed to contain the pile. 3/21/08.	Install controls as necessary to contain sediment and/or remove spoils from wetland buffer and store in an appropriate upland location. 3/21/08	Controls were installed around the spoil pile. <i>Remove spoils when feasible.</i>
Oak Ln C.C	Sand has been piled on the crane pad located upgradient of the wetland near structure #24095. 3/21/08	Add/maintain controls as necessary and remove sand when feasible. 3/21/08	Needs attention
<b>Bethany, CT</b> Litchfield Turnpike	Sediment has been removed from the erosion controls at the stream crossing between structures #24156-57. 3/21/08	Continue to monitor, and add/repair controls as necessary. 3/21/08	Sediment has been removed from the erosion controls at the stream crossing between structures #24156-57

Litchfield Turnpike (Bethany): Sediment has been removed from the controls at the stream crossing between structures #24156-57.

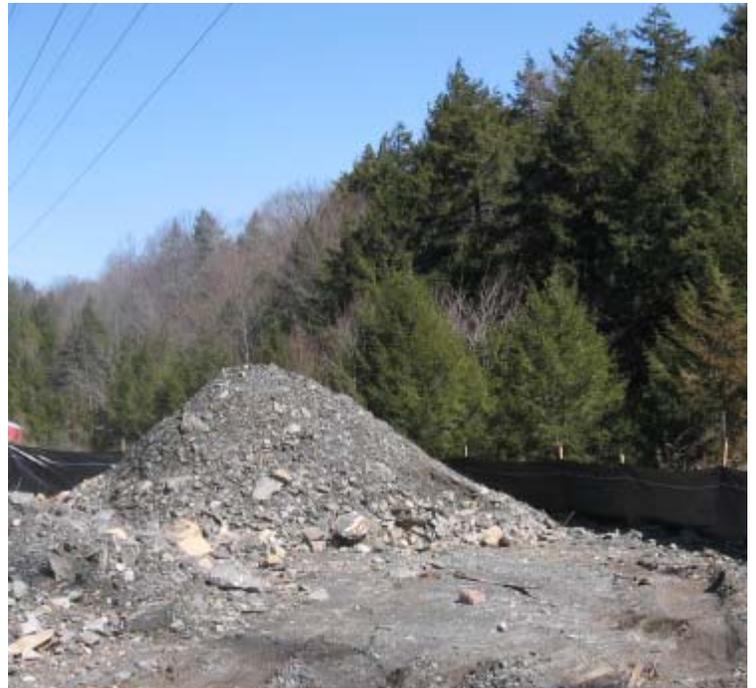
Spoils remain within the wetland buffer near structure #24157. Silt fence controls have been placed around the pile. 3/21/08	Remove spoils from wetland buffer and store in an appropriate upland location. 3/21/08	Silt fence controls have been placed around the spoils. <i>Remove spoils from wetland buffer when feasible</i>
<b>Hamden, CT</b> West Todd Street/ Gaylord Mountain	In approximately three areas, stormwater pooled along the perimeter controls and filtered through as concentrated flow off the ROW (4/27/07). This only occurs during large rain events and wetland resource areas were not affected by this off site flow. 3/21/08	Monitor during large rain events and investigate additional solutions to prevent stormwater conveyances off site. Although good efforts were made to control stormwater flow, continue to improve on-site containment. 3/21/08	Good efforts were made but <i>needs additional evaluation/monitoring</i>

Litchfield Turnpike: Silt fence controls have been installed around the spoil pile located in the wetland buffer near structure #24157.
