**Docket No. 272 – Development and Management Plan Inspection**

**Segment 2b Inspection**

**Date:** April 18, 2008

**Location:** Segment 2b – Cheshire/Hamden Town Line to East Devon Substation

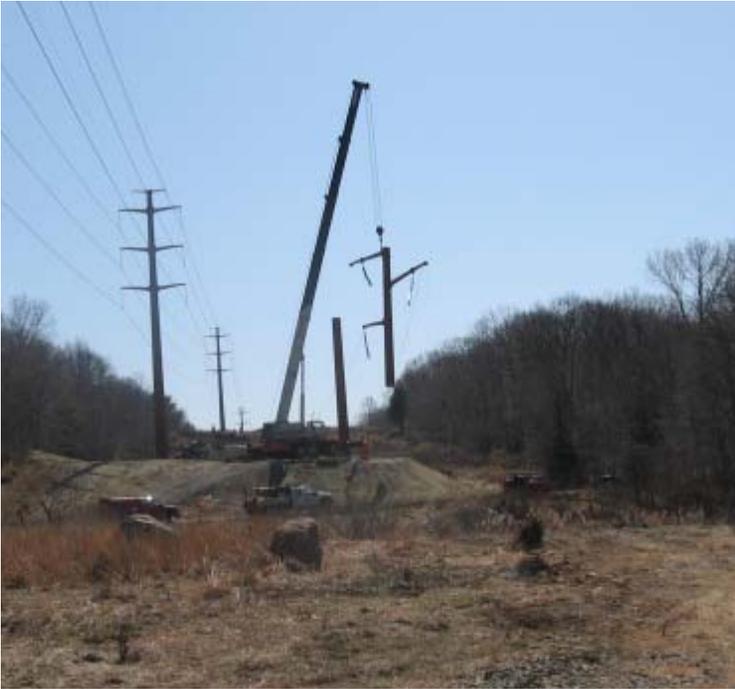
Dogburn Rd (Orange): Structure installation continues in this area.

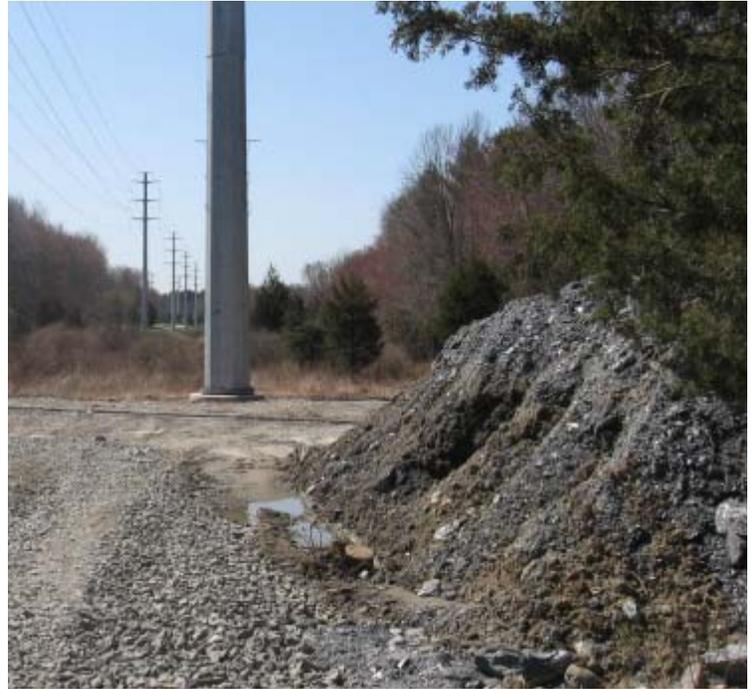
Brookwood Dr (Woodbridge): Spoils remain within the wetland buffer near structure #24096. Spoils appear to be contained on site.

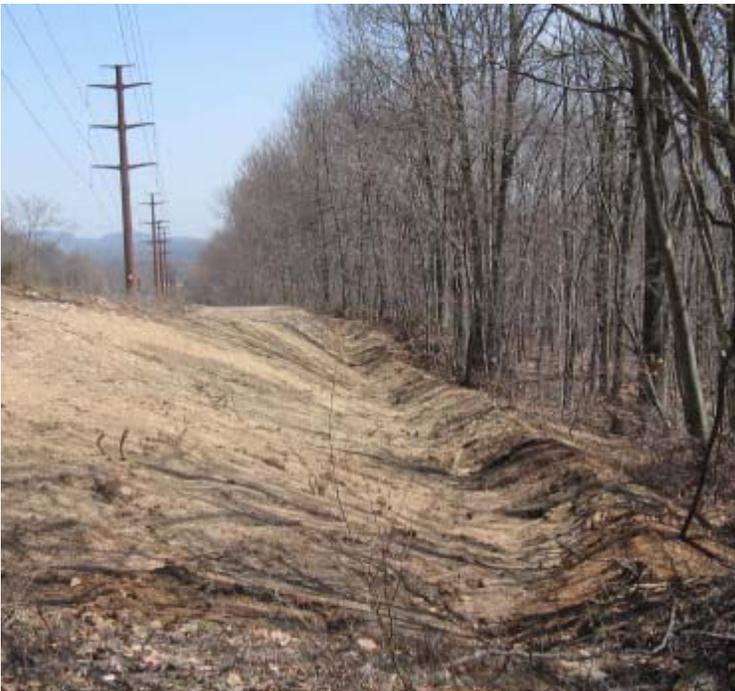
Gaylord Mtn Rd north (Hamden): Improvements were made to the ROW perimeter controls in this area and exposed soils have been temporarily stabilized with mulch.

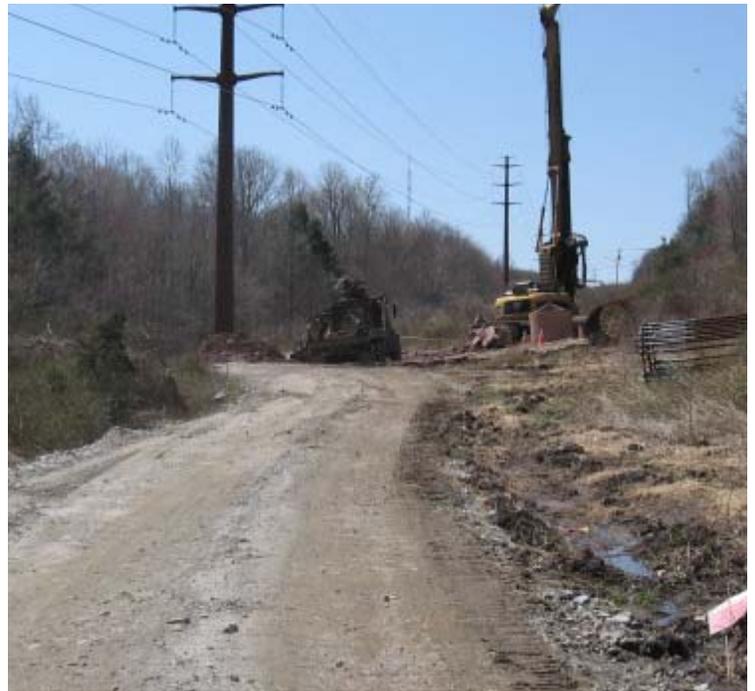
Gaylord Mtn Rd south: Drilling continues in this area. Construction equipment remains parked in a wetland area.

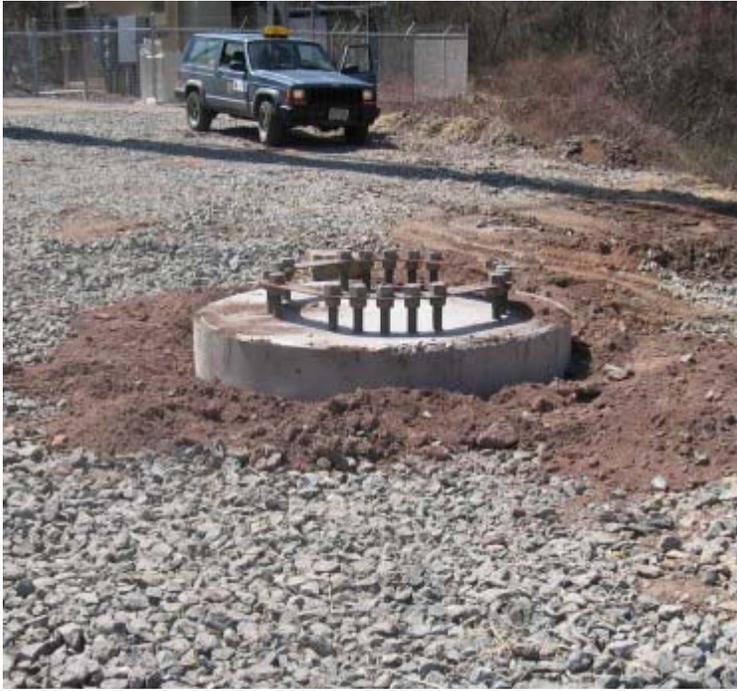
Whitney Ave (Hamden): Foundation installation is complete at structure #24195.

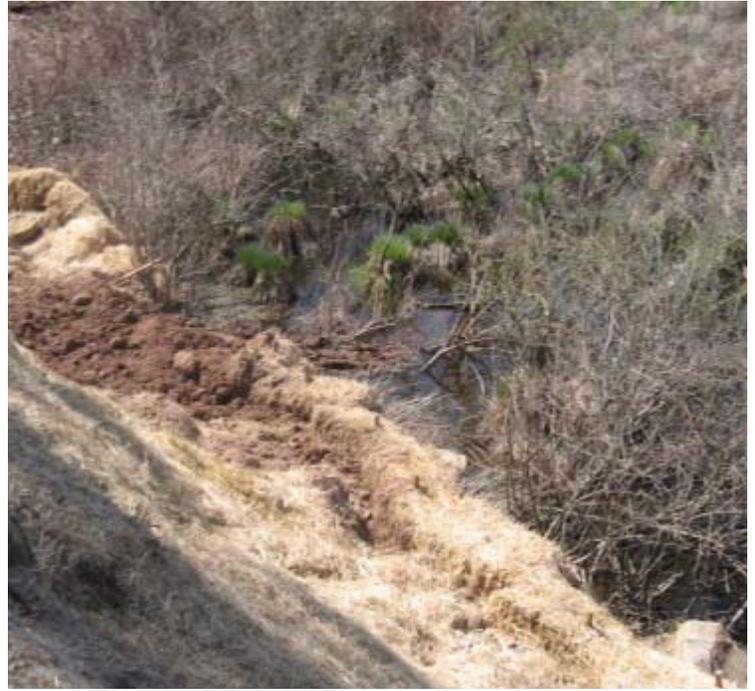
Whitney Ave: Some sediment from foundation installation has migrated to the wetland.

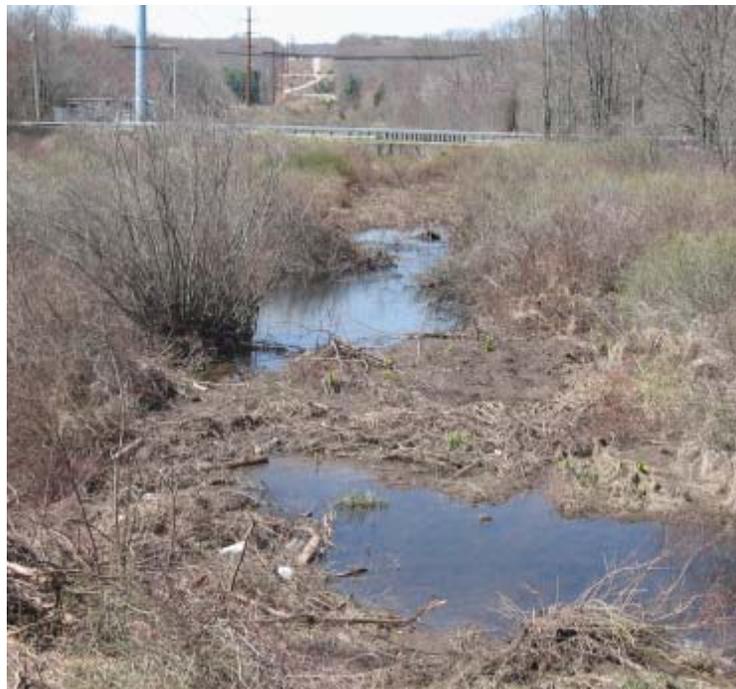
Willow St (Hamden): Timber mats were used in this area to access The wetland/Willow Brook for lattice tower removal.
