Docket No. 272 – Development and Management Plan Inspection

Segment 2b Inspection

Date: April 25, 2008

Location: Segment 2b – Cheshire/Hamden Town Line to East Devon Substation

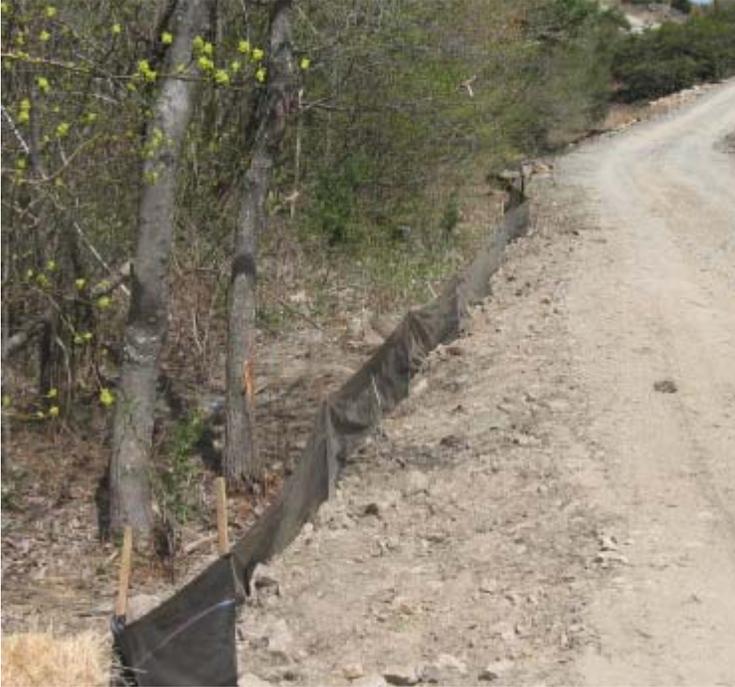
Downs Rd (Bethany): Repairs to silt fence/haybale controls are complete along the perimeter of the ROW.

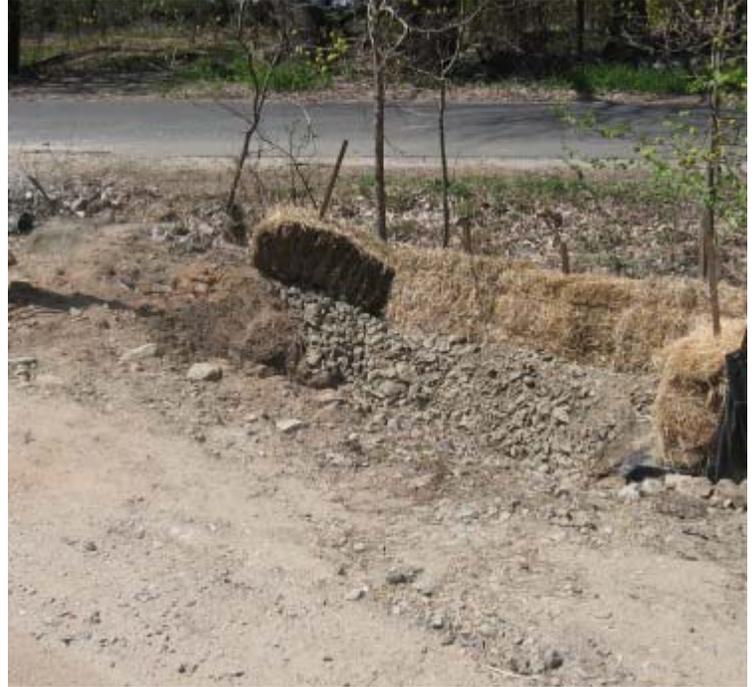
Downs Rd: Improvements have been made to perimeter controls in an attempt to control stormwater runoff.

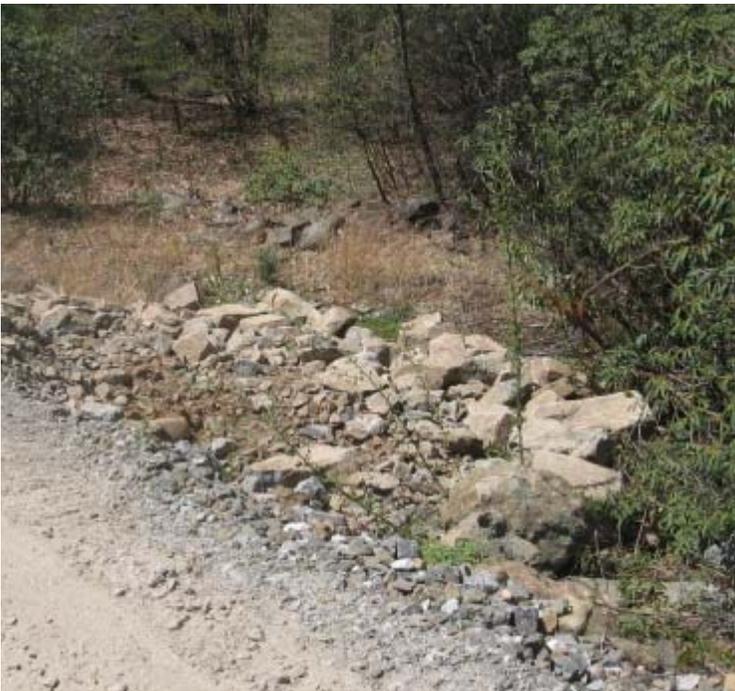
Downs Rd: Riprap controls were added along the perimeter of the ROW to help control stormwater runoff.

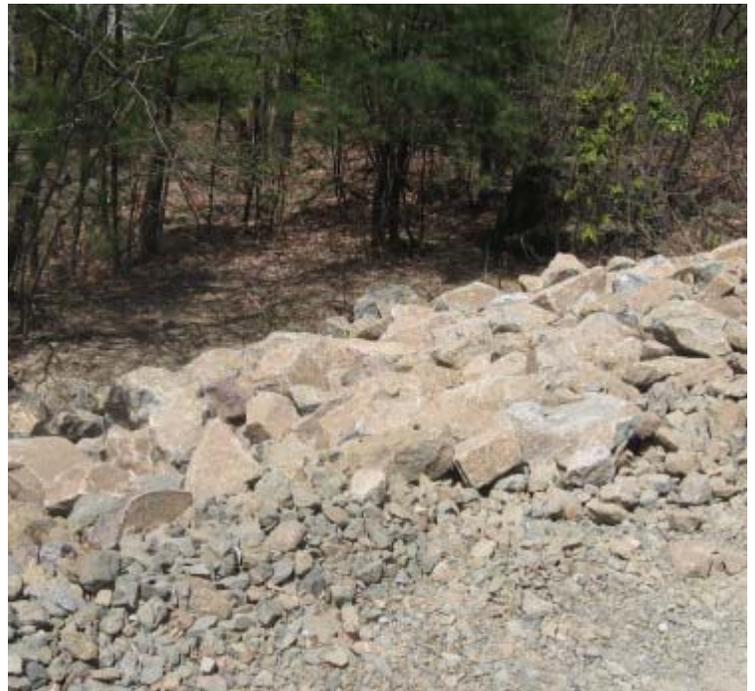
Downs Rd: An additional view of riprap controls.

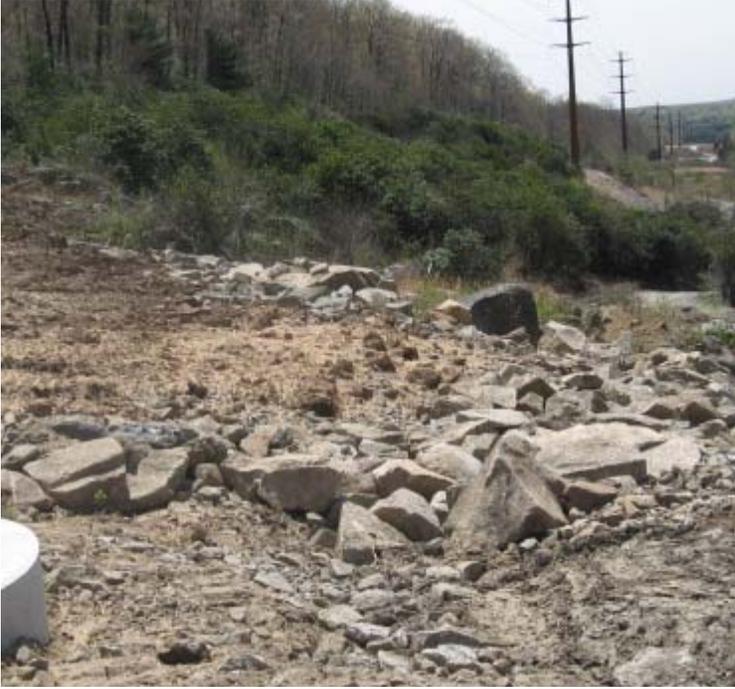
Downs Rd: Riprap controls were installed near structure #24169.

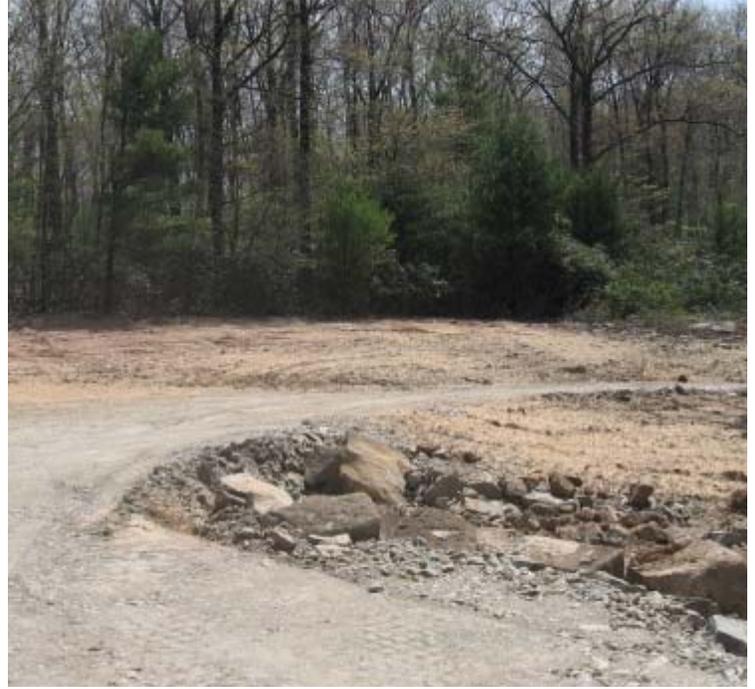
Downs Rd: A view of 115 kV pad reclamation and temporary soil stabilization.

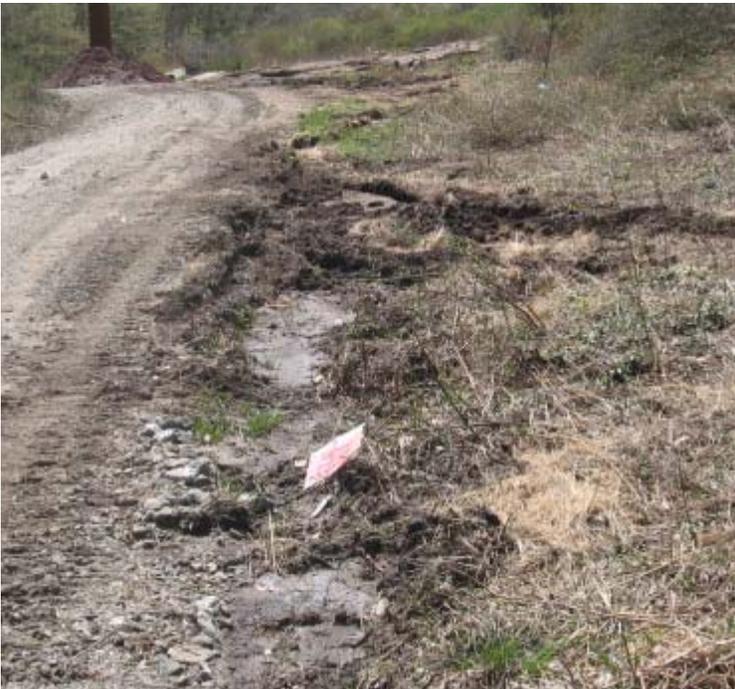
Gaylord Mtn Rd (Hamden): Tire ruts were noted in the wetland near Structure # 24179.
