Docket No. 272 – Development and Management Plan Inspection

Segment 2b Inspection

Date: May 22, 2008

Location: Segment 2b – Cheshire/Hamden Town Line to East Devon Substation

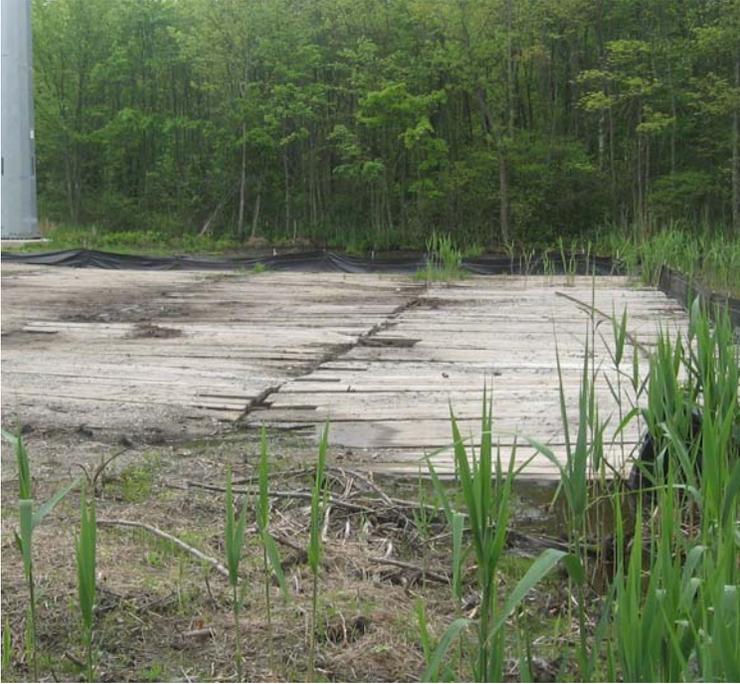
West River St (Milford): Wetland timber mats remain near structure #24023.

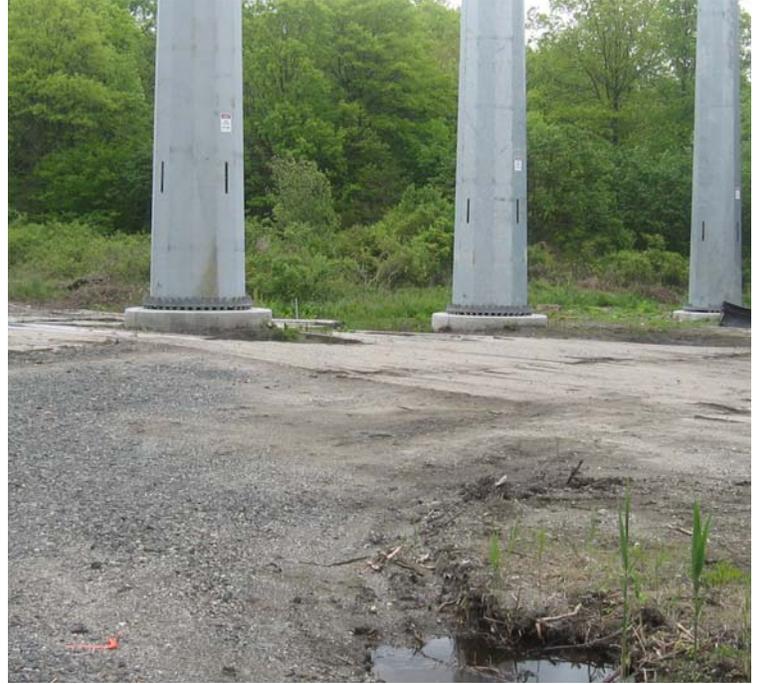
West River St: An additional view of the wetland timber mats near structure #24023.

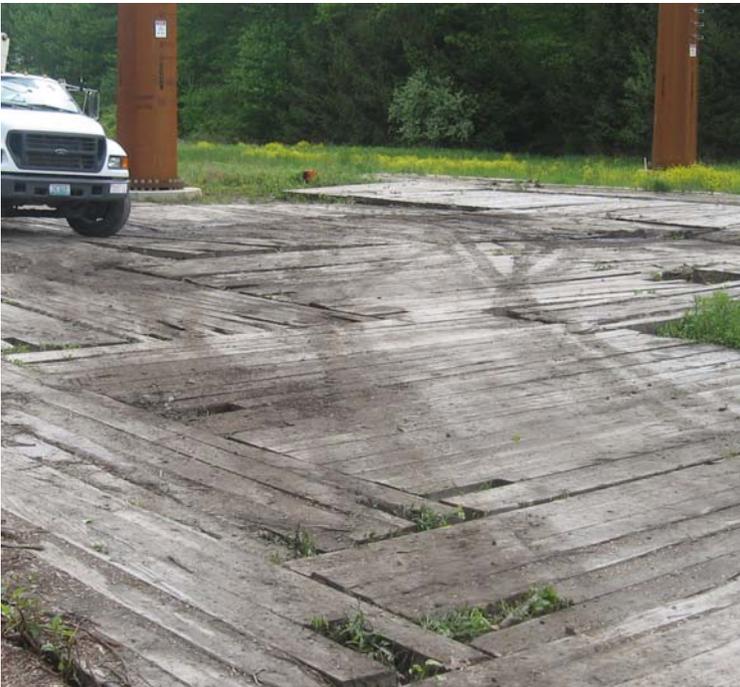
Russell Ave (Orange): Wetland timber mats remain near structure #24061.

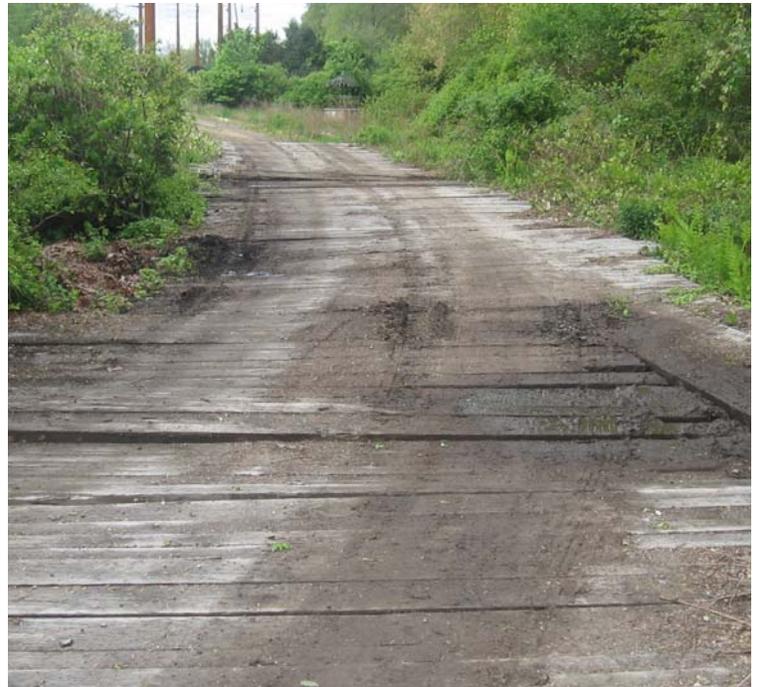
Russell Ave: Wetland timber mats remain within the access road near structure #24061.

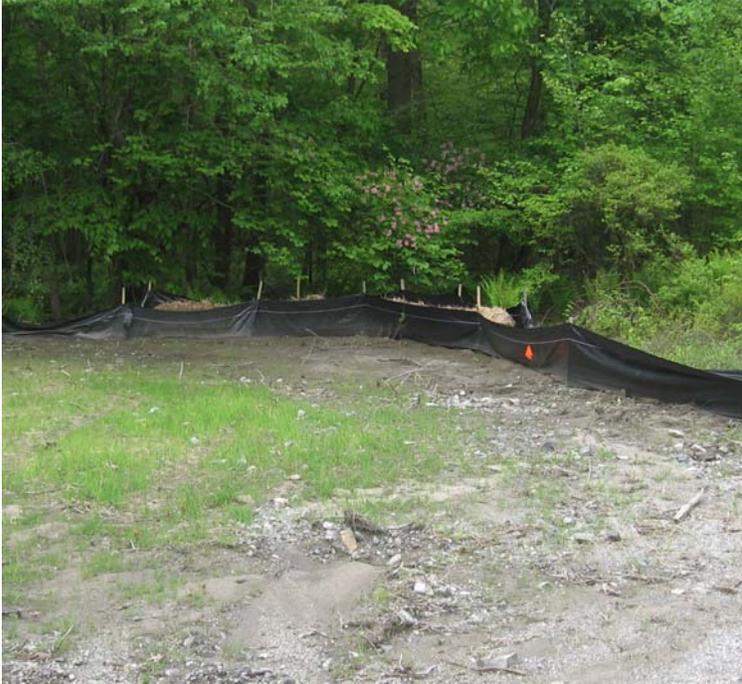
Rimmon Rd north (Orange): Silt fence controls remain functional near structure #3922.

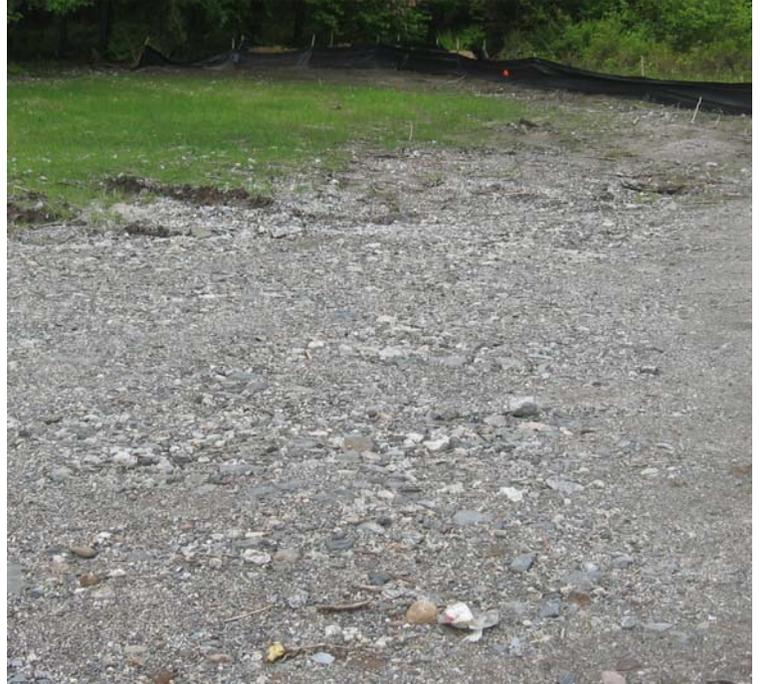
Rimmon Rd north: Stormwater is no longer flowing across the access road at this time.

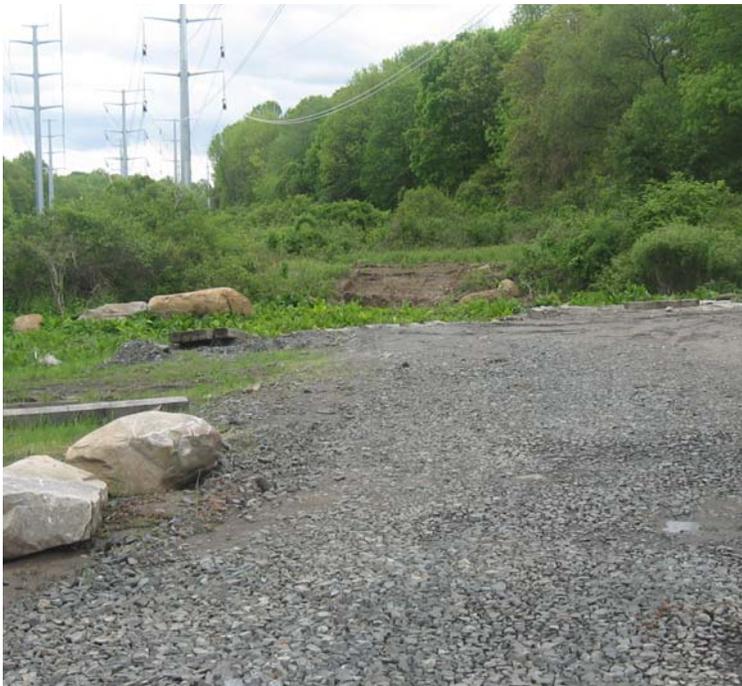
Rimmon Rd south: Vegetation growth has been noted where the timber mat stream crossing has been removed near structure #24105.

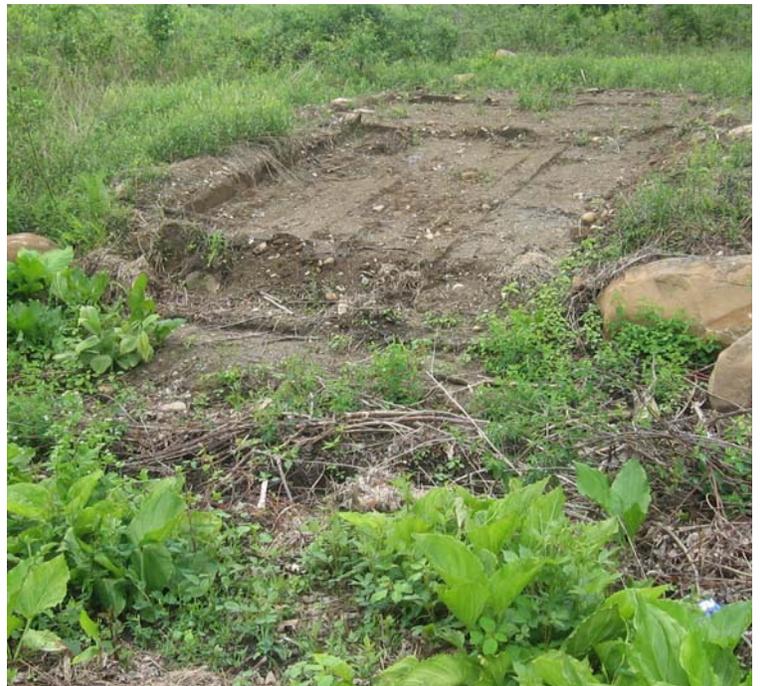
Rimmon Rd (south)	<p>Vegetative growth has been observed where the timber mats were removed, but exposed soils remain along the stream bank near structure #24105. 5/22/08</p>	<p>Continue to monitor until stabilization is achieved. 5/22/08</p>	<p>The timber mat crossing has been removed from the stream near structure #24105</p>
Oak Lane CC, Cow Path Lane, Salem Rd, Rimmon Rd, Brookwood Dr, Center Rd, Ansonia Rd, Manville Rd and Clear Ln to Rte 15	<p>Timber mat crane pads remain within the wetlands in these sections. 5/22/08</p>	<p>Continue to monitor. 5/22/08</p>	<p>NA at this time</p>
Bethany, CT Morris to Hatfield	<p>A stone access road and timber mats are in place in the wetland areas in this section. 5/22/08</p>	<p>Continue to monitor. 5/22/08</p>	<p>NA</p>

Rimmon Rd south: Exposed soils remain along the stream bank near structure #24105.

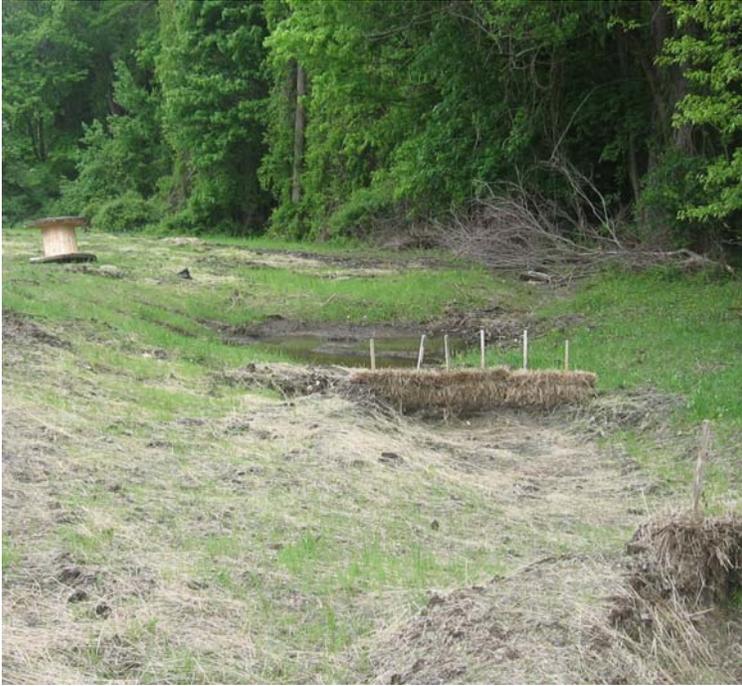
Glen Dam (Woodbridge): Access road controls (i.e waterbars) remain functional along the slope north of Glen dam.

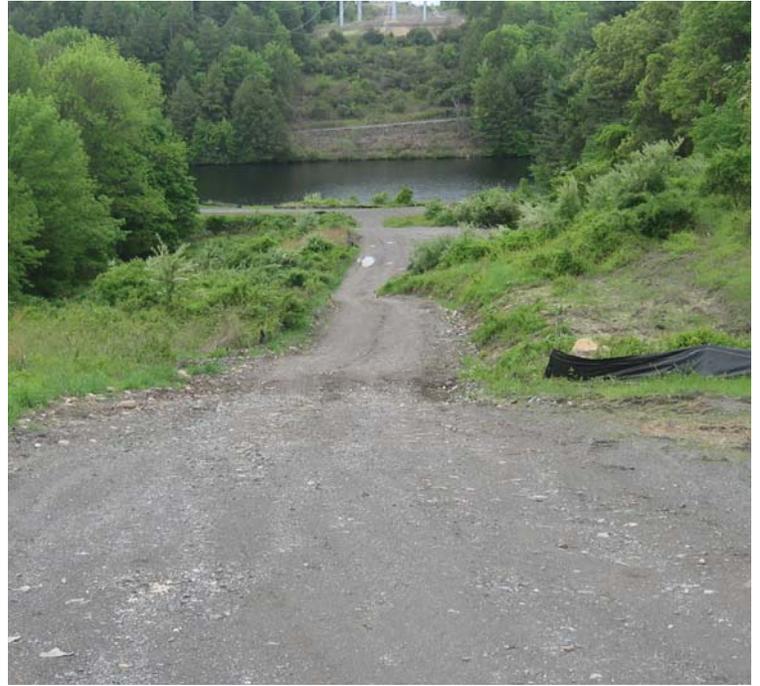
Glen Dam: The access road here remains stable, and waterbars/ sediment basins continue to function.

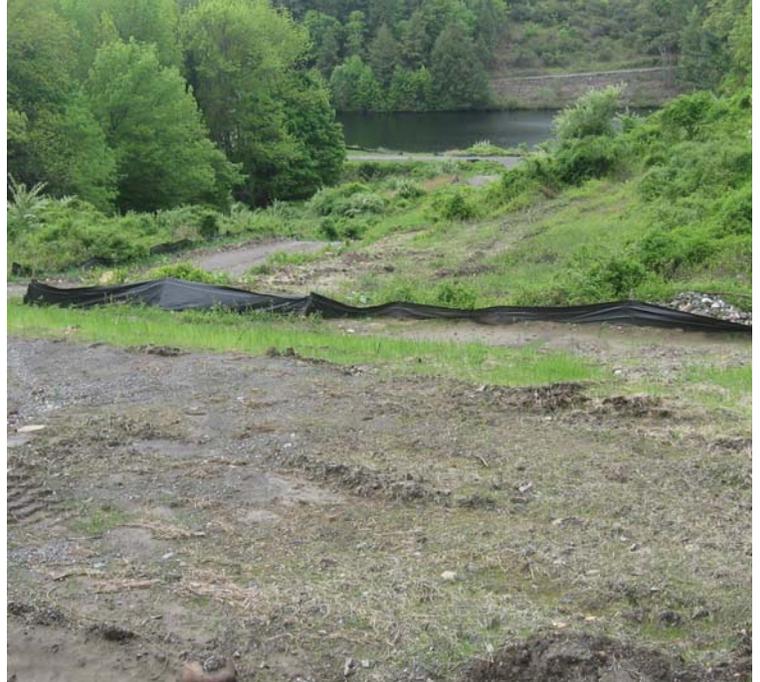
Glen Dam: An additional view of controls along the slope north of Glen Dam.

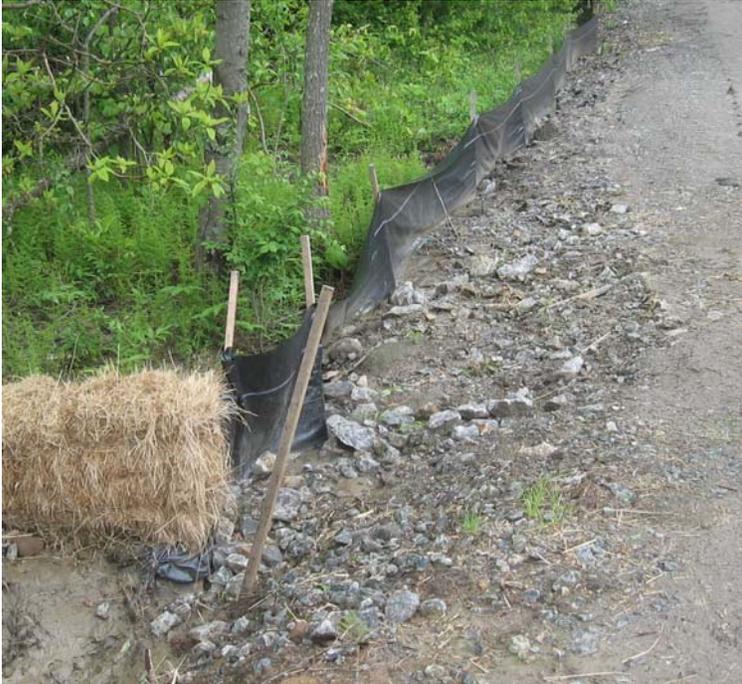
Downs Rd (Bethany): Erosion controls remain functional along the access road here.

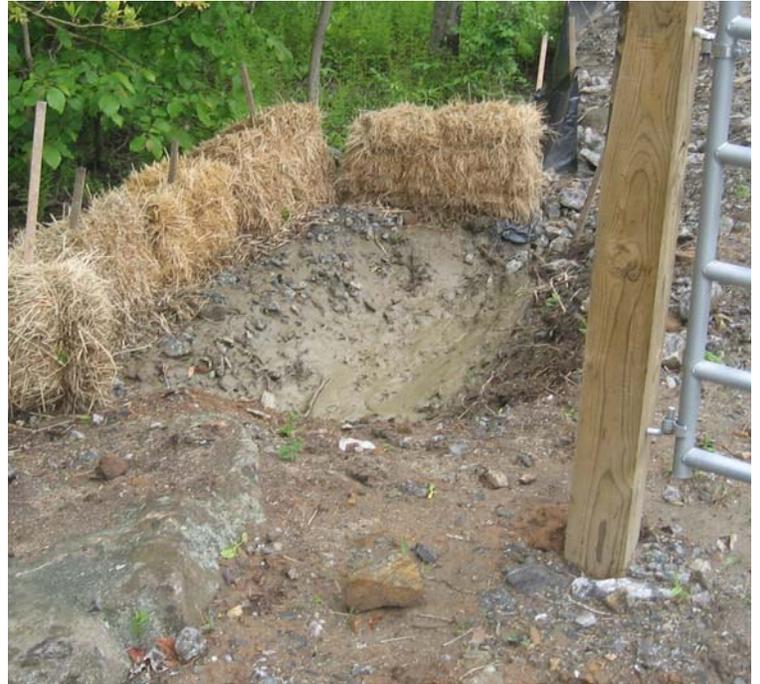
Downs Rd: An additional view of controls at the entrance of the access road.

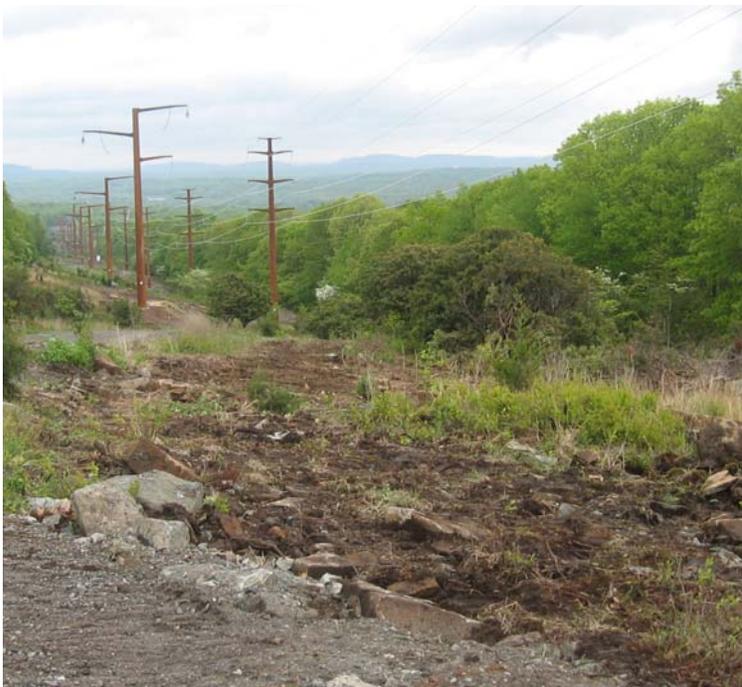
Gaylord Mtn Rd (Hamden): Exposed soils remain from grounding activity. Soils appear to be stable.

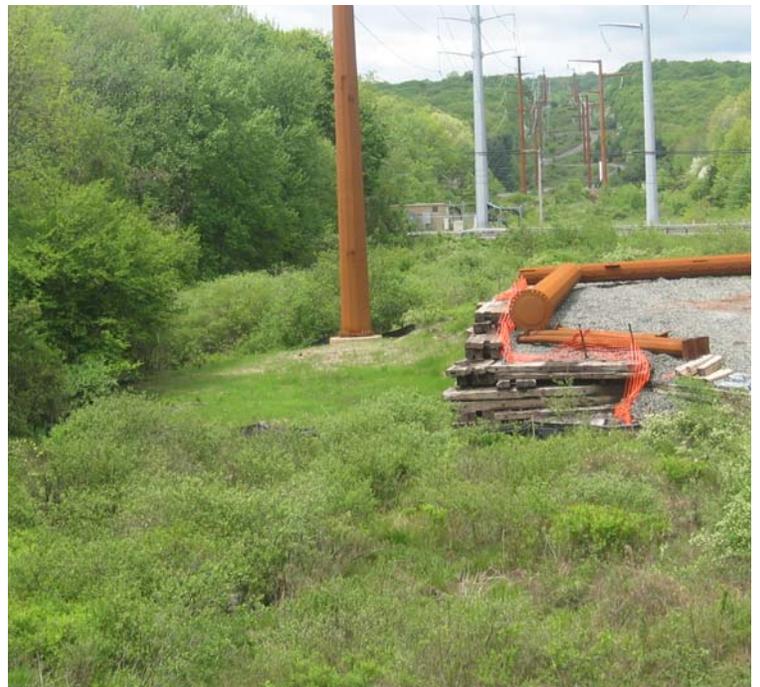
Willow St (Hamden): A view of restoration efforts near structure #4009.
