Docket No. 272 – Development and Management Plan Inspection

Segment 2b Inspection

Date: July 18, 2008

Location: Segment 2b – Cheshire/Hamden Town Line to East Devon Substation

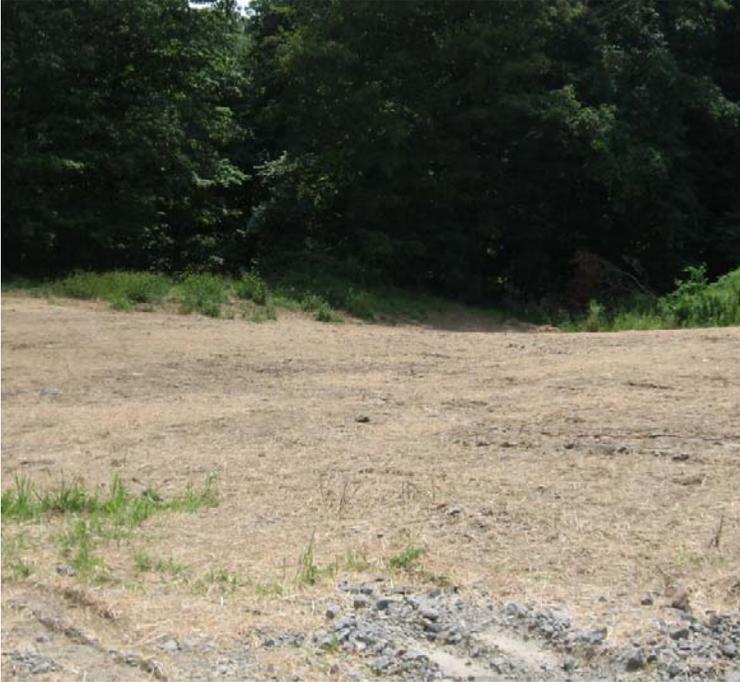
Wheelers Farm Rd (Milford): A view of 345 kV pad reclamation/restoration efforts.

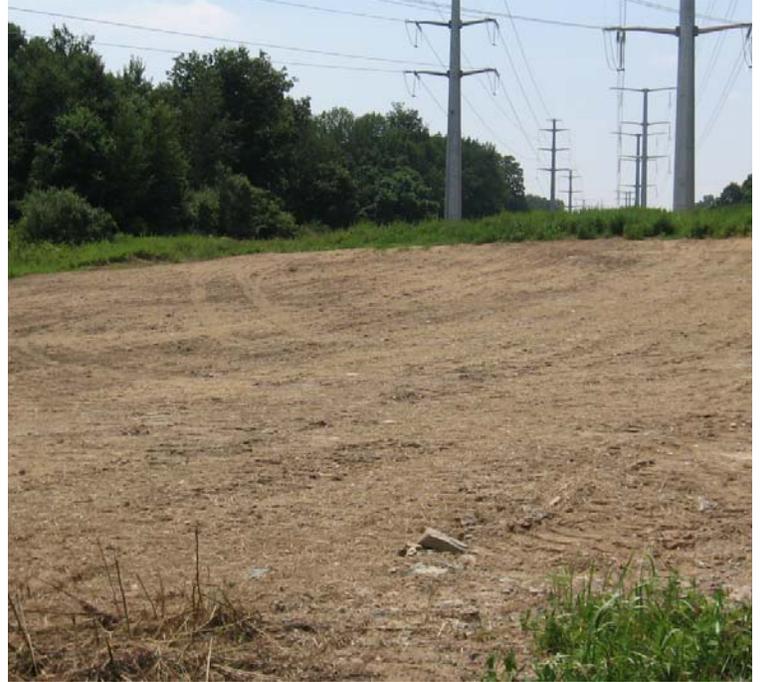
Wheelers Farm Rd (Milford): An additional view of 345 kV pad reclamation/restoration efforts.

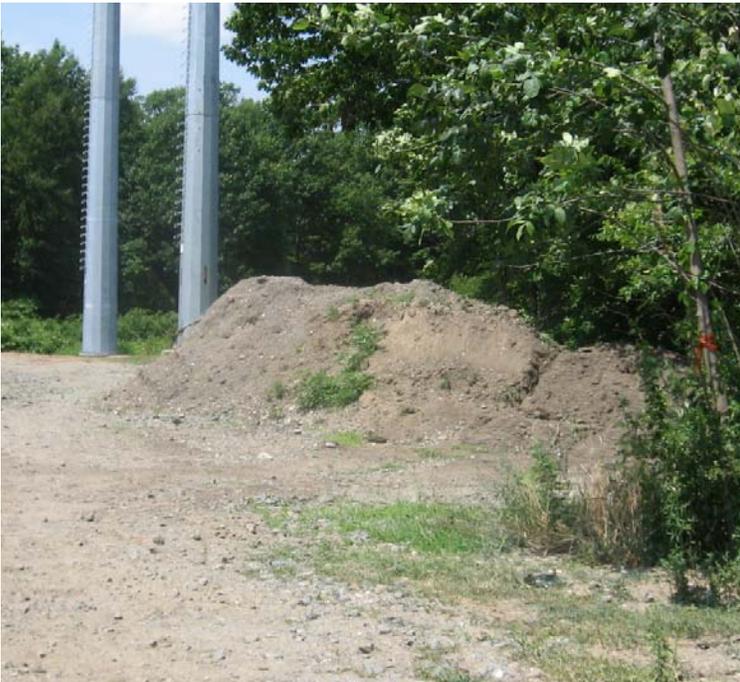
Milford, CT Wheeler's Farm Rd	The erosive gully near structure #3832 has been graded and exposed soils have been temporarily stabilized with mulch. Silt fence controls remain in place. 7/18/08	Continue to monitor until the area is stabilized with vegetation. 7/18/08	NA
Eisenhower Park	A spoil pile remains in the wetland buffer here. 7/18/08	Remove pile from wetland buffer when feasible. 7/18/08	Needs attention
Orange, CT Dogwood Rd	Silt fence is in need of repair near structure #24067. 3/12-7/18/08	Repair/ remove controls as necessary during 345 kV restoration efforts. 7/18/08	Needs attention during 345 kV restoration efforts

Eisenhower Park (Milford): A soil pile remains within the ROW.

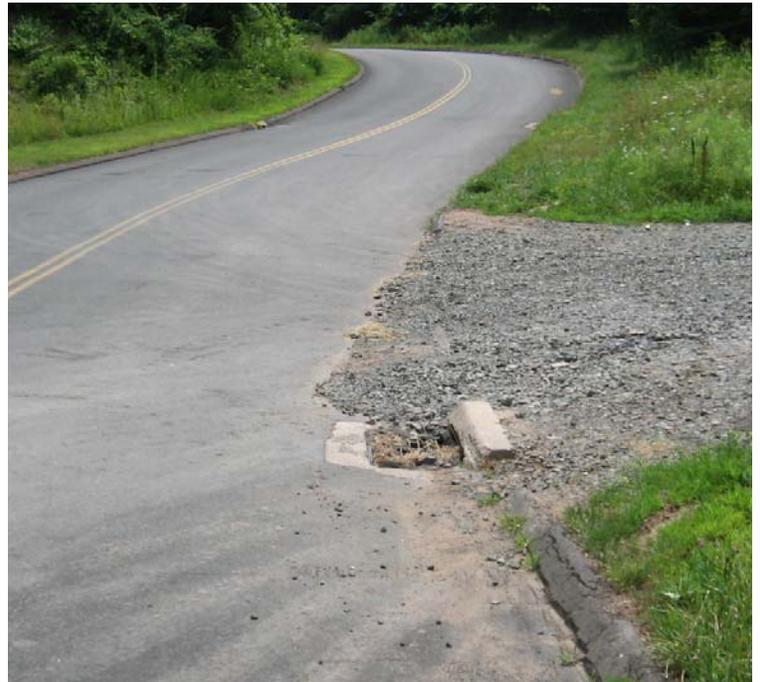
Areas of Inspection	Observation	Recommended Action	Corrected Action
Hamden, CT Old Ln	Catch basin controls need attention here. 7/18/08	Continue to monitor. Provide and maintain catch basin protection. 7/18/08	Needs attention
Foundation and site construction All sections	H- frame structure and lattice tower removal appears to be complete at this time. 7/18/08 115-kV work appears to be complete within the ROW at this time. Restoration efforts continue. 7/18/08 345-kV work appears to be complete within the ROW at this time. 7/18/08	NA. 7/18/08 Continue to monitor. See EC Section. 7/18/08 Continue to monitor. See EC Section. 7/18/08	NA NA NA
Erosion and sediment controls	Roots have been retained in most cleared areas to maintain some soil stability. Crews have made good efforts to temporarily stabilize most disturbed areas with hay mulch. Timber mats and erosion controls are in place in and adjacent to wetland areas. 7/18/08	None at this time. Continue to utilize the appropriate erosion control measures and stabilize disturbed soils as necessary. 7/18/08	NA

Old Ln (Hamden): Catch basin controls need attention.
