Docket No. 272 – Development and Management Plan Inspection

Segment 2b Inspection

Date: August 14, 2008

Location: Segment 2b – Cheshire/Hamden Town Line to East Devon Substation

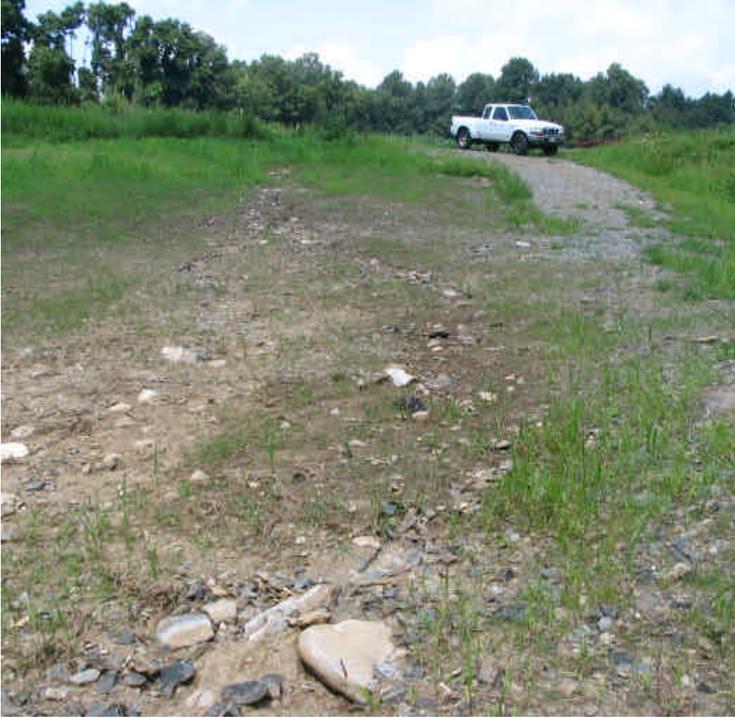
Whealers Farm Rd (Milford): Some gullying and scouring has resumed along the slope near structure #3832. Place check dams or divert the flow until the slope is stable.

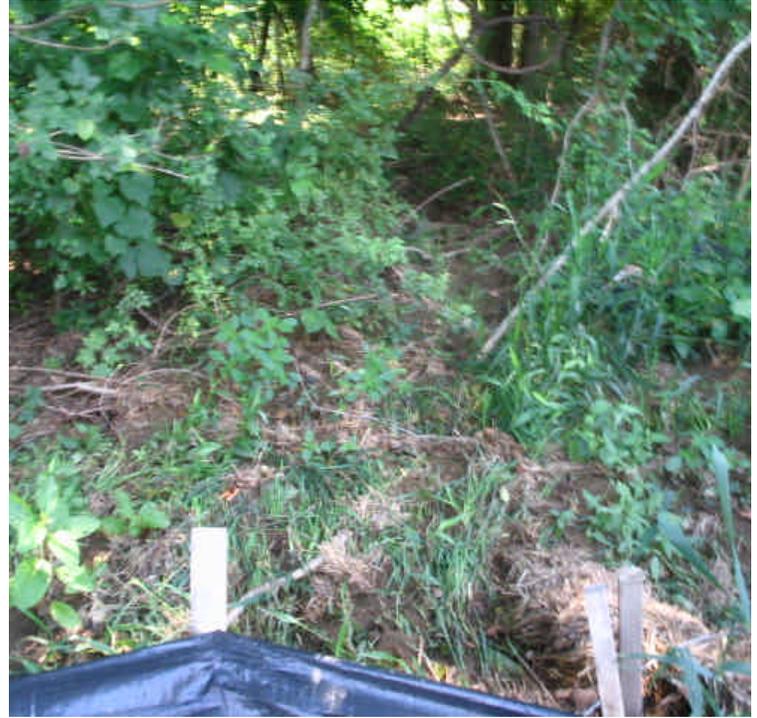
Whealers Farm Rd (Milford): Run-off from the slope is undermining the silt fence in place at the base. Water flows off the ROW at this point.

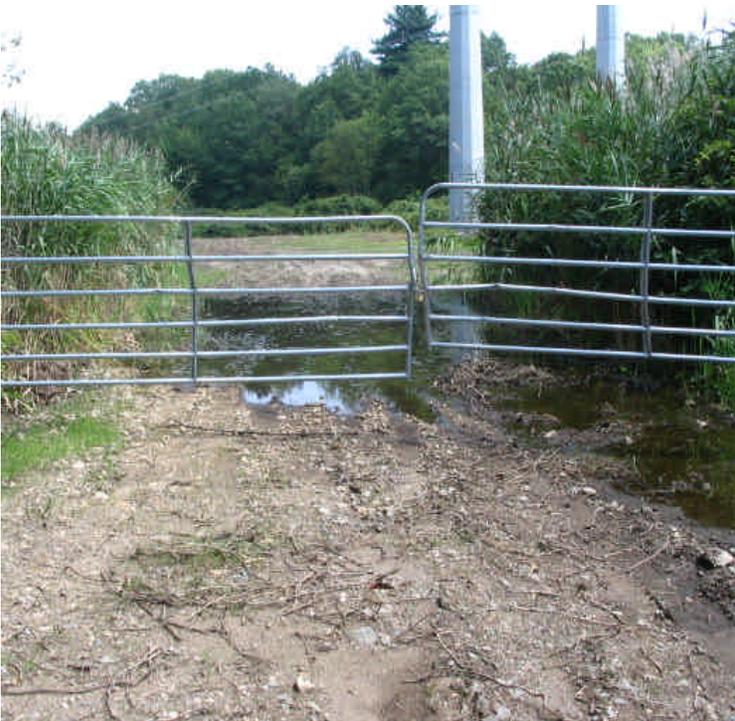
West River Rd (Milford): The access road has recently been restored in this section but soils are still relatively bare. Vegetative cover remains sparse.

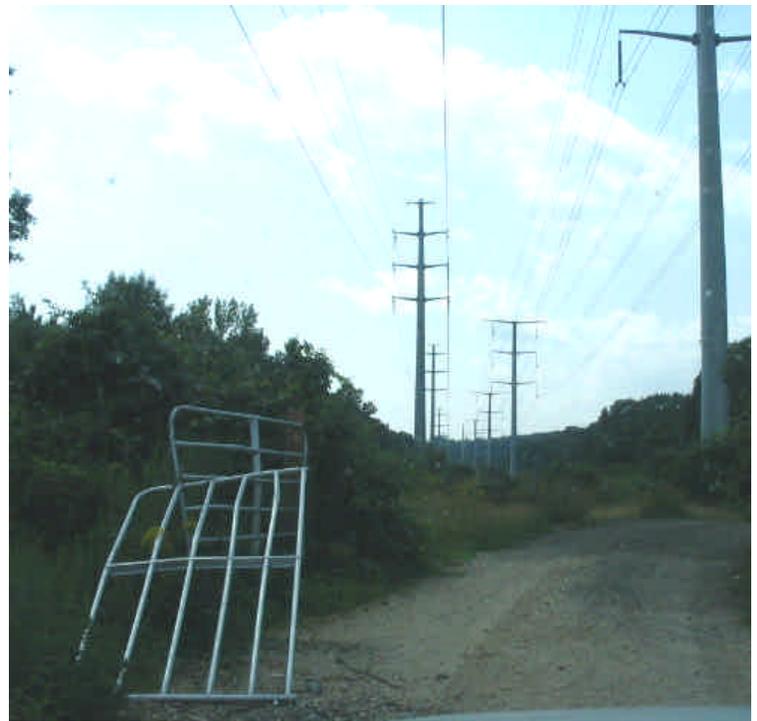
Eisenhower Park	The gate to the access road has been torn down (not project related) allowing access to the mitigation area. 8/14/08	Block public access until areas is stabilized. 8/14/08	Needs attention

Eisenhower Park (Milford): The gate to the access road has been torn down. (Not project related). However, this provides open vehicle access to the wetland mitigation area.

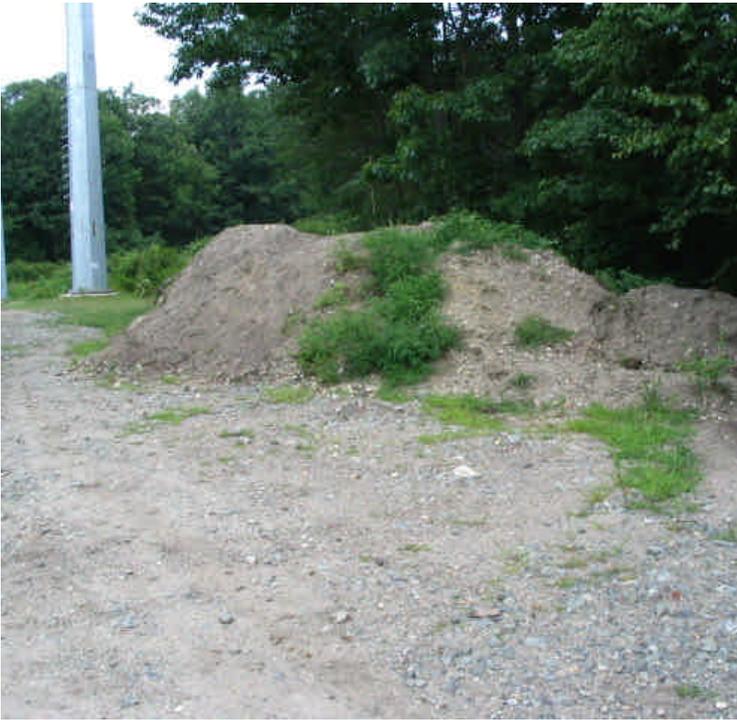
Eisenhower Park (Milford): A topsoil stockpile from the landscaping activities at the wetland mitigation area remains.

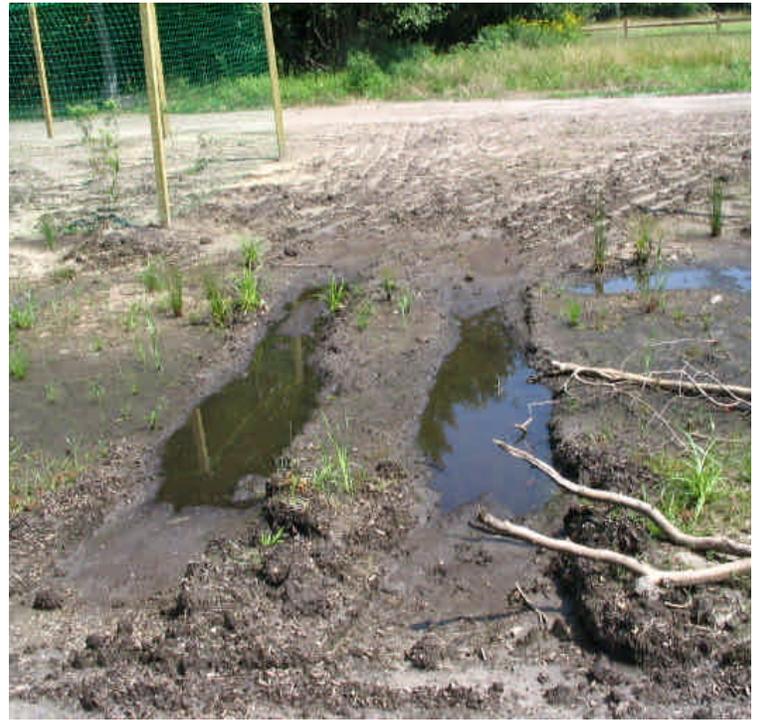
Eisenhower Park (Milford): Vehicle tracks were noted in the mitigation area here, indicating that the access road gate should be repaired. The area should also be seeded as soon as feasible to get ground cover established.

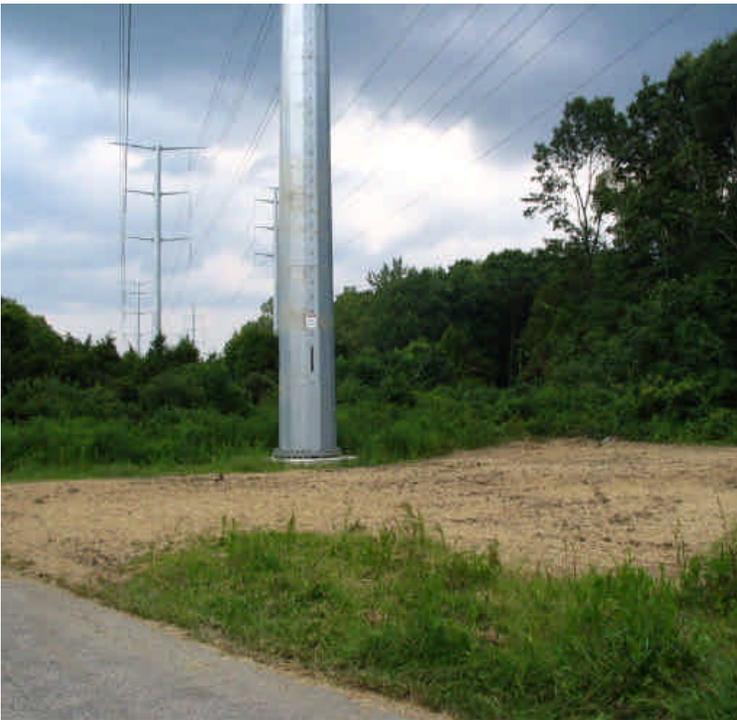
Salem Rd (Woodbridge): Pads in this location have been restored, seeded and mulched.

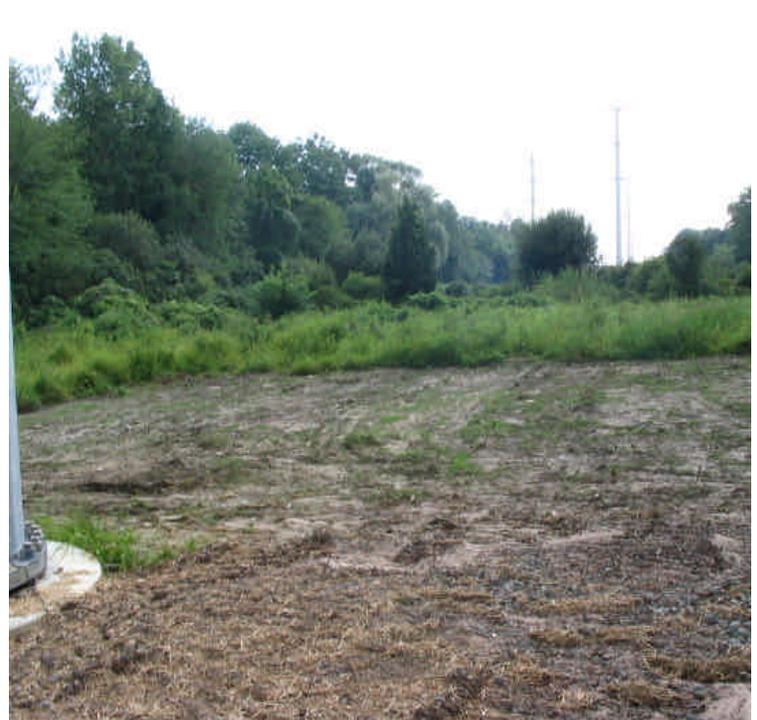
Manville Rd. (Woodbridge): Restoration recently completed on both sides of the roadway here.

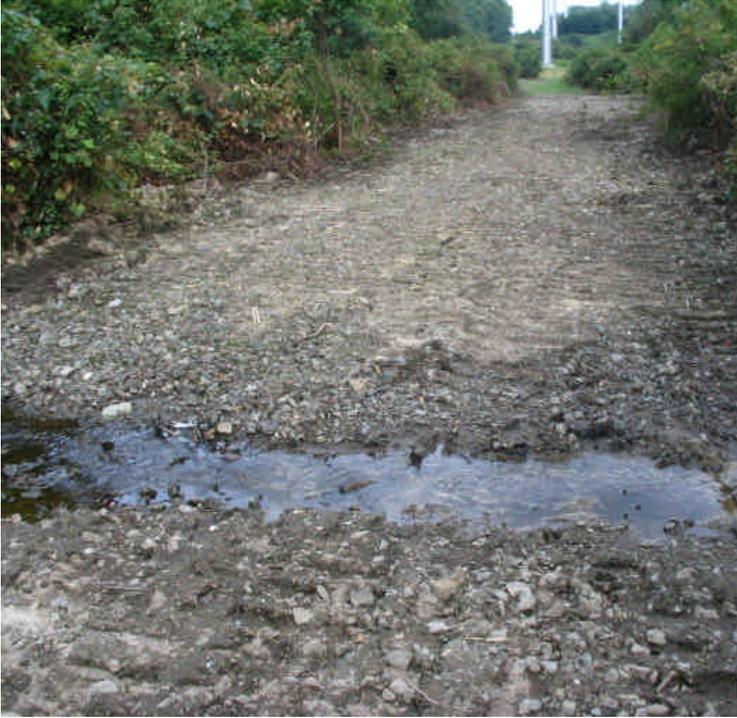
Rimmon Rd-B'Nai Jacob (Woodbridge): Access road mats were recently removed but soil adjacent to the stream channel remains bare/exposed. Seed the area as soon as feasible and/or place haybales along both banks.

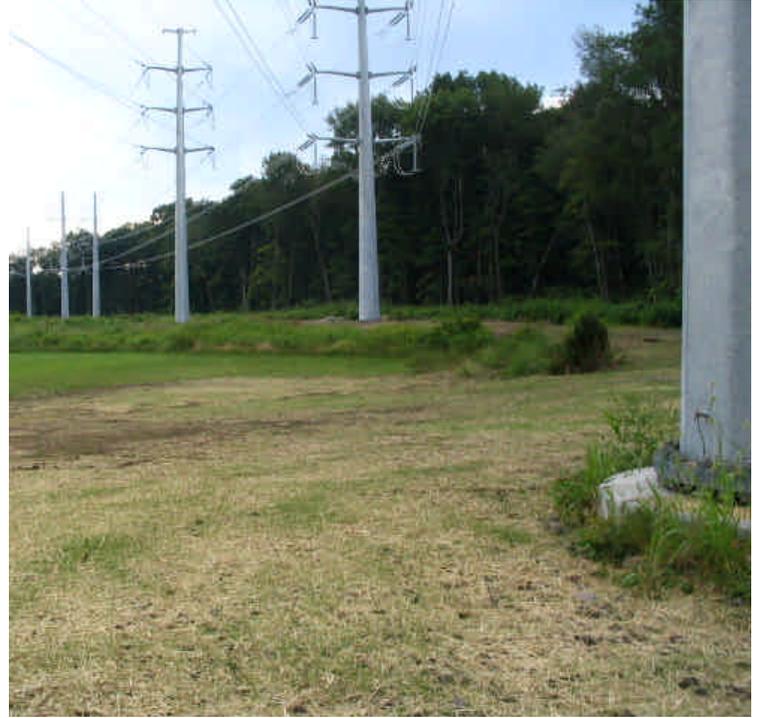
Rimmon Rd-B'Nai Jacob (Woodbridge): The restored portions of the ROW are in good shape and some minor grass growth was noted.

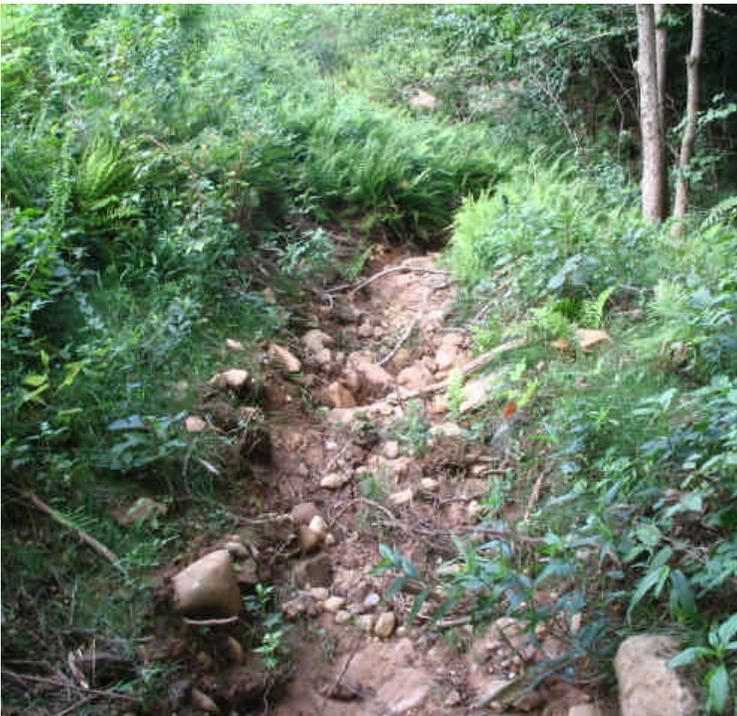
Gaylord Mtn. Rd. (Hamden): View of the scoured swale that flows off ROW near structure #3990. Water needs to be diverted or contained as sediment is flowing to a wetland off site.

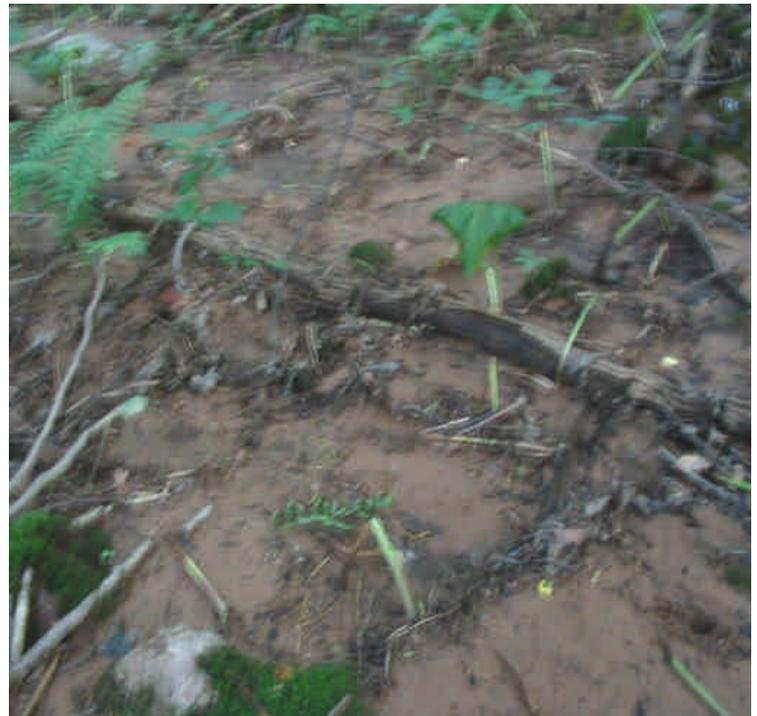
Gaylord Mtn. Rd. (Hamden): View of the sediment accumulating in the wetland. It will have to be removed by hand as equipment cannot access this location.
