Docket No. 272 – Development and Management Plan Inspection

Segment 2b Inspection

Date: September 19, 2008

Location: Segment 2b – Cheshire/Hamden Town Line to East Devon Substation

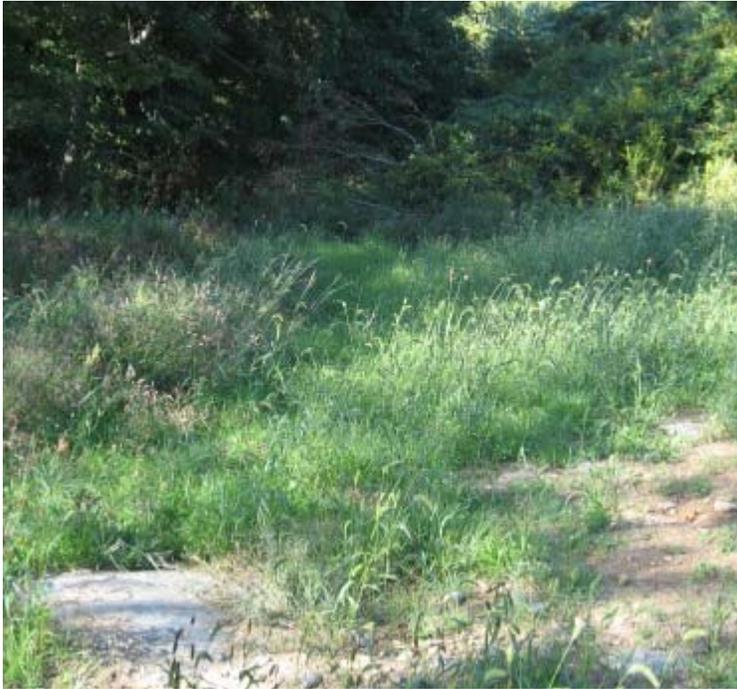
Areas of Inspection	Observation	Recommended Action	Corrected Action
Wheeler's Farm Rd	9/19/08 Stormwater runoff is causing minor scouring near structure #3832. Runoff from the slope is undermining the silt fence here. Approximately 65-70% vegetative cover has been noted outside of the stormwater path in this area. 8/14-9/19/08	Place check dams or divert runoff flow until the slope is stable. 9/19/08	Approximately 65-70% vegetative cover has been noted outside of the stormwater path in this area. <i>Needs additional attention</i>
West River Street	Access roads and timber mat crane pads have been removed. Vegetative growth continues. 9/19/08	Continue to monitor and stabilize exposed soils. 9/19/08	Vegetative growth continues
Eisenhower Park	A spoil pile remains in the wetland buffer here. 9/19/08	Remove pile from wetland buffer when feasible. 9/19/08	Needs attention when feasible
Eisenhower Park Mitigation Area	Soils in the mitigation area remain exposed, but appear to be contained on site. In general, all plantings appear to be doing well at this time. 9/19/08	Continue to monitor until final stabilization is achieved. Exposed soils should be seeded if grass growth is not observed now that the plantings are complete. 9/19/08	Needs attention

Wheelers Farm Rd (Milford): Vegetation growth continues. Vegetation covers approximately 65-70% of the restored crane pad near structure #3832/24019. Signs of minor scouring from stormwater run-off remain. Additional stabilization efforts need to be evaluated here.

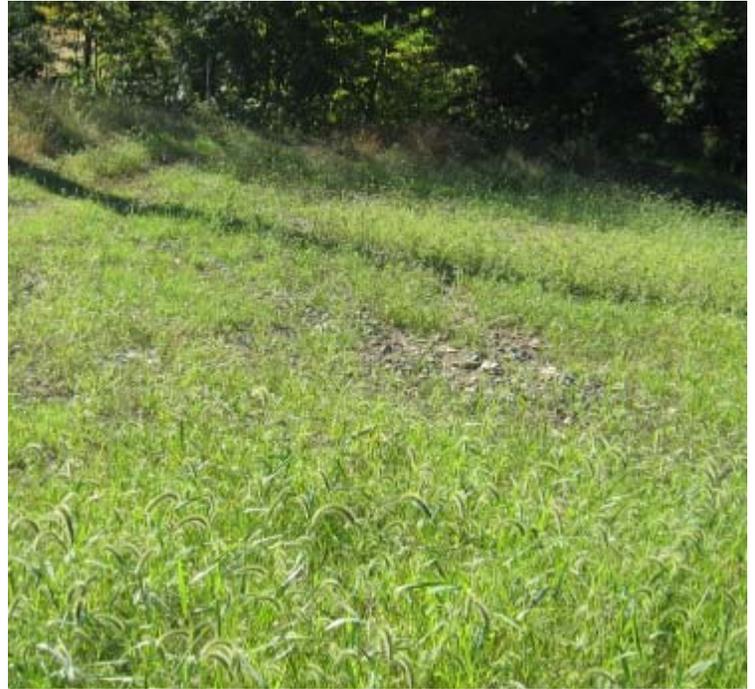
Wheelers Farm Rd: An additional view of vegetation cover near structure #3832/24019.

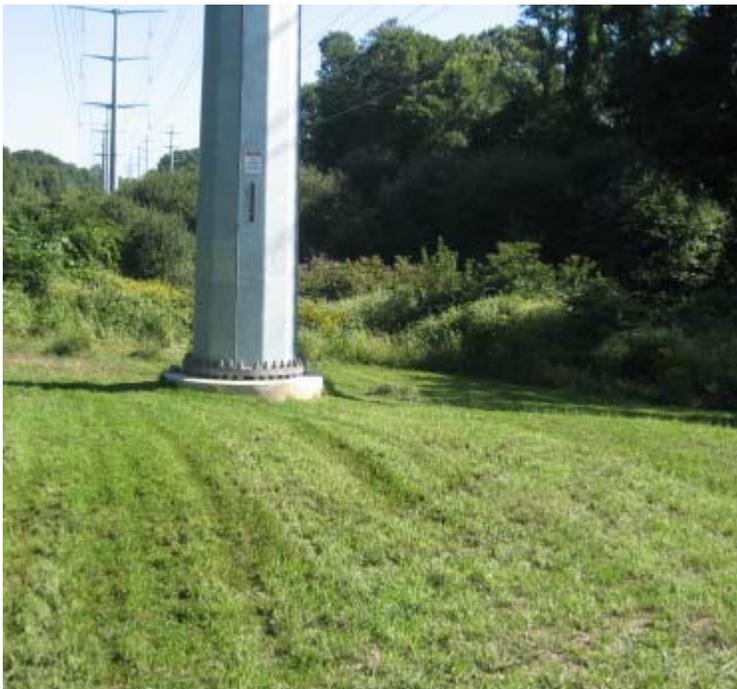
Oronoque Rd (Milford): A view of the vegetative cover near structure # 24008.

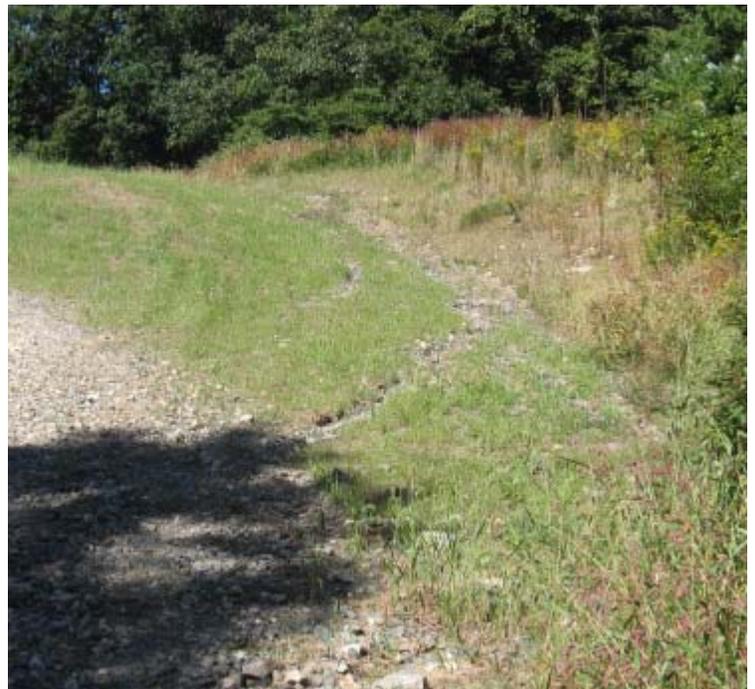
Lexington Way: Stormwater run-off has caused some scouring within the restored crane pad. Additional stabilization is needed here.

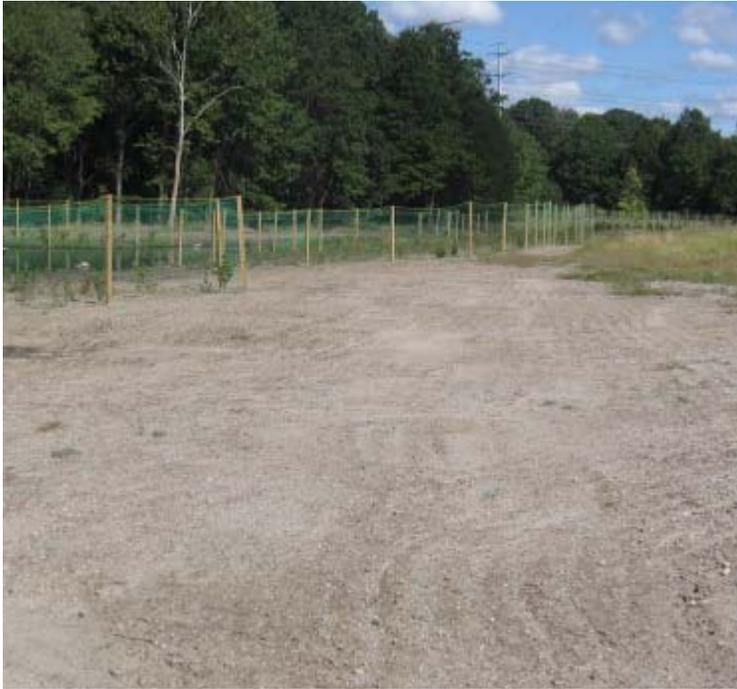
Eisenhower Park Mitigation Area (Milford): Exposed soils remain around the perimeter of the mitigation area.

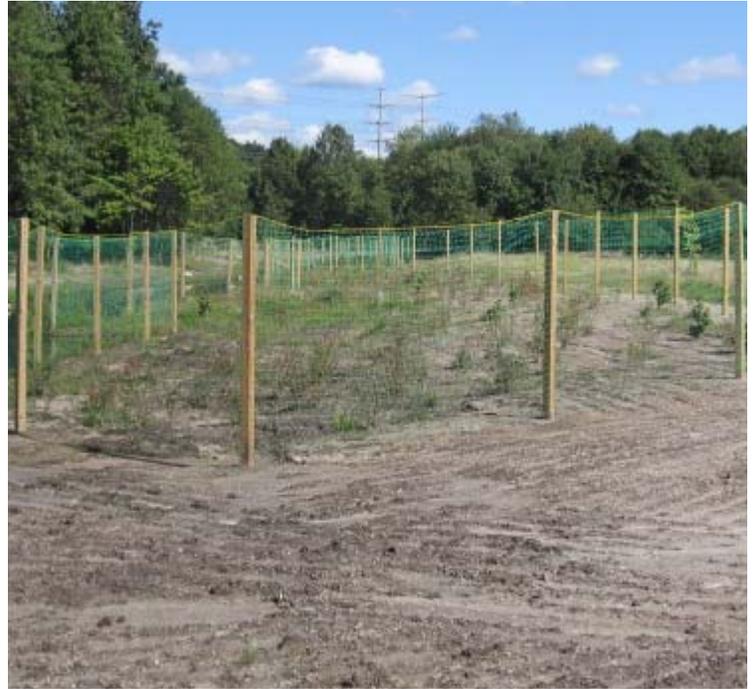
Eisenhower Park Mitigation Area: The shrub and herbaceous plantings continue to do well.

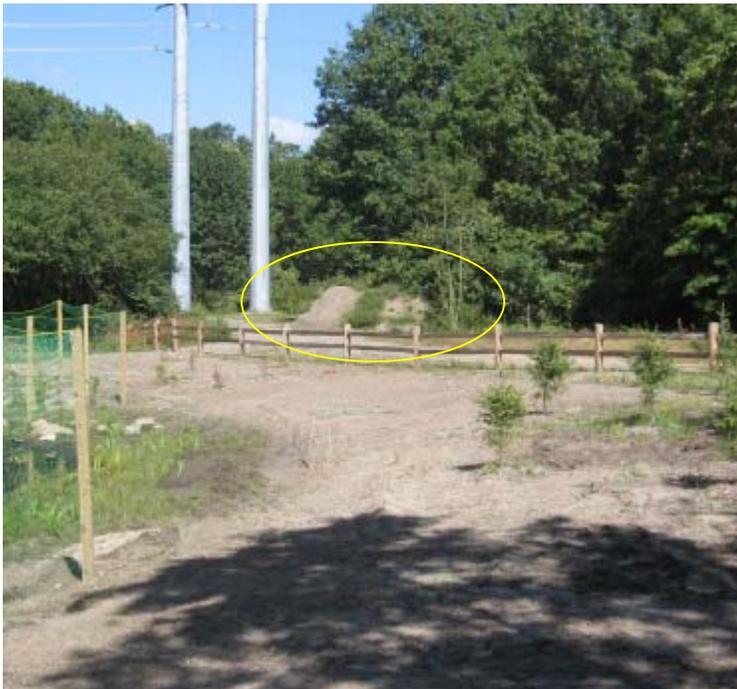
Eisenhower Park Mitigation Area: A stockpile remains in the wetland buffer near structure #3839. Sediment migration is not evident at this time.

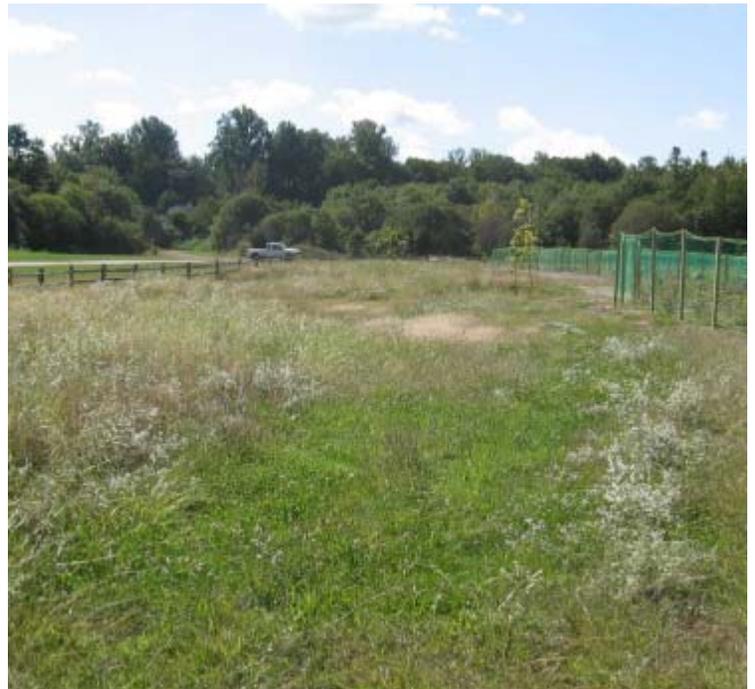
Eisenhower Park Mitigation Area: Good vegetative cover exists along the eastern edge of the mitigation area.

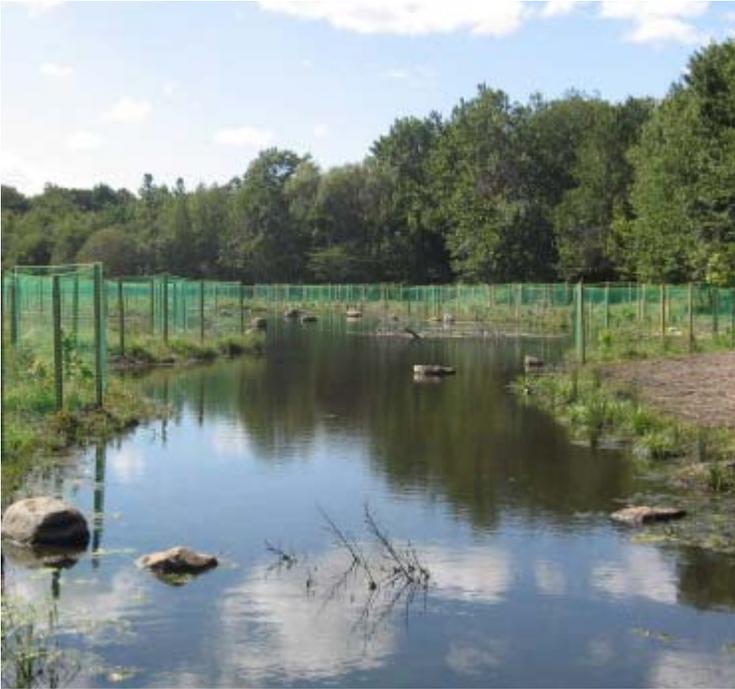
Eisenhower Park Mitigation Area: A general view of the mitigation area. The mitigation area is providing quality habitat for numerous species of wildlife.

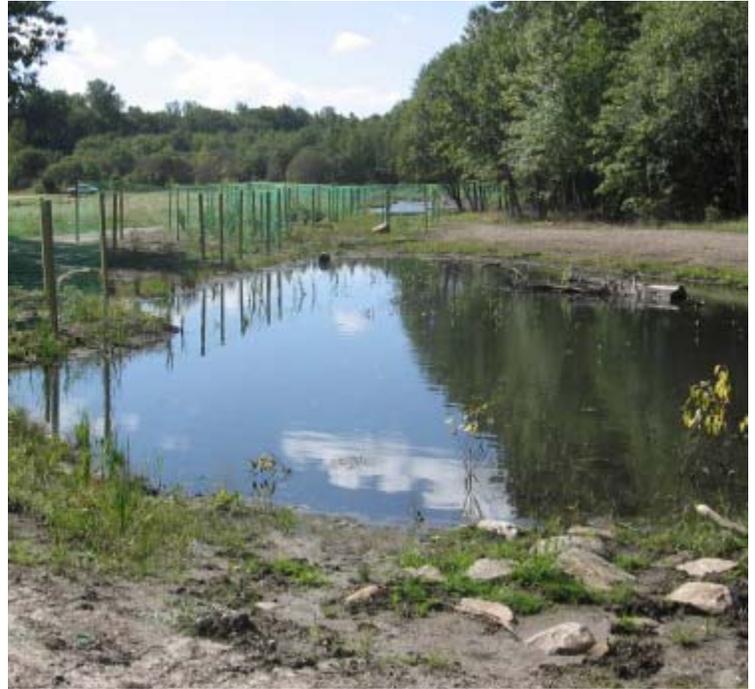
Eisenhower Park Mitigation Area: A general view of the mitigation area looking south from the northern end.

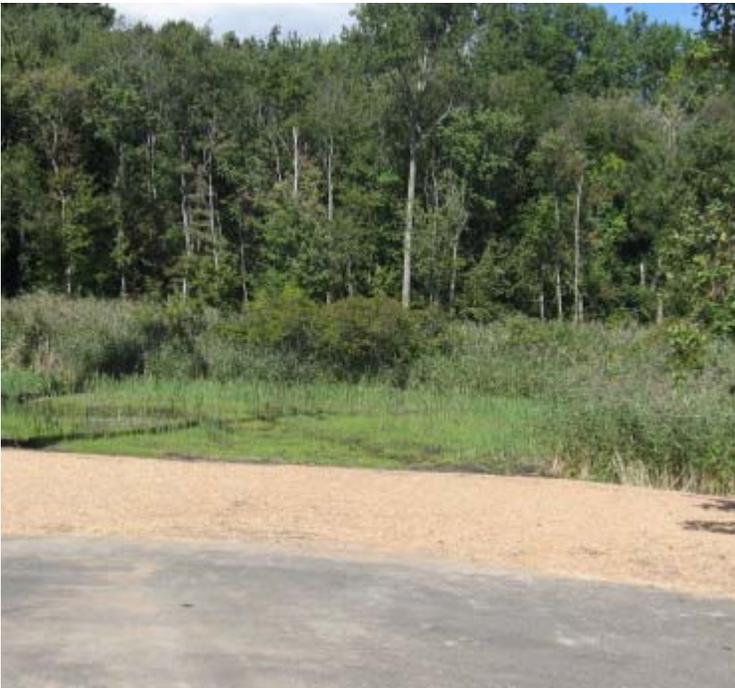
Hunting Hill Rd: A view of the restoration efforts near structures #3881/24068. Vegetation has returned to the wetland where a timber-mat crane pad had been removed.

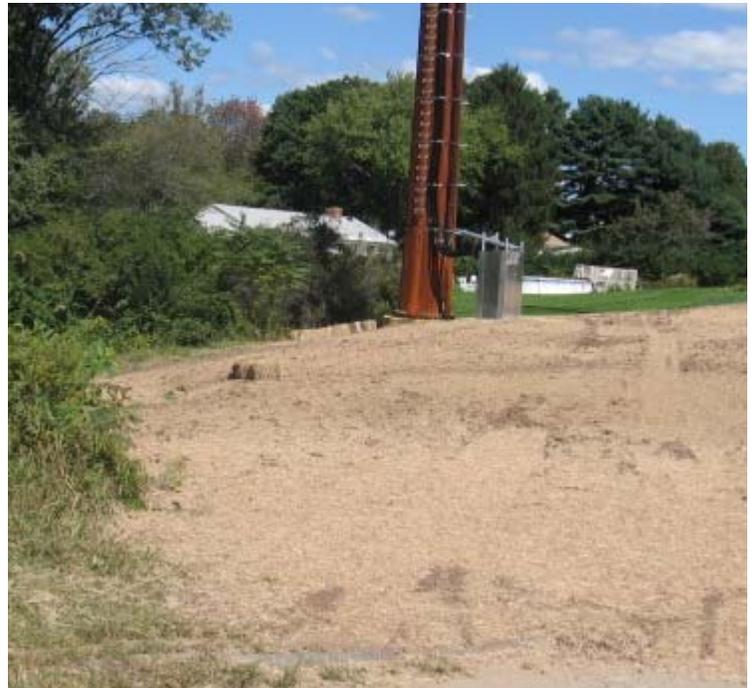
Hunting Hill Place: A view of the restoration efforts near structures #3882/24069. All soils appear stable at this time.
