**Docket No. 272 – Development and Management Plan Inspection**

**Segment 2b Inspection**

**Date:** October 2, 2008

**Location:** Segment 2b – Cheshire/Hamden Town Line to East Devon Substation

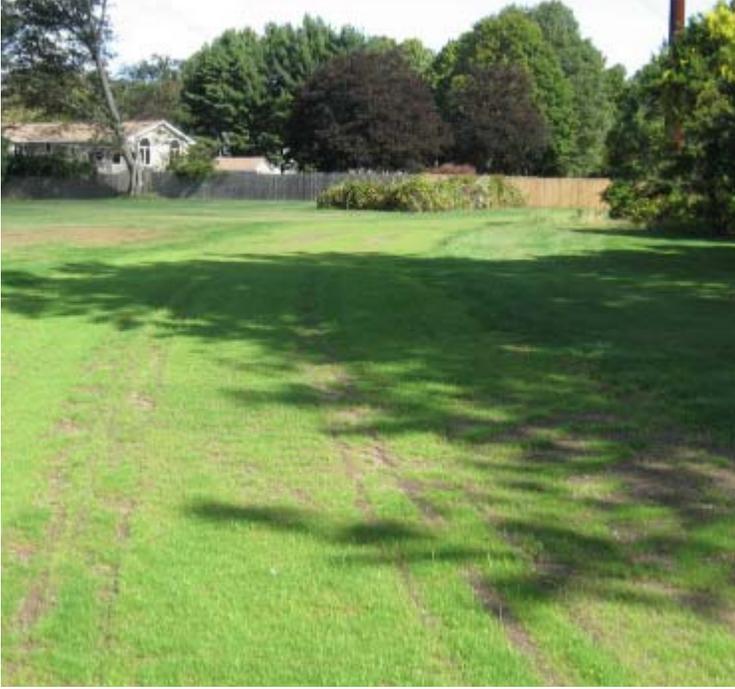
Treat Ln (Orange): Vegetative growth continues within the restored access road.

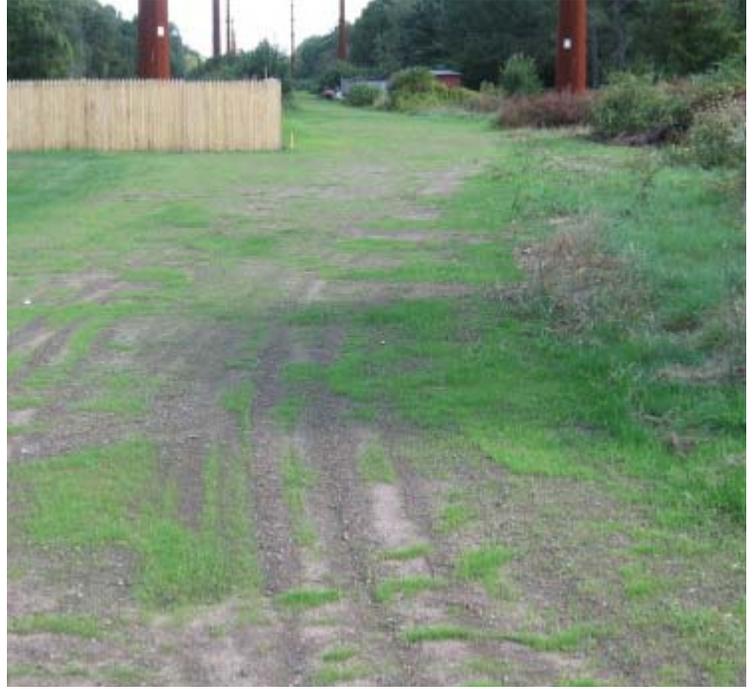
Treat Ln: An additional view of vegetative cover near structures #3850/24037.

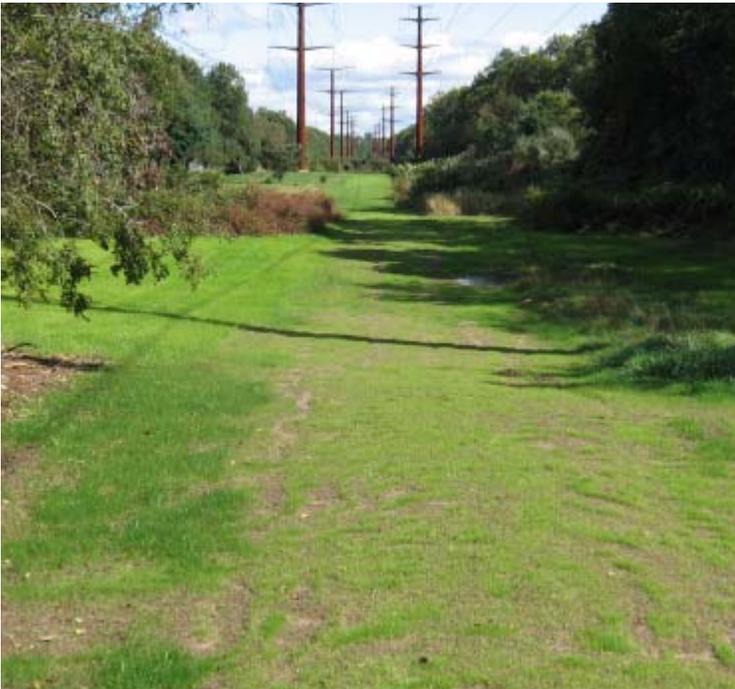
Treat Ln: An additional view of vegetative cover within the restored access road.

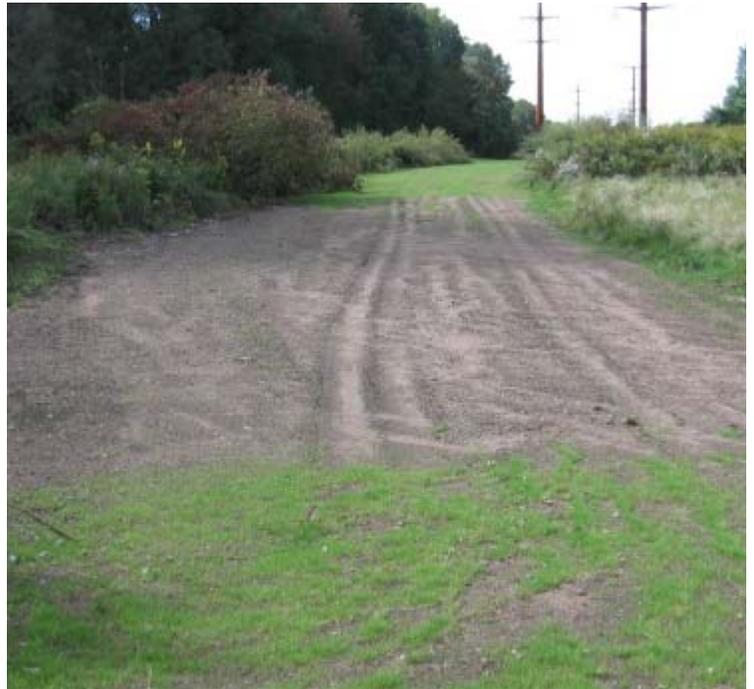
Orange Center Rd (Orange): View of the vegetative cover within the restored access road area.

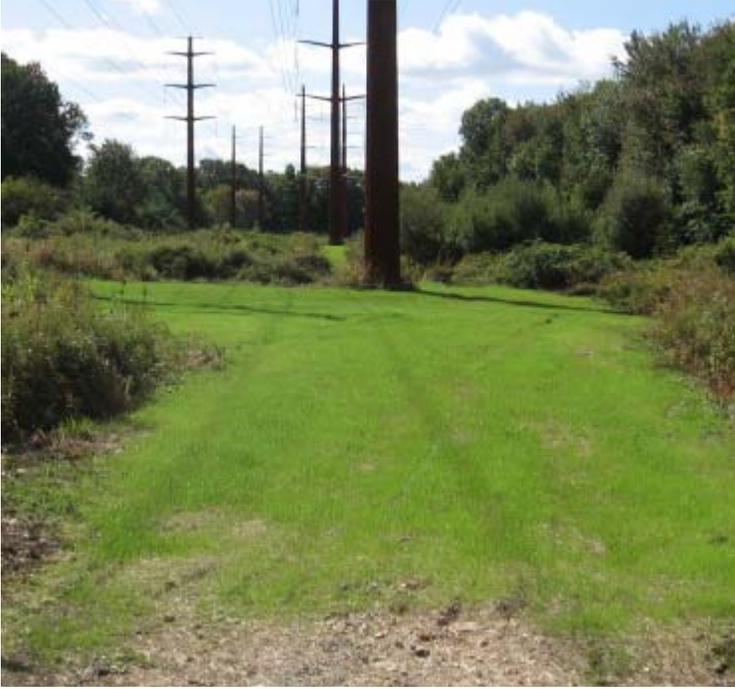
Sunset Dr (Orange): View of the restored access road. Final stabilization has been achieved in this section.

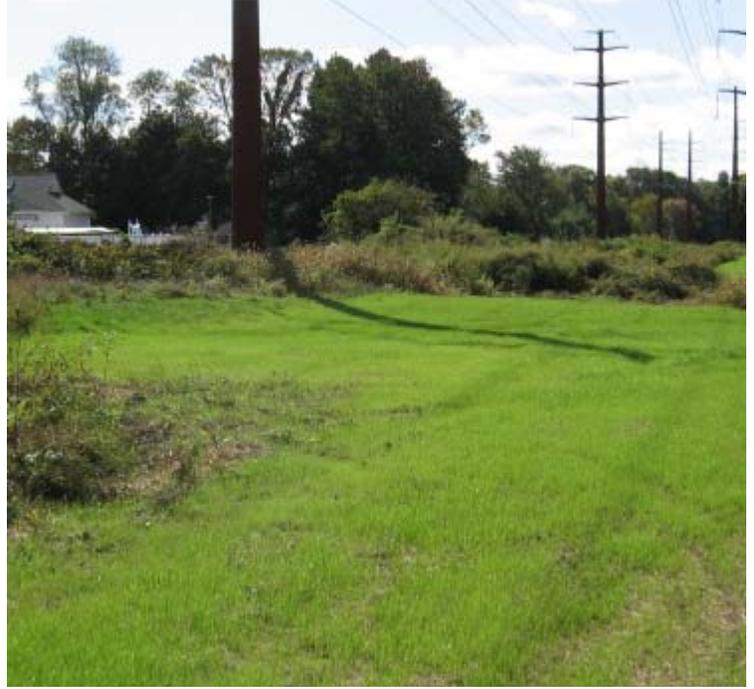
Sunset Dr: View of the restored crane pad. Final stabilization has been achieved in this section.

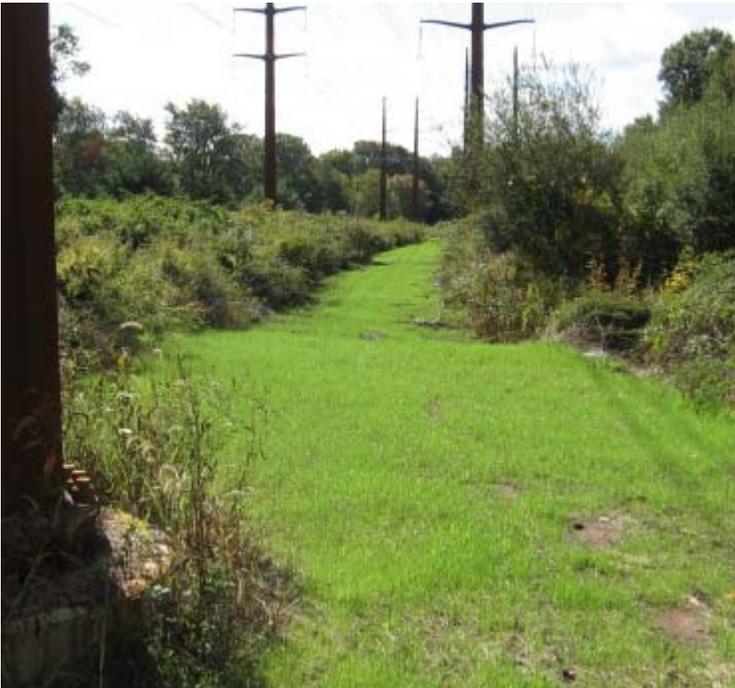
Sunset Dr: View of the restored wetland crossing. Final stabilization has been achieved in this section.

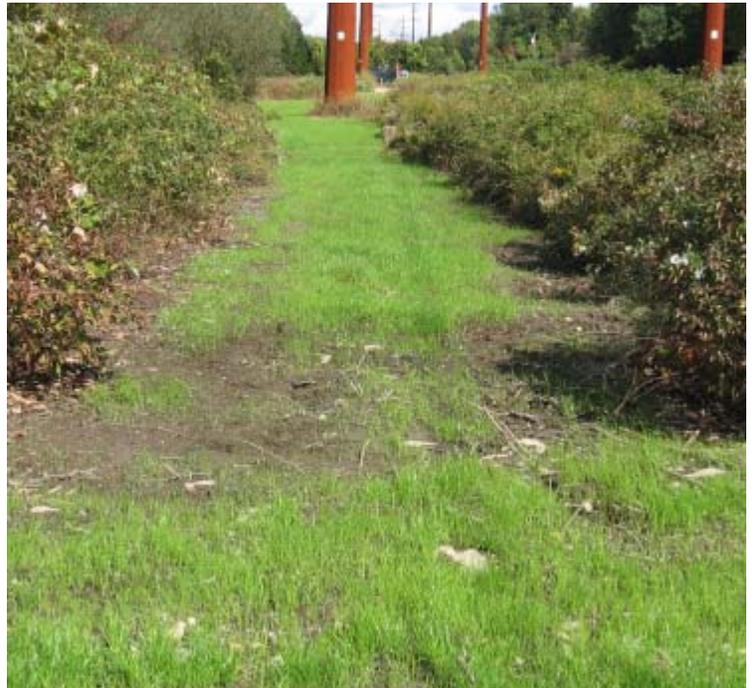
Sunset Dr: An additional view of the restored wetland crossing. Final stabilization has been achieved in this section.

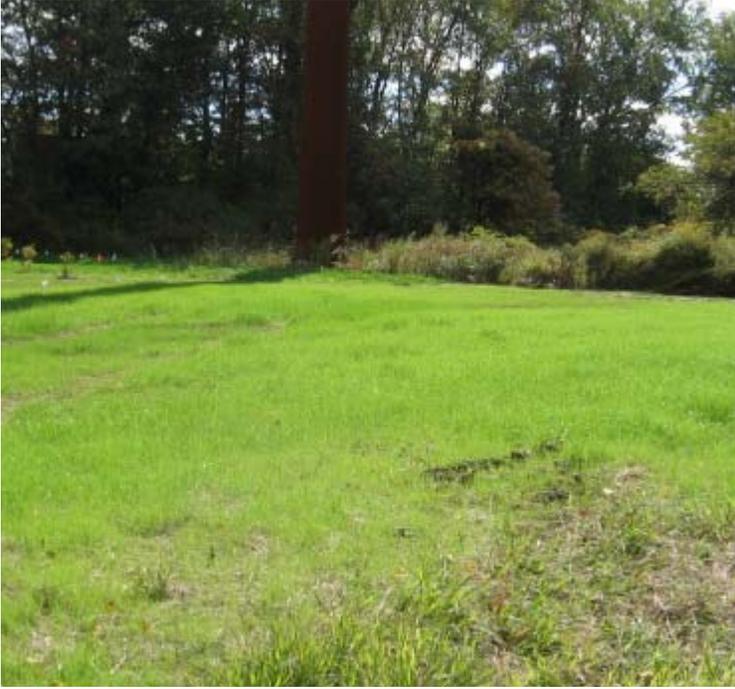
Hall Dr (Orange): Final stabilization has been achieved near structures #3868/24055.

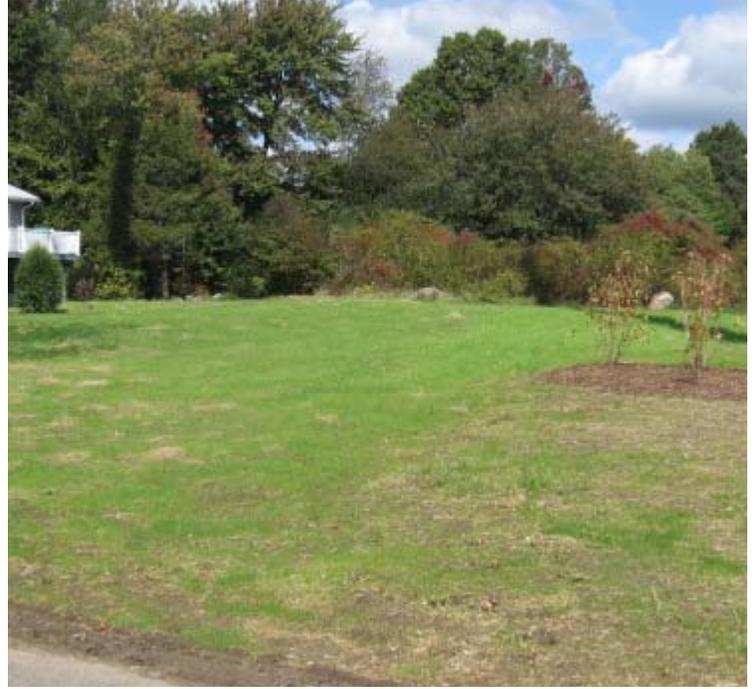
Edward Ct (Orange): Final stabilization has been achieved near structures #3869/24056.

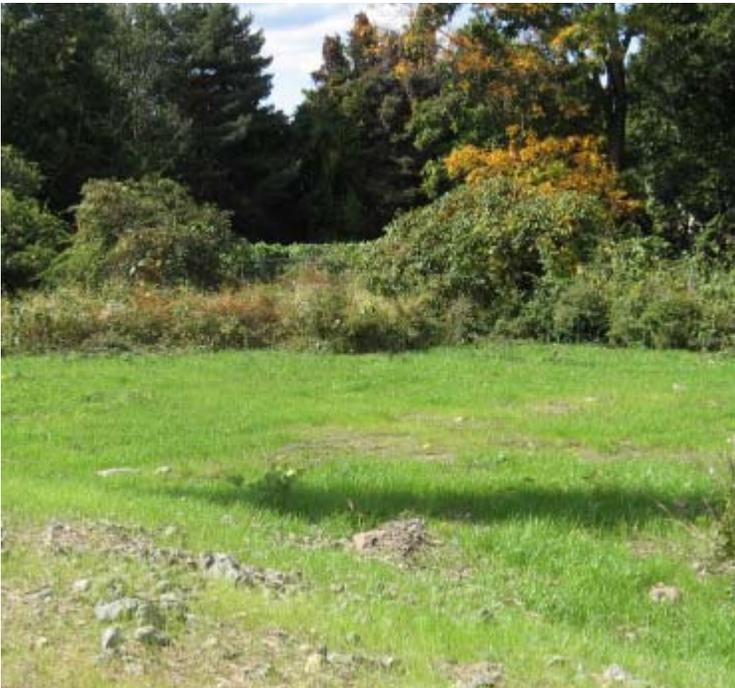
Racebrook Rd (Orange): Final stabilization has been achieved near structures #3870/24057.

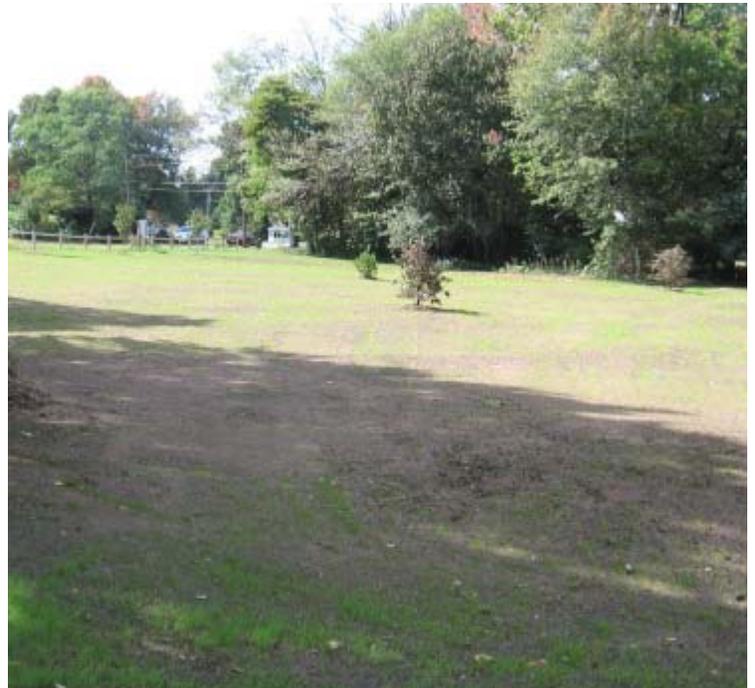
Russell Ave (Orange): View of the restoration efforts here. Plantings have been noted.

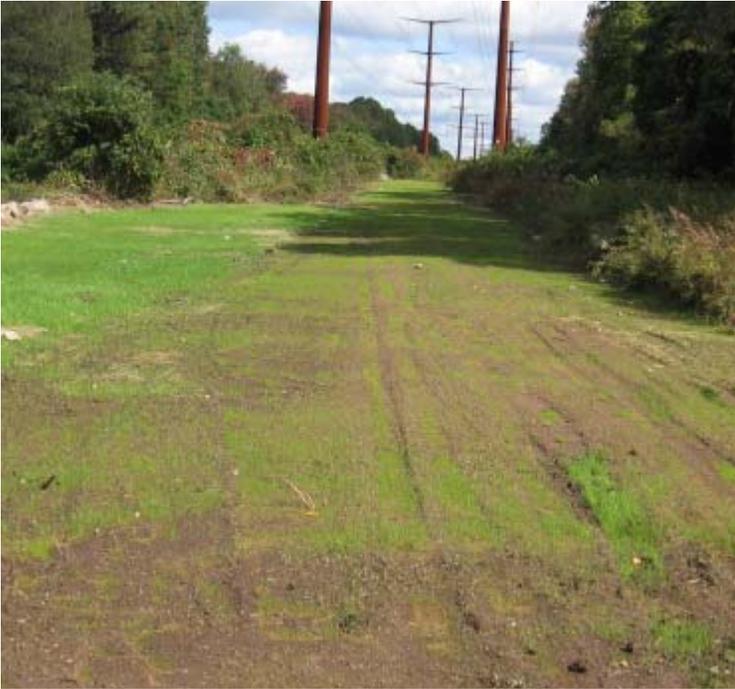
Russell Ave: Access roads have been restored in this section. Vegetative has been noted.

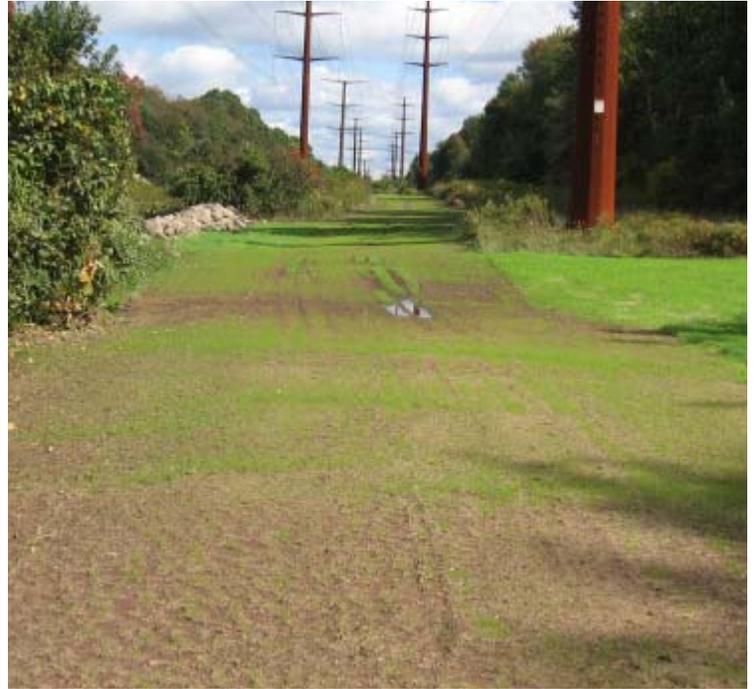
Russell Ave: An additional view of the access road restoration growth efforts.

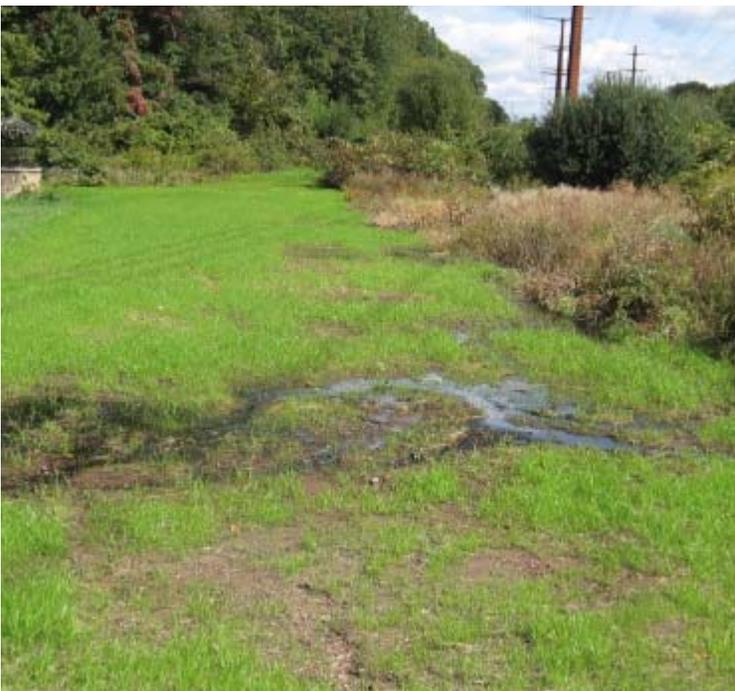
Russell Ave: View of the restored wetland crossing.

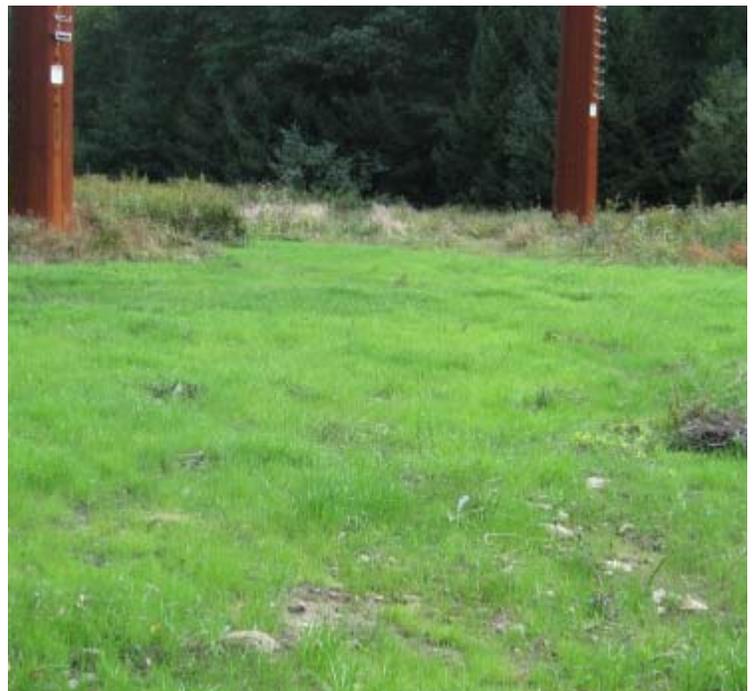
Russell Ave: View of the restored crane pad near structures #3874/24061. Good vegetative growth exists within the restored wetland.

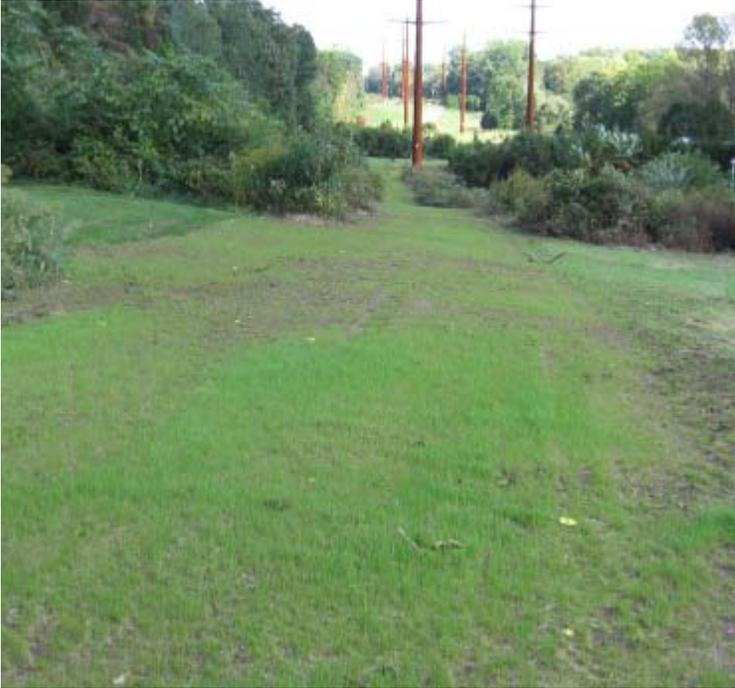
Overland Dr (Orange): View of restoration efforts. Vegetative growth has been noted.

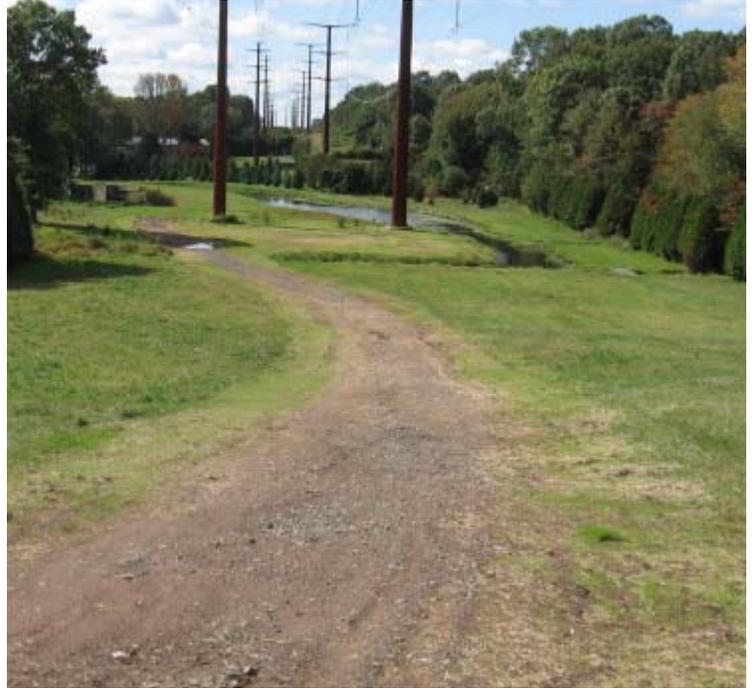
Dogwood Rd (Orange): View of the restoration efforts here. Soils appear stable at this time. Vegetative growth has been noted.

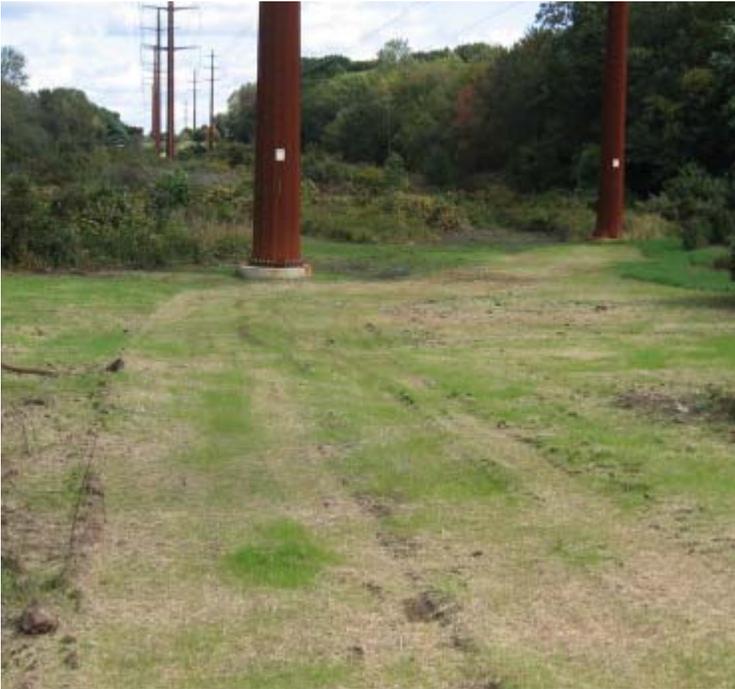
Dogwood Rd: View of access road/crane pad/wetland restoration efforts near structures #3880/24067.

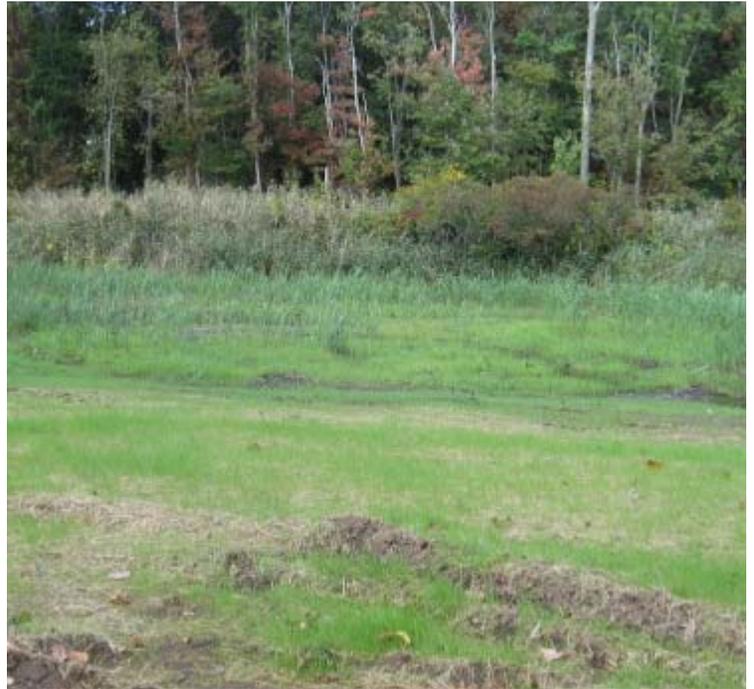
Hunting Hill Rd (Orange): Additional vegetative growth has been noted within/around the wetland near structures #3881/24068.

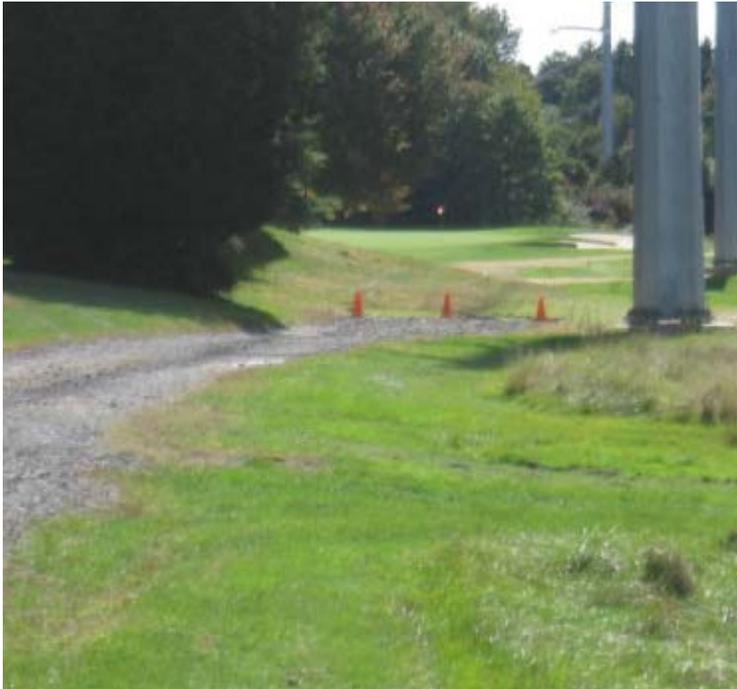
Oak Ln CC (Woodbridge): Restoration efforts continue within the wetland areas here.

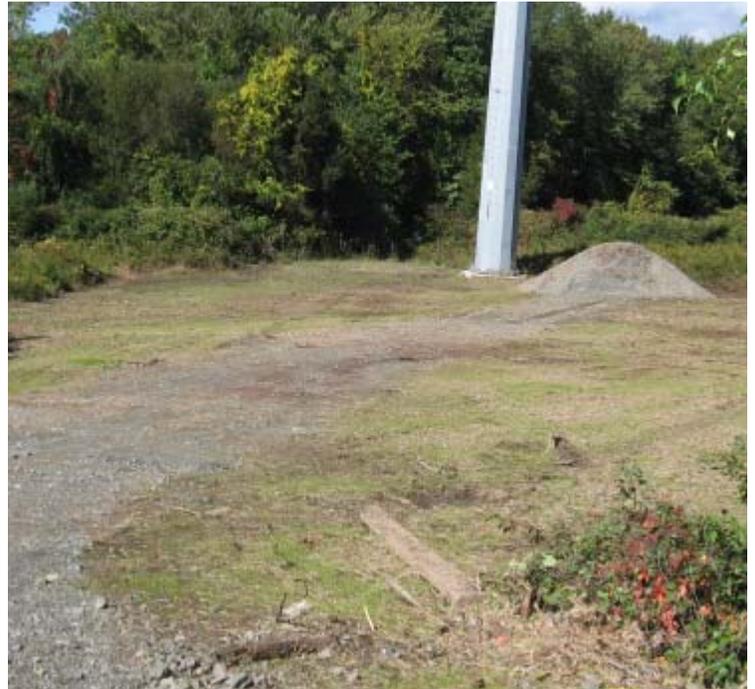
Oak Ln CC: A stock pile remains within the wetland buffer with no controls. The pile appears contained in the upland area at this time.

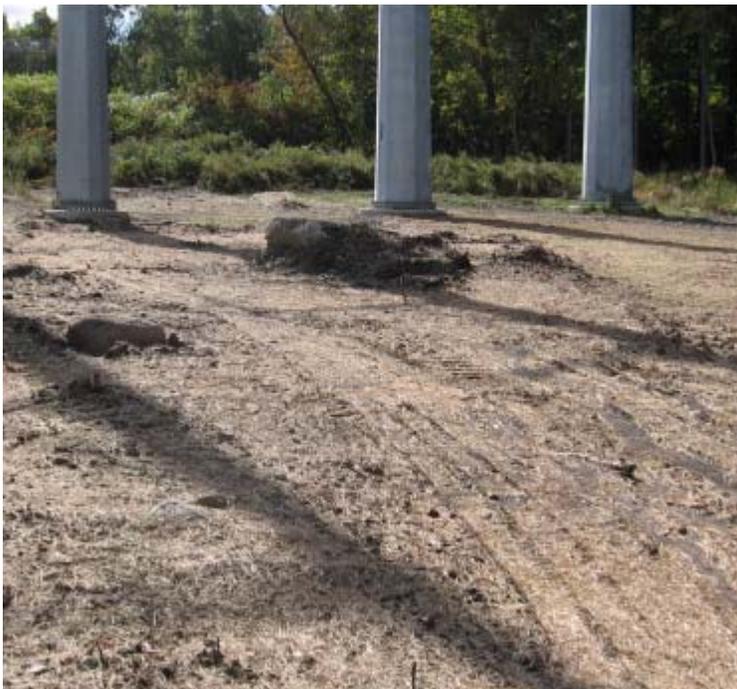
Pease Rd/JCC (Woodbridge): Timber mats have been removed and the wetland area has been restored near structures #3932/24119.

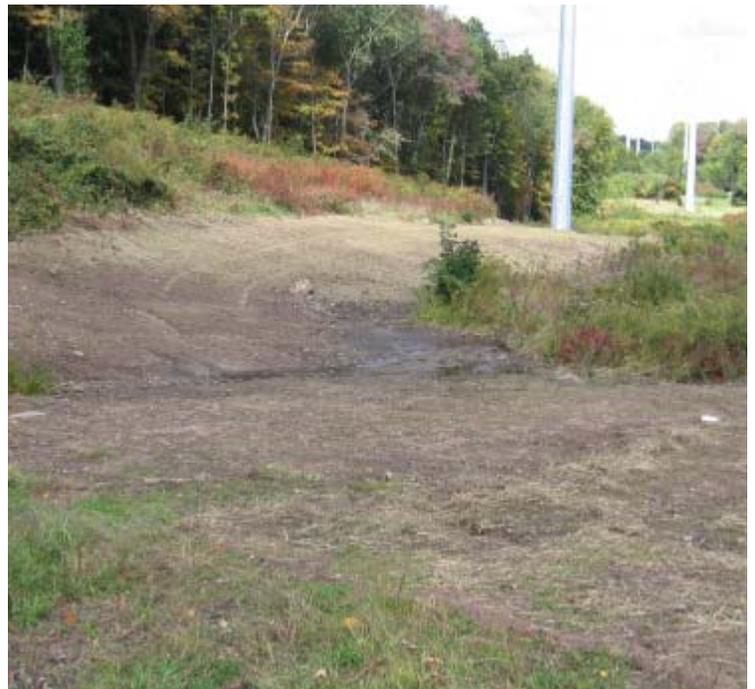
<b>Orange, CT</b> Dogburn Rd	Stormwater run-off has caused scouring in the restored crane pad area near structure #24077. 8/22-10/2/08	Stabilize exposed soils and continue to monitor and repair/add controls as necessary. 10/2/08	Needs attention
Pease Rd/JCC	Haybale controls are needed along the wetland and stream channel where the access road has recently been restored. 10/2/08	Add controls and continue to monitor. 10/2/08	Needs attention
Oak Ln CC	A stockpile remains in the ROW within a wetland buffer. The stockpile appears to be contained at this time. 10/2/08	Add controls to help contain the pile and remove from the ROW when feasible. 10/2/08	Needs attention
<b>Bethany &amp; Hamden, CT</b>	Spoils remain on the ROW off Hatfield Rd, Downs to Gaylord Mtn Rd, Tom Swamp, &	Remove spoil piles during 345 kV restorations. 10/2/08	Remaining spoil piles need attention during 345 kV restoration efforts

Pease Rd/JCC: View of the wetland/stream crossing. Haybale controls are needed along the wetland boundary here to help control sediment migration to the watercourse.

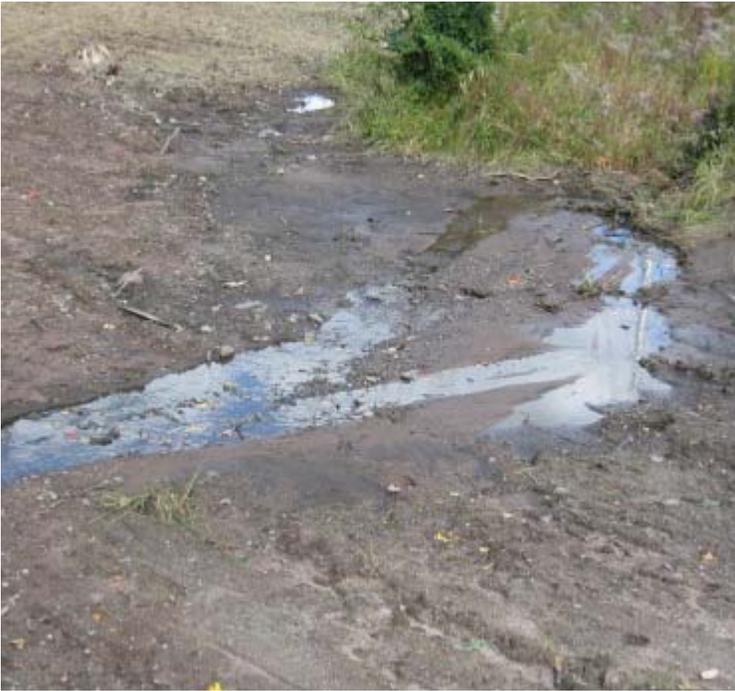
Pease Rd/JCC: Haybale controls are needed within the restored access road to help prevent sediment migration to the watercourse.

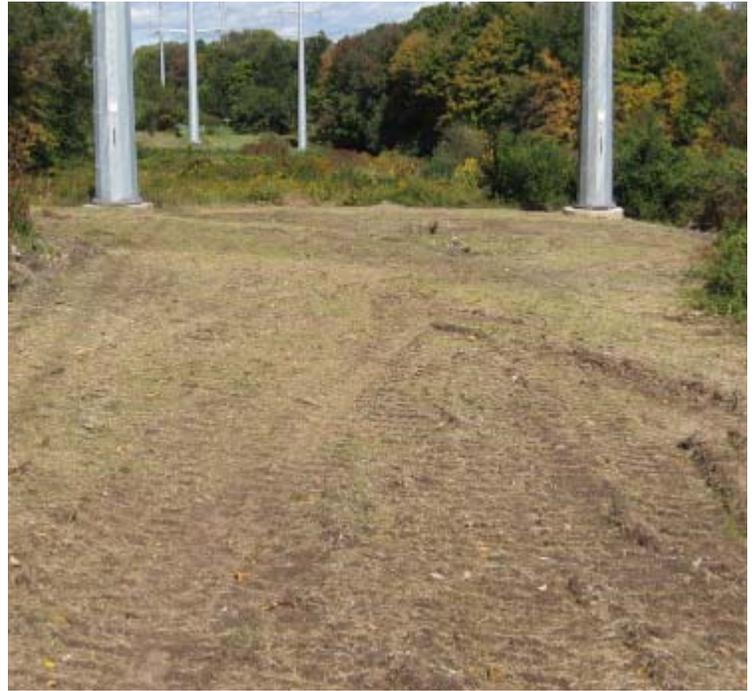
Pease Rd/JCC: View of restoration efforts near structures #3933/24120. Stone pad/access road has been removed and exposed soils have been graded and mulched.

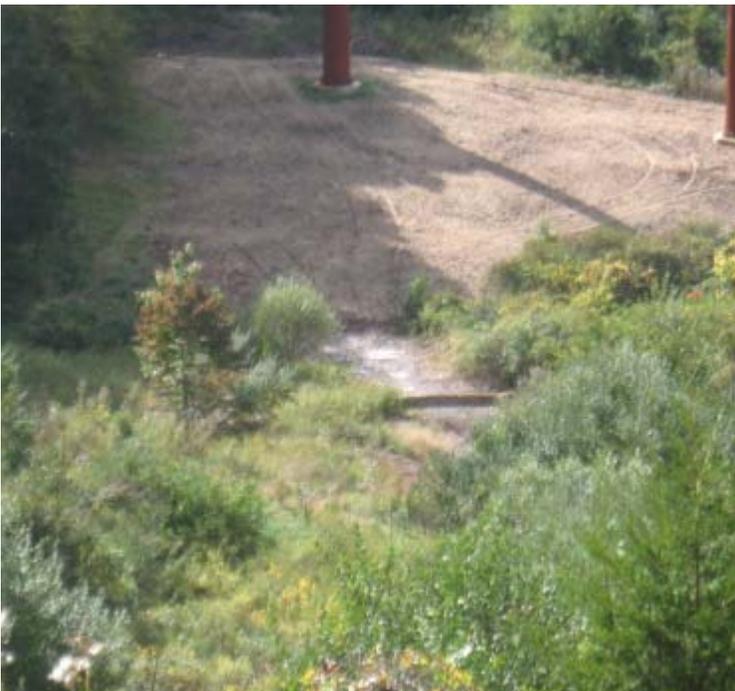
Old Ln (Hamden): View of crane pad/wetland crossing restoration efforts. Haybale controls are in place along the wetland boundary to help prevent sediment migration to the wetland.

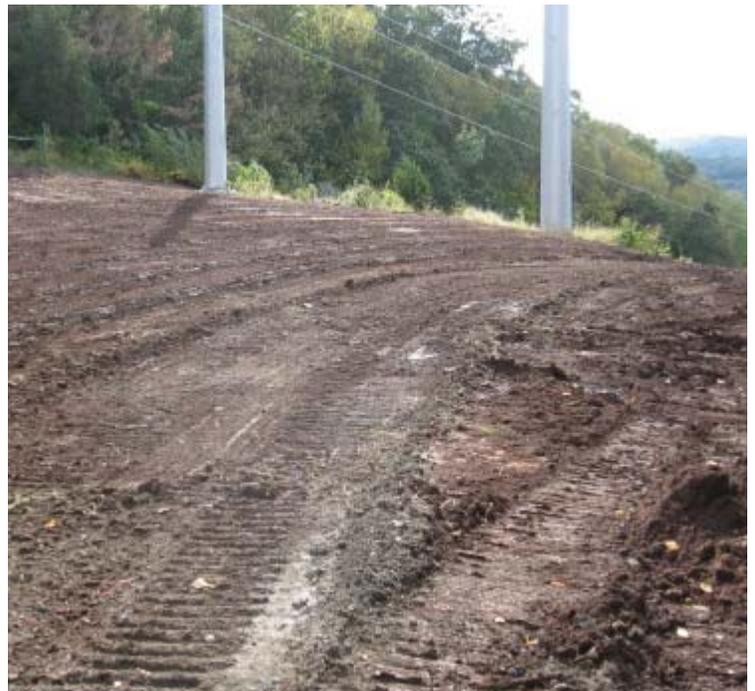
Old Ln: View of crane pad restoration efforts. Exposed soils are being actively mulched for temporary stabilization.
