Docket No. 272 – Development and Management Plan Inspection

Segment 2b Inspection

Date: November 21, 2008

Location: Segment 2b – Cheshire/Hamden Town Line to East Devon Substation

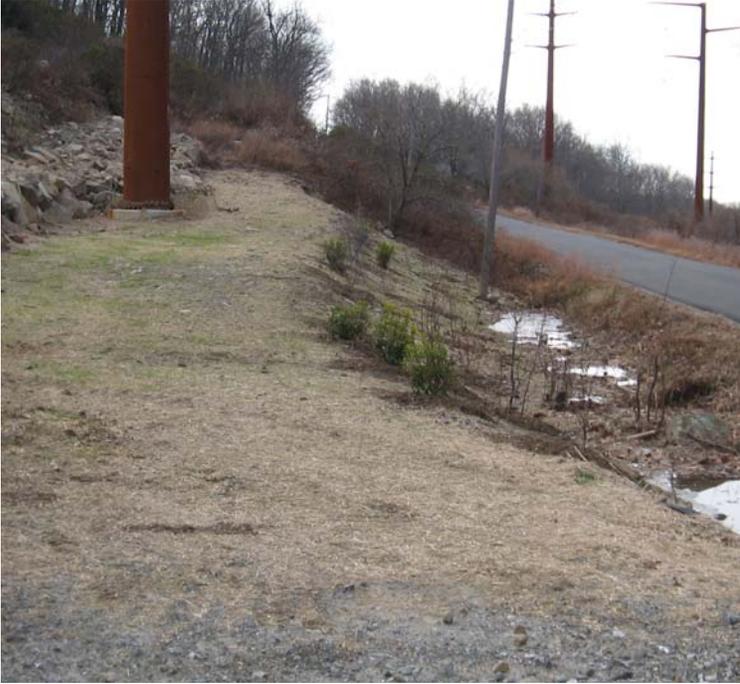
Downs Rd (Bethany): A view of the restoration efforts and plantings near structure #3981/24168.

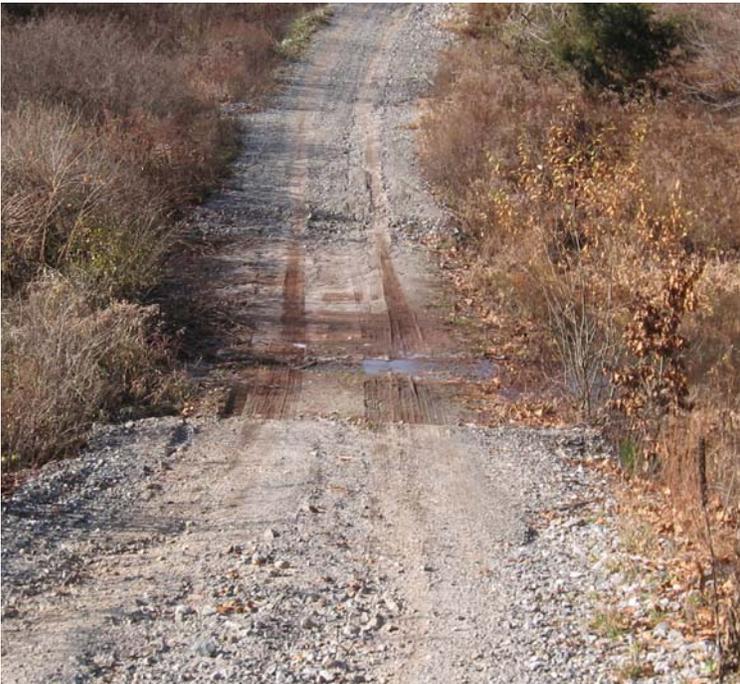
Brooksvale Ave (Hamden): A view of the permanent access road through wetland #100. The pre-existing water course has been altered by the access road.

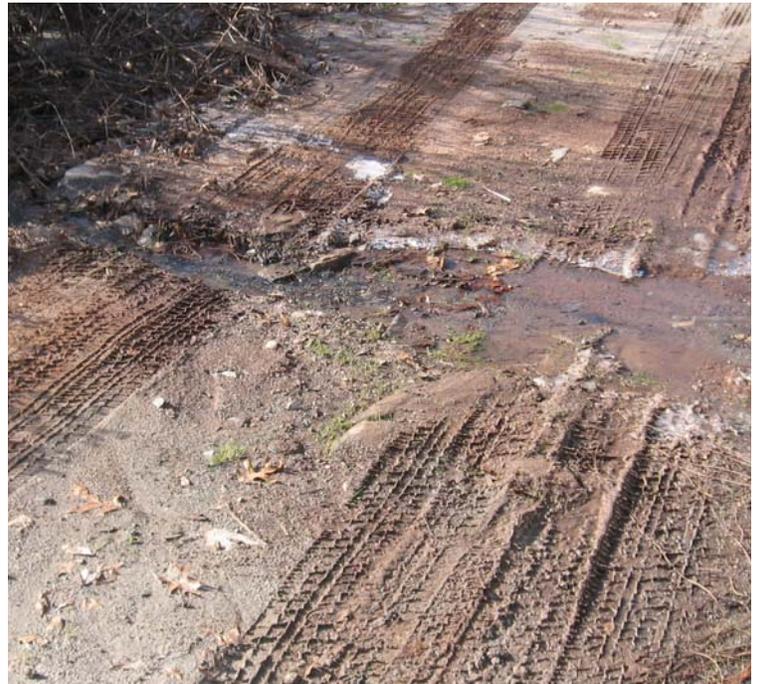
Brooksvale Ave: Runoff has scoured a channel through the access road.

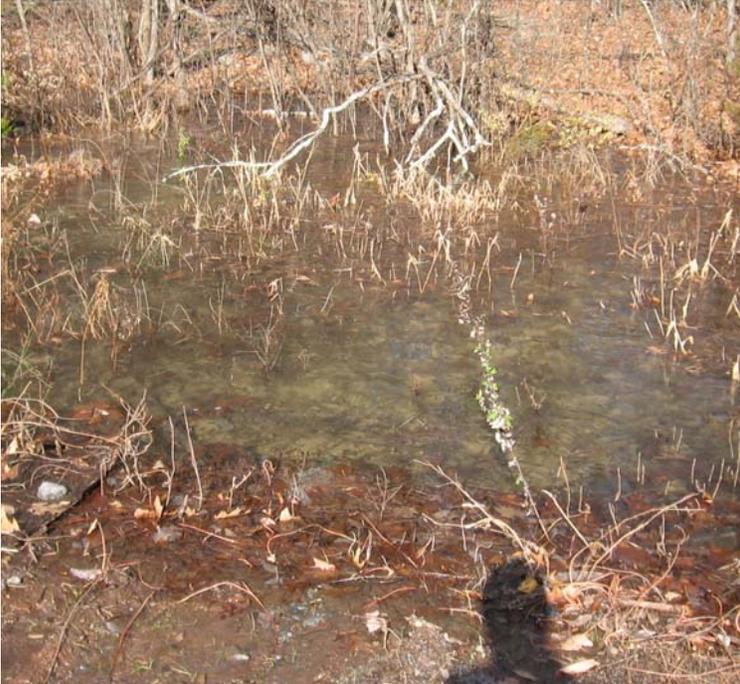
Brooksvale Ave: Runoff is ponding at the access road. The D & M Plan depicts stream flow in this area.

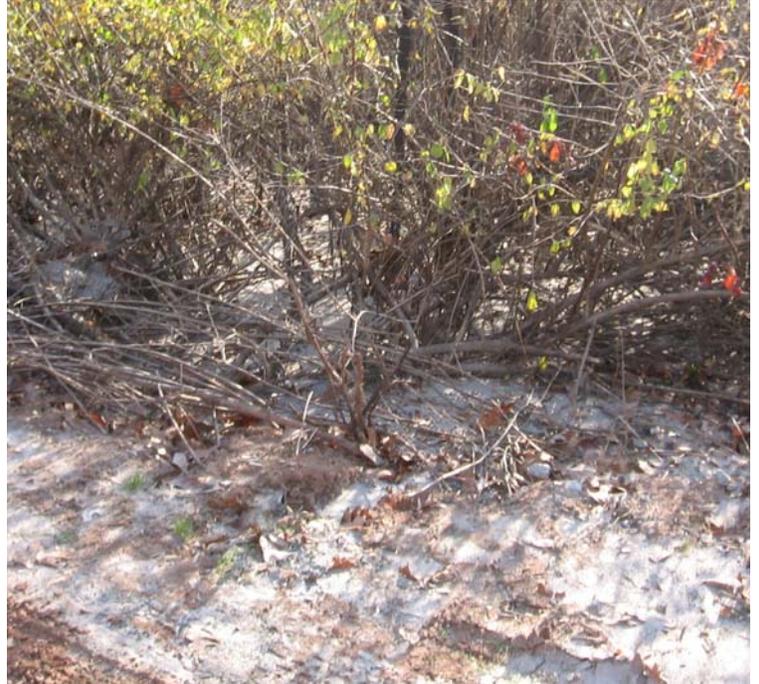
Brooksvale Ave: Sediment from the access road has been observed in wetland #100.

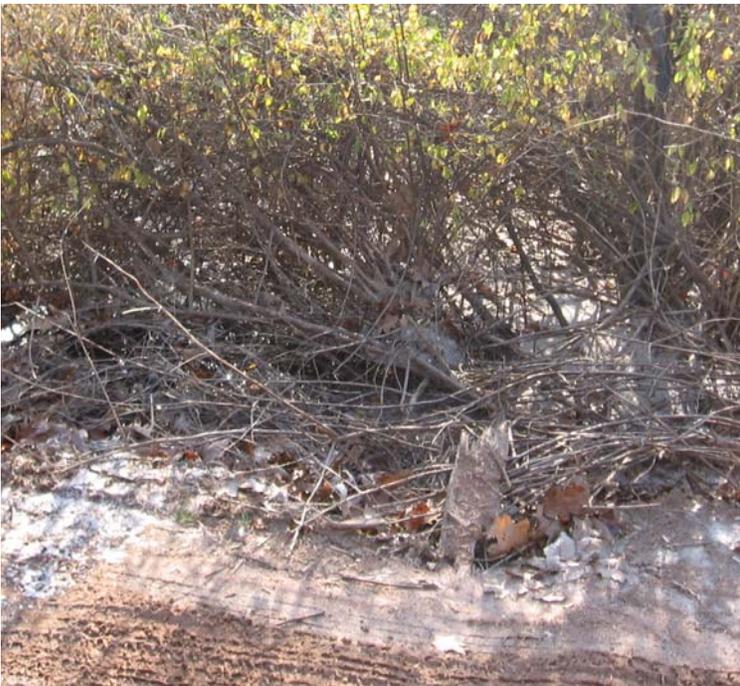
Brooksvale Ave: An additional view of sedimentation to wetland #100.

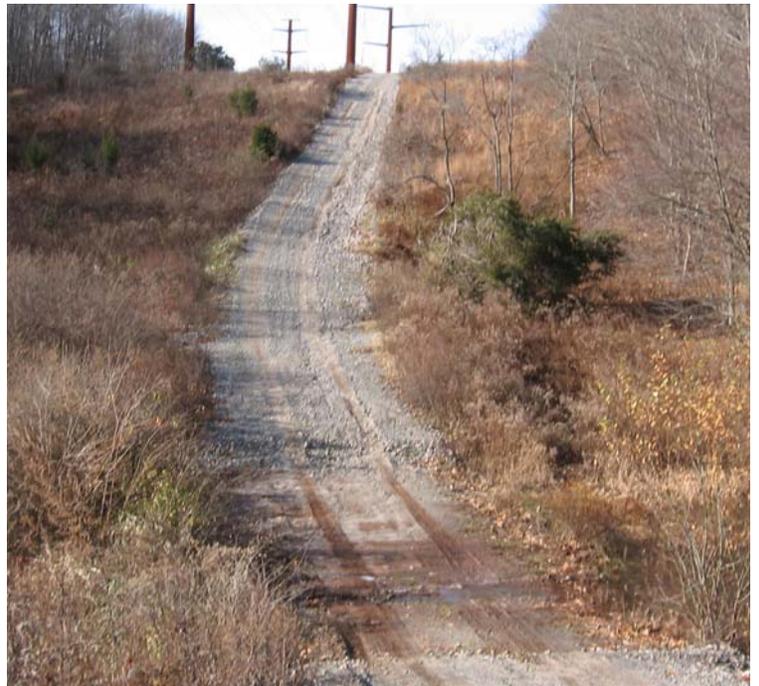
Brooksvale Ave: An additional view of the permanent access road and wetland #100. Additional controls are recommended here.
