Docket No. 272 – Development and Management Plan Inspection

Segment 2b Inspection

Date: April 3, 2008

Location: Segment 2b – Cheshire/Hamden Town Line to East Devon Substation

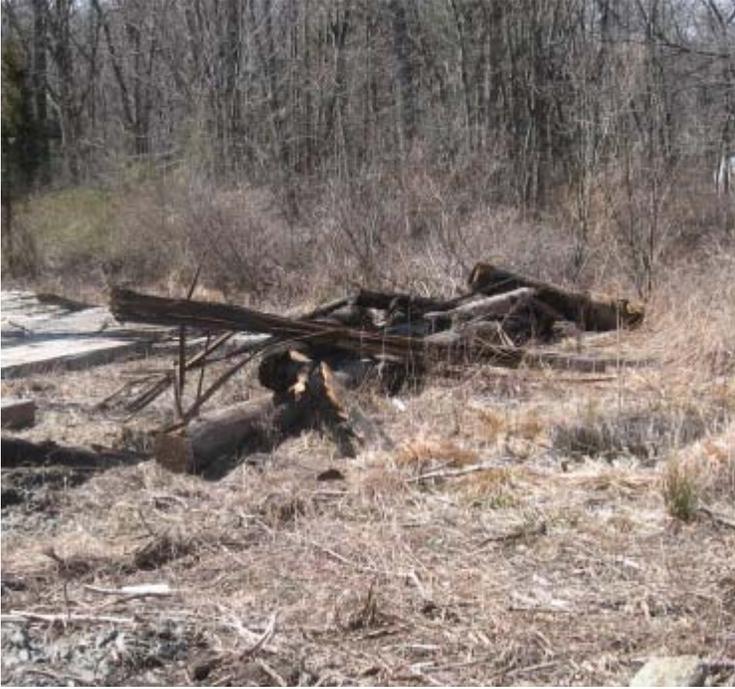
Areas of Inspection	Observation	Recommended Action	Corrected Action
Ansonia Rd	Disassembled “H” frame structures were observed in the wetland near structure #24100. 4/3/08	Remove the disassembled structure from the wetland. 4/3/08	Needs attention
Clearview Lane	Spoils from foundation drilling remain within the wetland buffer. 4/3/08	Remove spoils from wetland buffer and store in an appropriate upland location. See EC Section. 4/3/08	Needs attention
JCC/B’Nai Jacob	The wetland areas near the JCC and B’Nai Jacob have been cleared as a result of the permitted re-location of the ROW. Stone access roads remain in portions of the wetlands in these sections. 4/3/08	Continue to monitor. Adjust controls as necessary. 4/3/08	NA at this time
Rimmon Rd/B’Nai	Sediment was observed in the wetland near structure #3922. 4/3/08	Carefully remove sediment during the dry season if it is greater than 2” in depth. See EC Section. 4/3/08	Needs attention

Ansonia Road (Woodbridge): Disassembled "H" frame structures remain in the wetland near structure #24100.

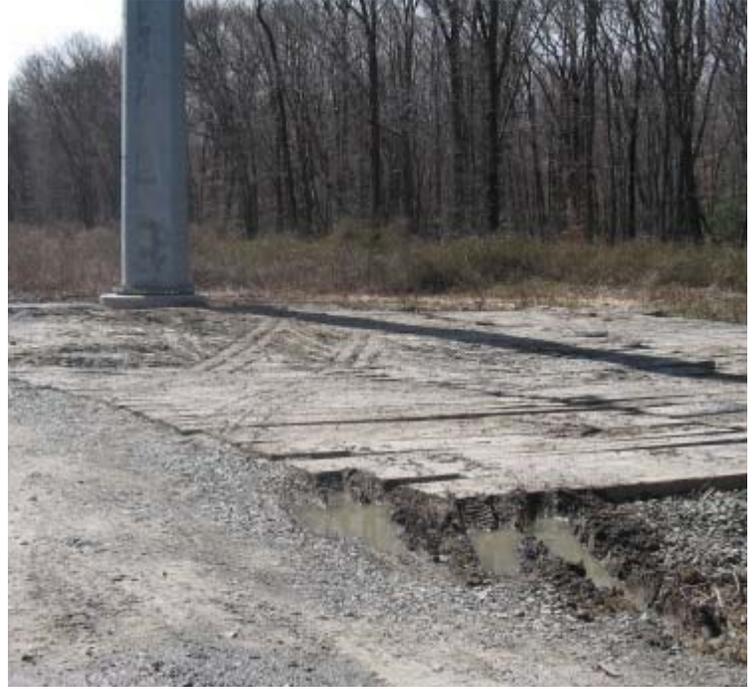
Ansonia Road (Woodbridge): Drilling is complete here, but excess sediment remains on the timber mats.

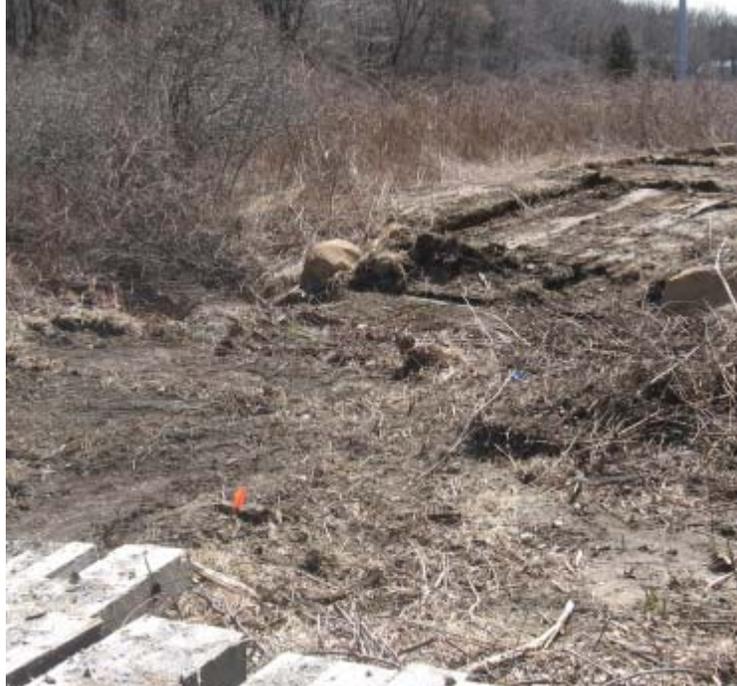
Rimmon Rd (south)	The timber mat crane pad crossing has been removed from the tributary stream near structure #24105. 4/3/08	Continue to monitor. Stabilize and grade as necessary. 4/3/08	The timber mat crossing has been removed from the stream near structure #24105
Oak Lane CC, Cow Path Lane, Salem Rd, Rimmon Rd, Brookwood Dr, Center Rd, Ansonia Rd, Manville Rd and Clear Ln to Rte 15	Timber mat crane pads remain within the wetlands in these sections. 4/3/08	Continue to monitor. 4/3/08	NA at this time
Bethany, CT Morris to Hatfield	A stone access road and timber mats are in place in the wetland areas in this section. 4/3/08	Continue to monitor. 4/3/08	NA
Litchfield Turnpike	Excess sediment has accumulated on the timber mat crossings within the access road here. Sediment has	Carefully remove sediment from wetland areas when timber mats are removed. See EC Section. 4/3/08	Needs evaluation/attention

Rimmon Rd (Woodbridge): Timber mats have been removed from the stream crossing near structure #24105.
