Docket No. 272 – Development and Management Plan Inspection

Segment 3 Underground Line

Date: January 31, 2008

Location: East Devon Substation to the Housatonic River Crossing

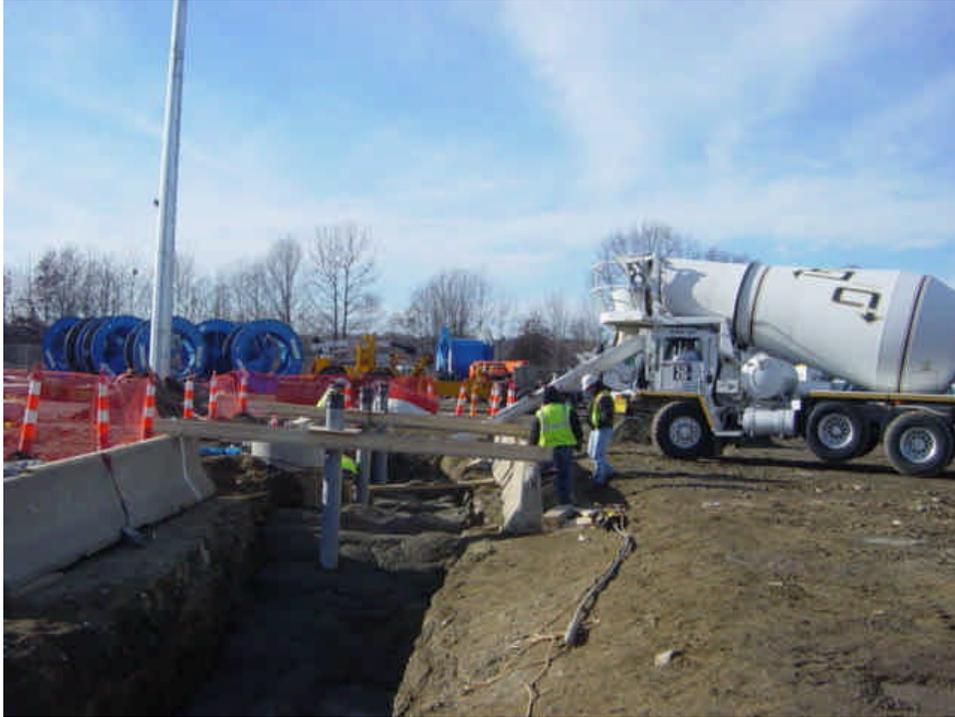
Trenching and backfill work continues near sta. #1120 near the East Devon substation, which is currently under construction.
