**Docket No. 272 – Development and Management Plan Inspection**

**Segment 3 Underground Line**

**Date:** March 6, 2008

**Location:** East Devon Substation to the Housatonic River Crossing

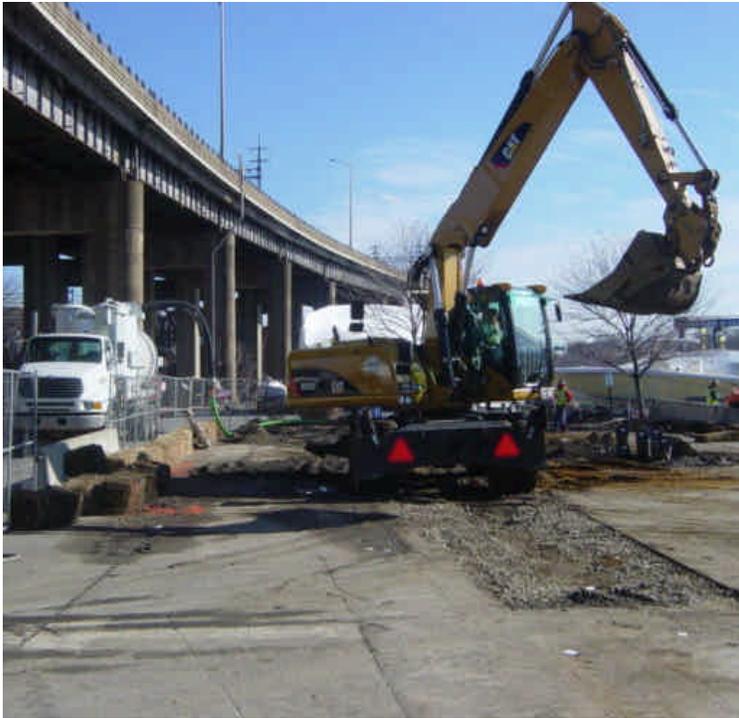
**On the west side of the Housatonic River, crews were tying-in the HDD conduits to the existing vault at sta. #999.**

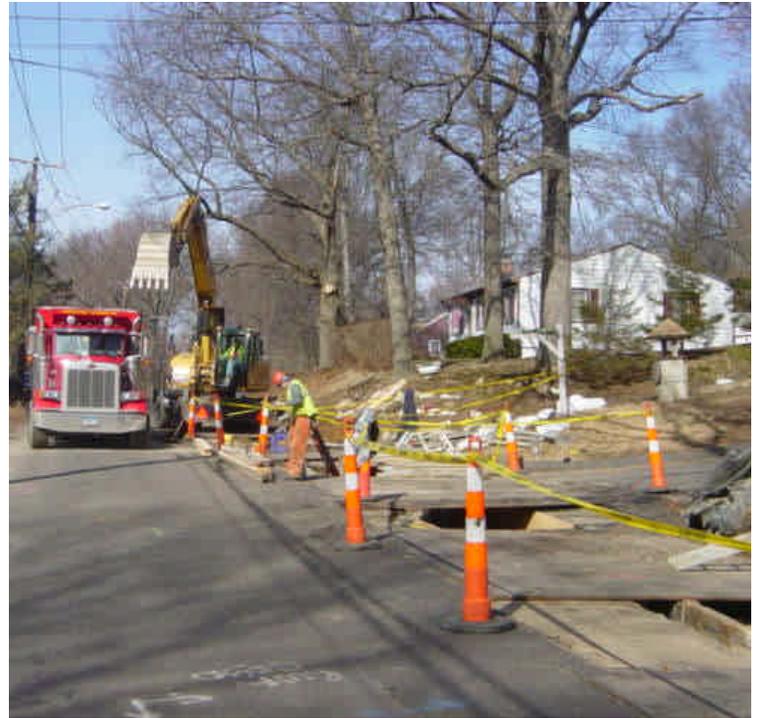
**On Naugatuck Avenue, near sta. #1037-1038, trenching was in progress.**

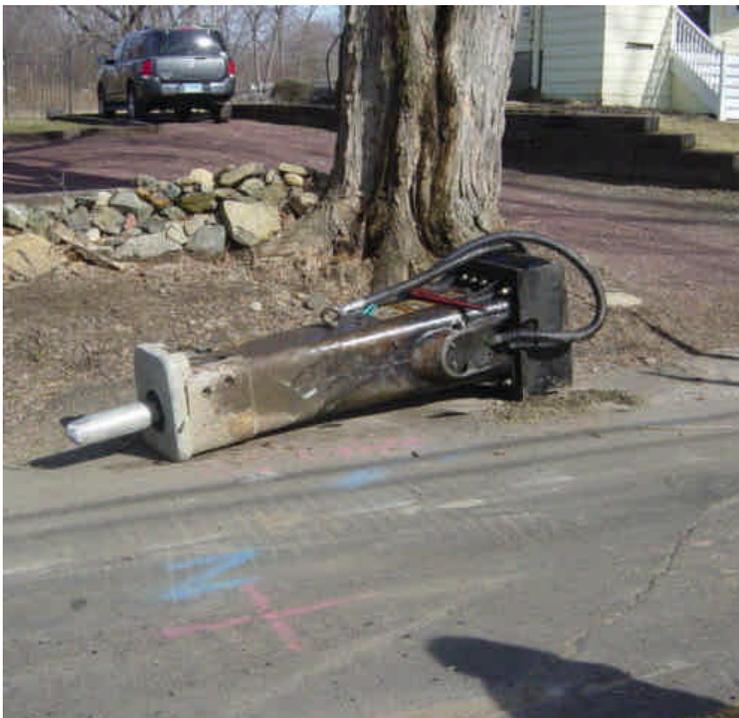
**A hydraulic jacking hammer was temporarily stored along the side of the road at the work site. Consider installing secondary containment, proactively.**

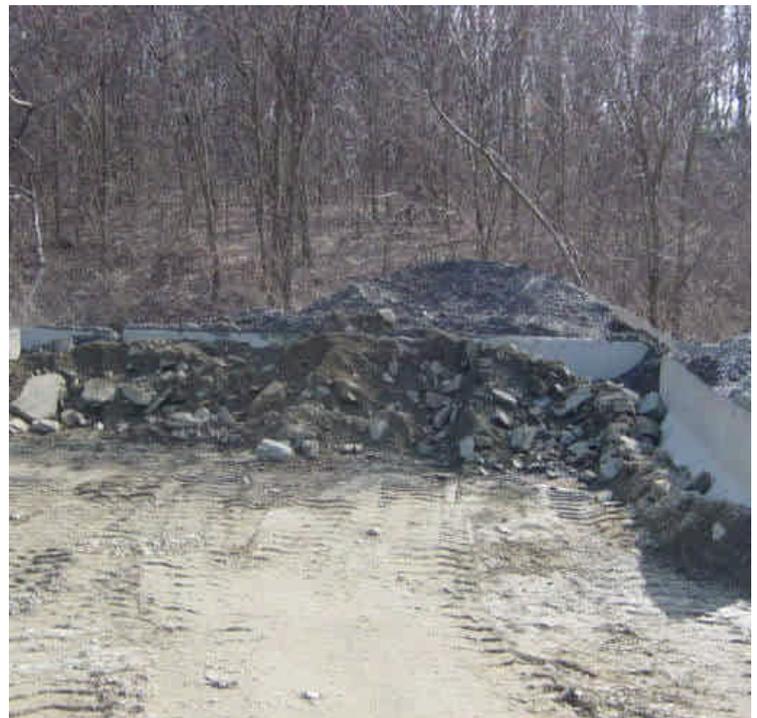
**Stockpiled material was pushed beyond the limits of the storage bins in the Shelland St yard, most likely during snow removal activities. Due to the increase in material, consider removing it at this time, rather than waiting until the restoration of the yard.**
