Docket No. 272 – Development and Management Plan Inspection

Segment 3 Underground Line

Date: March 20, 2008

Location: East Devon Substation to the Housatonic River Crossing

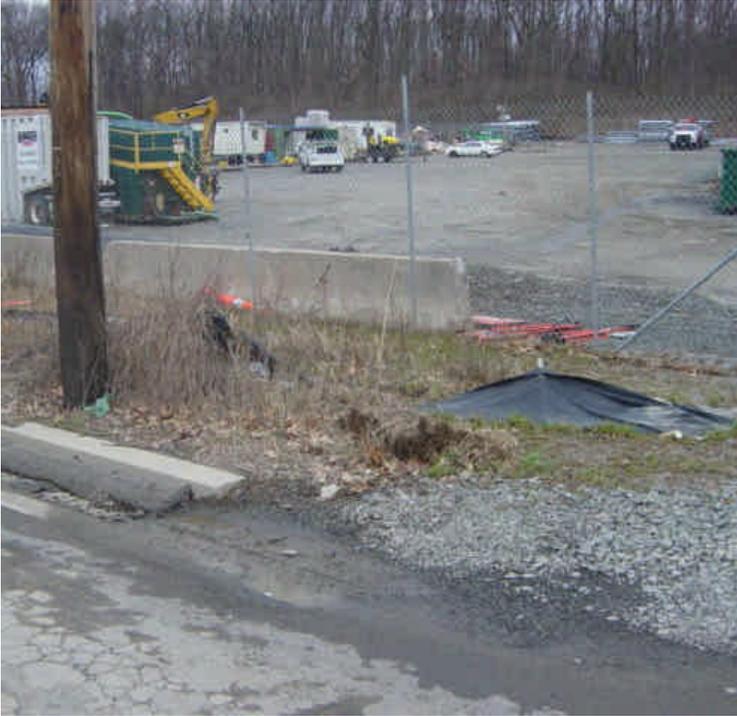
Sediment has accumulated behind the stone berm near the entrance to the Shelland Street lay down yard. A minor amount has migrated beyond the berm. The catch basin remains protected.

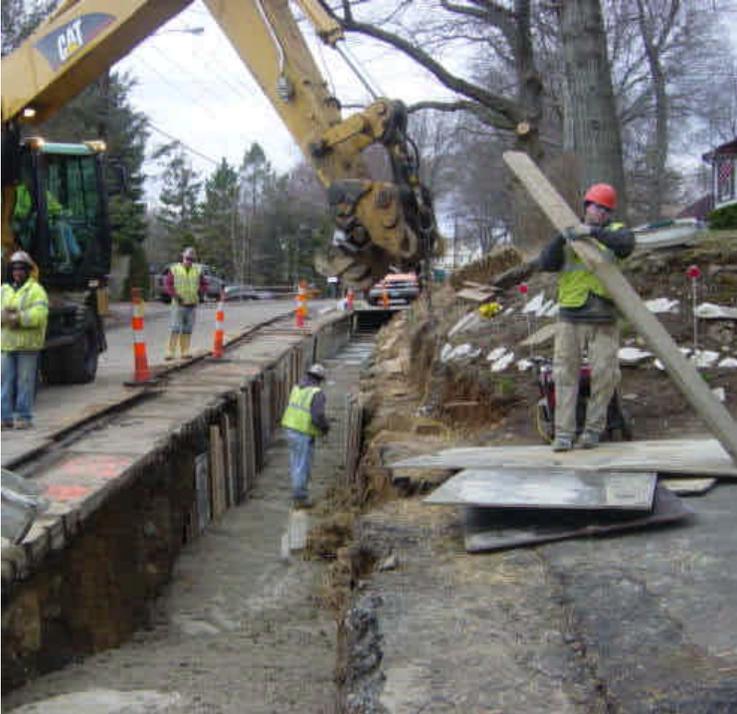
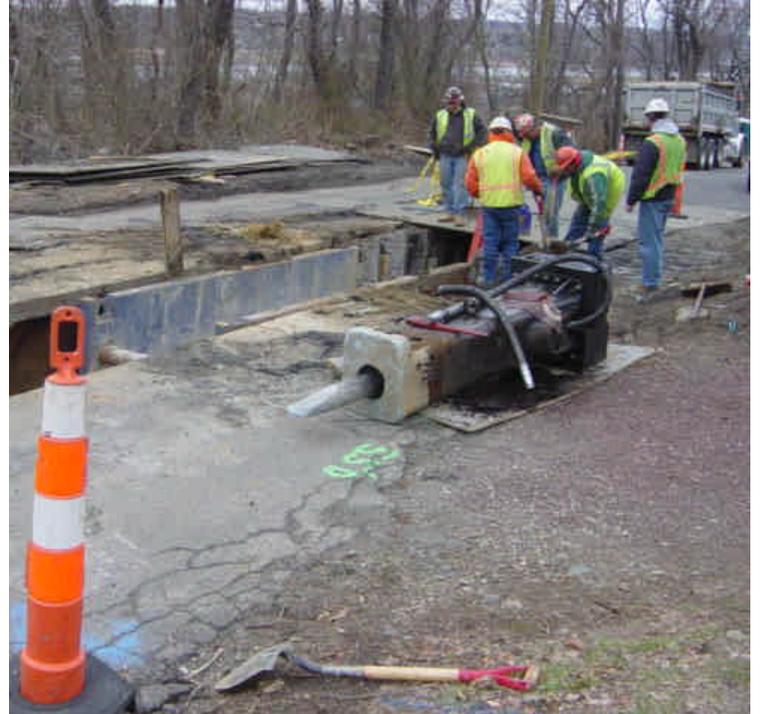
Trenching continues along Naugatuck Avenue near sta. #1038-1039 and #1046-1047. A hydraulic jacking hammer was being appropriately and proactively stored at the job-site on a sheet of plywood to absorb any potential leaks.
