Docket No. 272 – Development and Management Plan Inspection

Segment 3 Underground Line

Date: March 28, 2008

Location: East Devon Substation to the Housatonic River Crossing

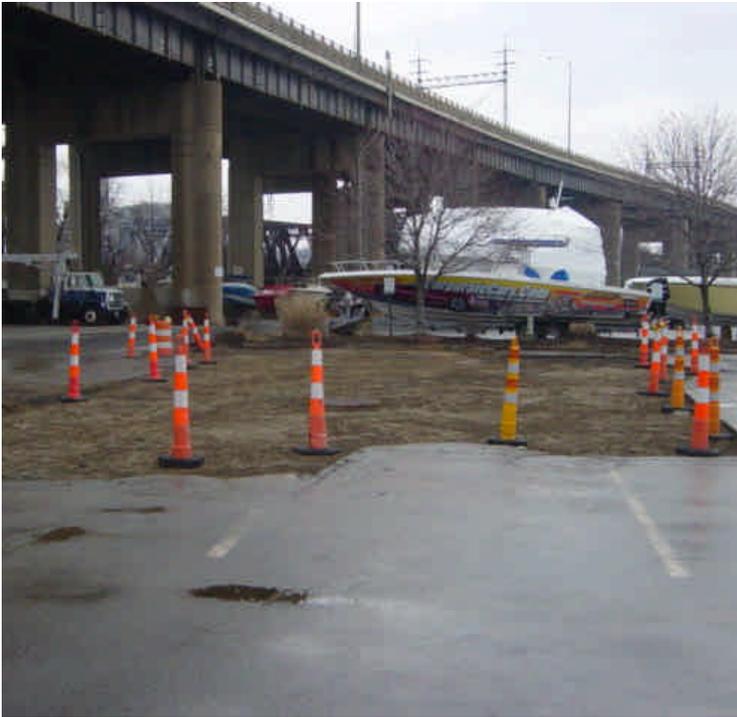
On the west side of the Housatonic River at sta. #999, the tie-in work has been completed. The drill pit has been backfilled and the area is ready to be paved.

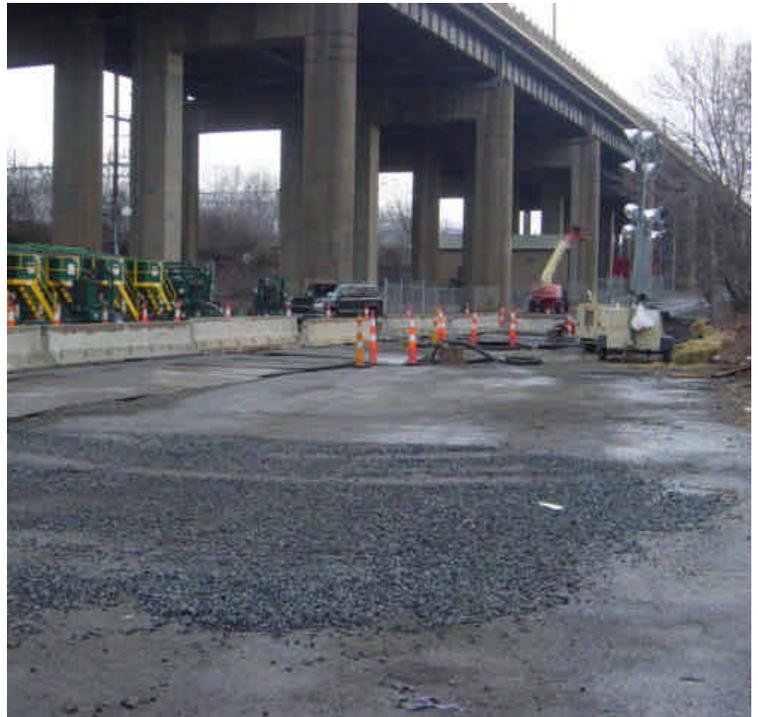
On the east side of the Housatonic River near sta. #1015-1020 vault tie-in work is underway. An extensive dewatering system is in place and several frac tanks have been brought on site to accommodate the large amount of ground water that is anticipated in this area.

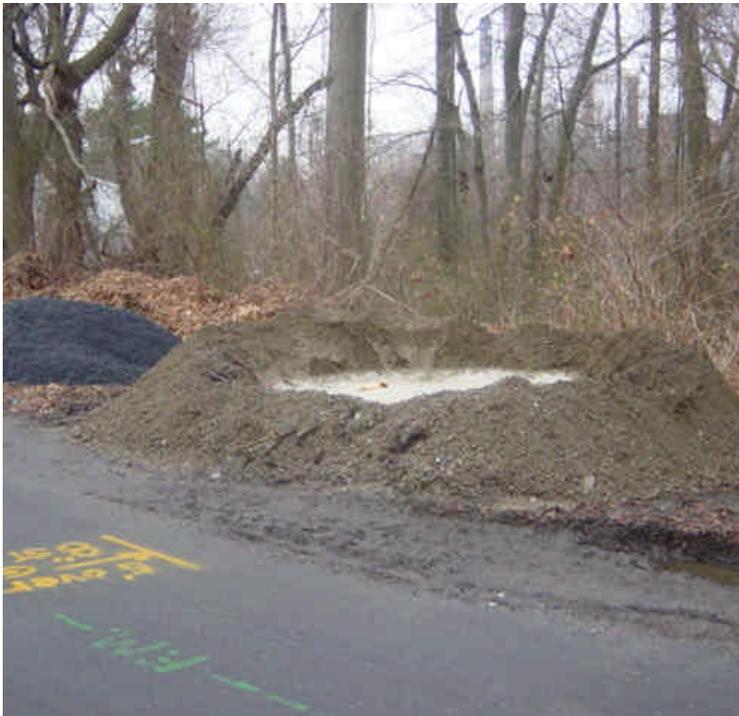
A concrete washout area was observed along the shoulder of the roadway near sta. #1044 and provides adequate containment.

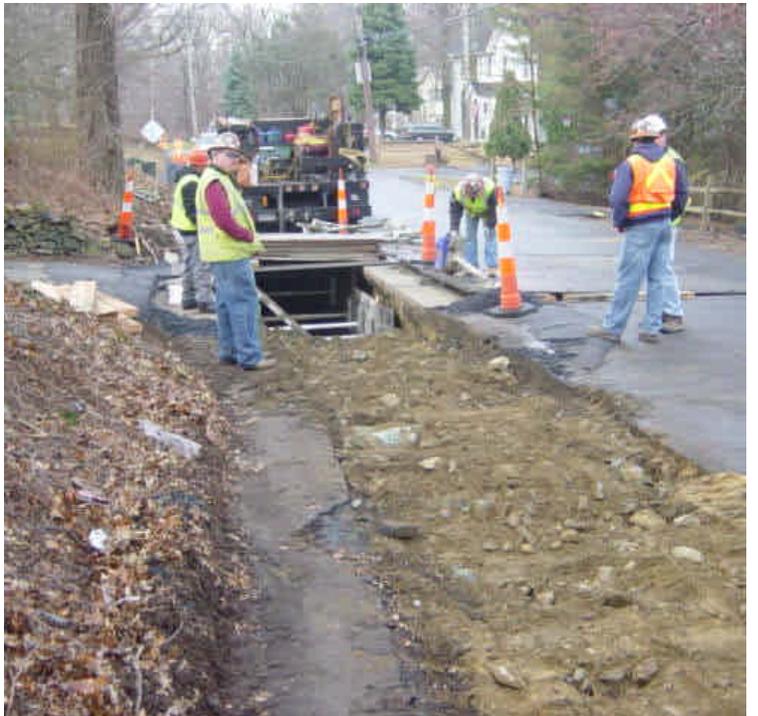
Trenching and backfilling activities continue along Naugatuck Ave. near sta. #1045+50-1047. Crews were preparing to pave some areas.
