Docket No. 272 – Development and Management Plan Inspection

Segment 3 Underground Line

Date: April 3, 2008

Location: East Devon Substation to the Housatonic River Crossing

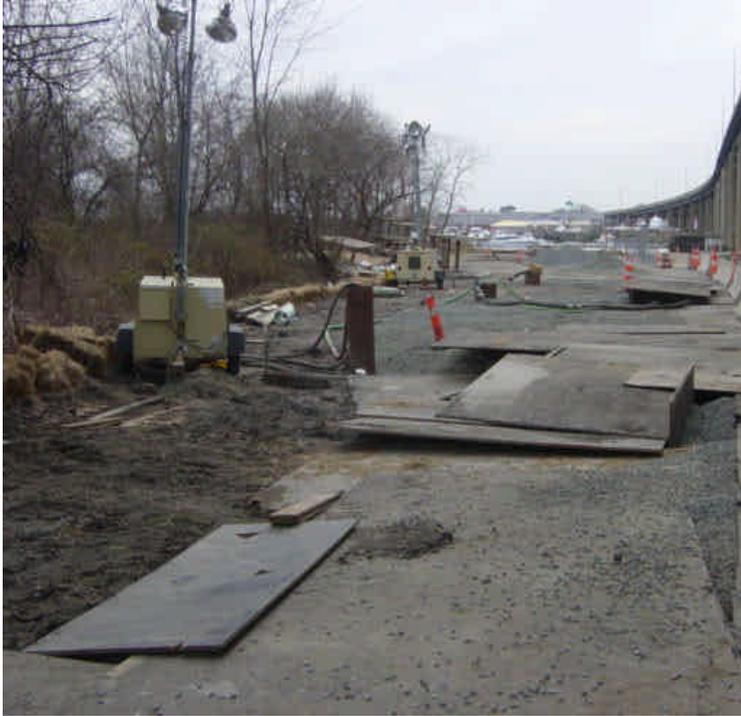
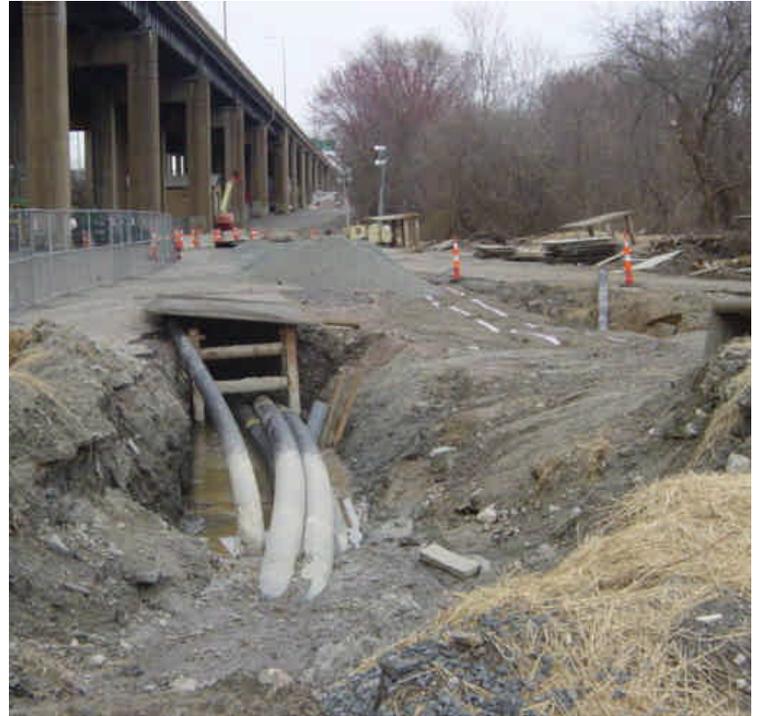
Vault tie-in work continues near sta. #1015-1020. Steel plates remain in place over the trench. Haybales are in place along the south side of the staging area. An extensive dewatering system has been set-up to accommodate the large volume of groundwater in this area. Drill pit remains open, but contained with a dirt berm.

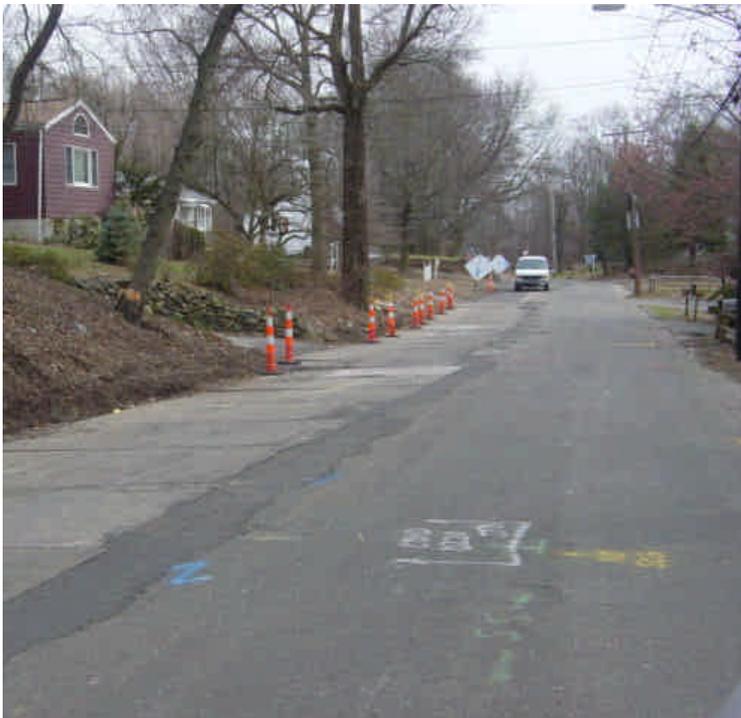
Trenching continues along Naugatuck Avenue near sta. #1040-1042. Steel plates remain in place over the trench.

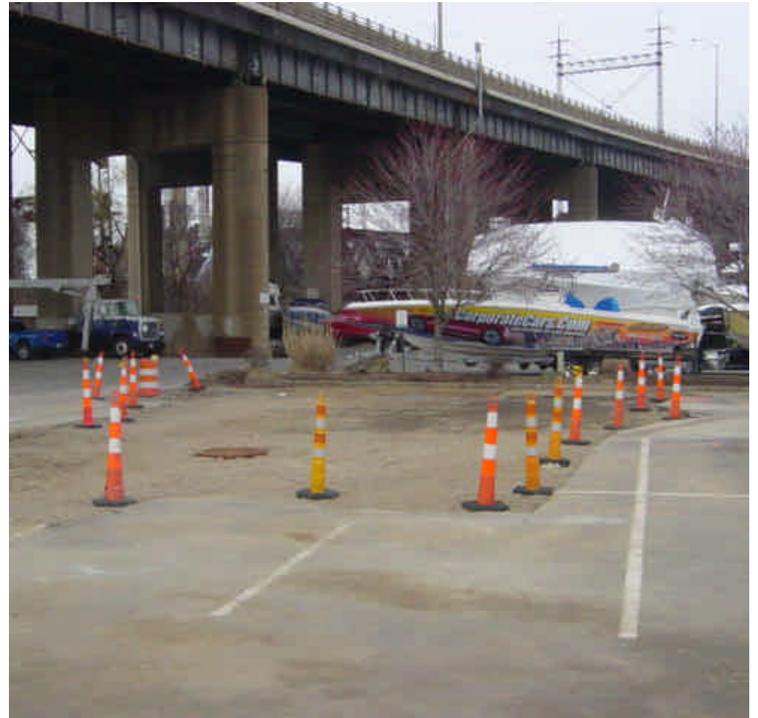
On the west side of the Housatonic River near sta. #999, the drill pit has been backfilled and is waiting to be paved.
