**Docket No. 272 – Development and Management Plan Inspection**

**Segment 3 Underground Line**

**Date:** May 1, 2008

**Location:** East Devon Substation to the Housatonic River Crossing

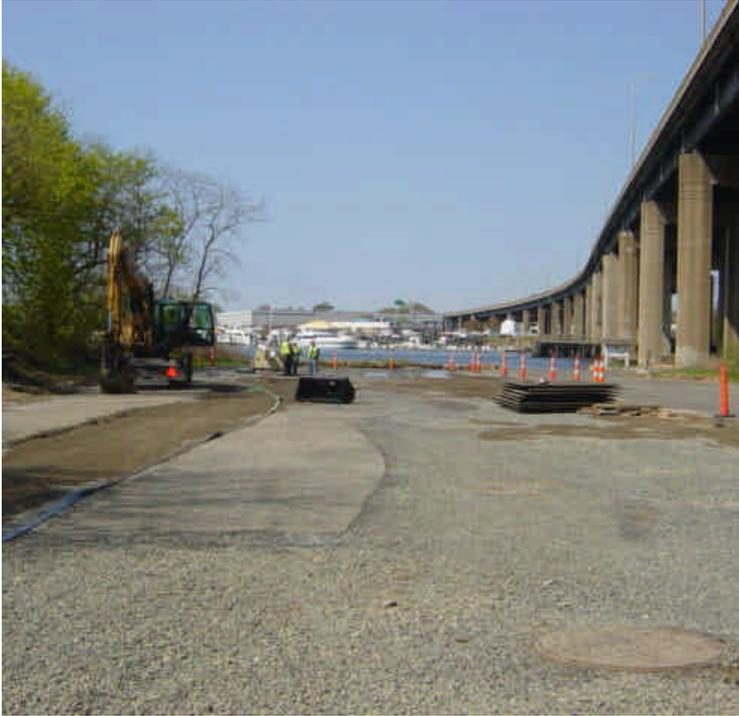
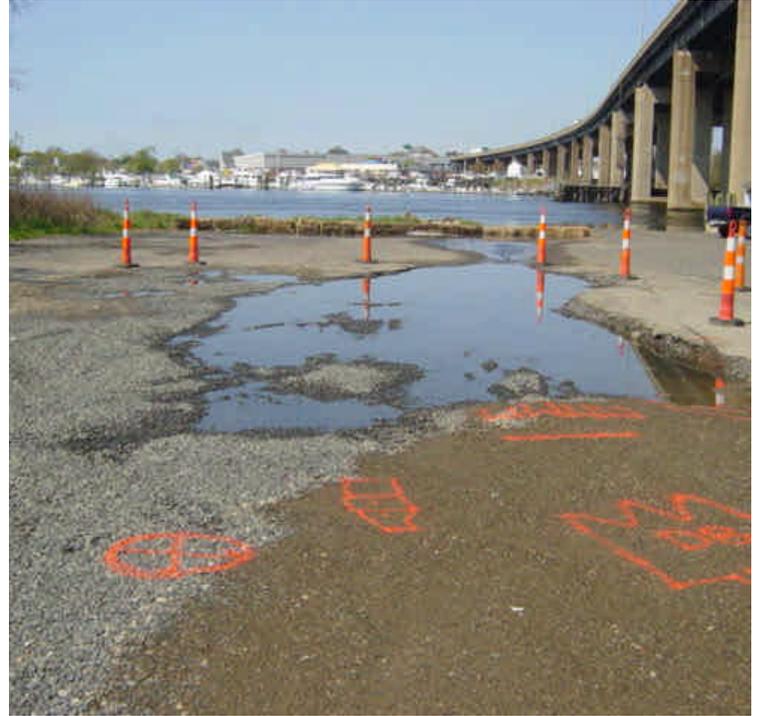
**HDD work has been tied-in to the vault near sta. #1015. The area has been backfilled with crushed stone in preparation for paving but during tie-in work, the conduit sections were crossed and need to be partially excavated and corrected. The dewatering system remains on site. Haybales continue to control run-off.**

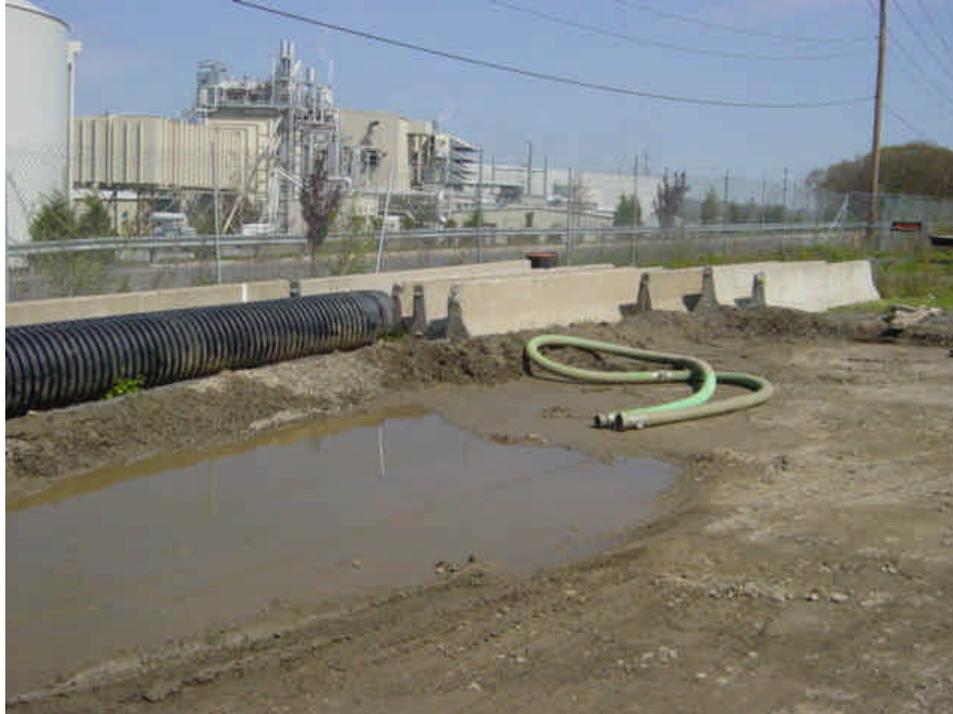
<b>Areas of Inspection</b>	<b>Observation</b>	<b>Recommended Action</b>	<b>Corrected Action</b>
<b>Access Roads and Adjacent Roadways</b>	<b>A crushed-stone berm controlling sedimentation remains near the entrance to the Shelland Street lay-down yard. An increased amount of sediment has accumulated behind the berm. 5/1/08</b>	<b>Continue to monitor area and sweep roadway as necessary. Remove accumulated sediment from behind the stone berm or ensure the yard remains contained. 5/1/08</b>	<b>Needs proactive attention when feasible but no immediate issues.</b>
<b>Vault Openings and Trench Construction</b>	<b>Portions of Naugatuck Avenue were closed due to trenching and backfilling activities at sta. #1031. 5/1/08</b>	<b>None. 5/1/08</b>	<b>Not applicable (NA)</b>
	<b>Area near sta. #1015-1020 has been backfilled, however the conduits had been inadvertently crossed and need to be partially excavated and corrected. 5/1/08</b>	<b>None. See erosion control section. 5/1/08</b>	<b>NA</b>

**A stone berm remains near the entrance to the Shelland Street yard. A fair amount of sediment has accumulated behind the berm but it continues to appropriately filter stormwater runoff.**
