Docket No. 272 – Development and Management Plan Inspection

Segment 3 Underground Line

Date: May 8, 2008

Location: East Devon Substation to the Housatonic River Crossing

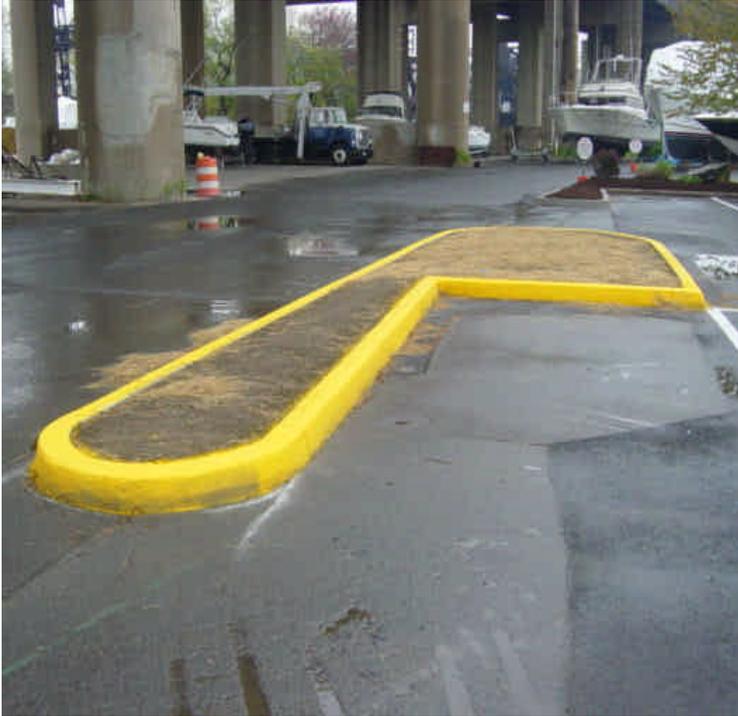
Areas of Inspection	Observation	Recommended Action	Corrected Action
	remains in other areas. 5/8/08		
Additional Observations	New curbing has been installed near sta #999 over the previously unpaved area. This completes restoration efforts in this area. 5/8/08	None. 5/8/08	Area is at final restoration.

Curbing has been installed on the west side of the Housatonic River near sta. #999. Final restoration efforts are now complete on this side of the river.

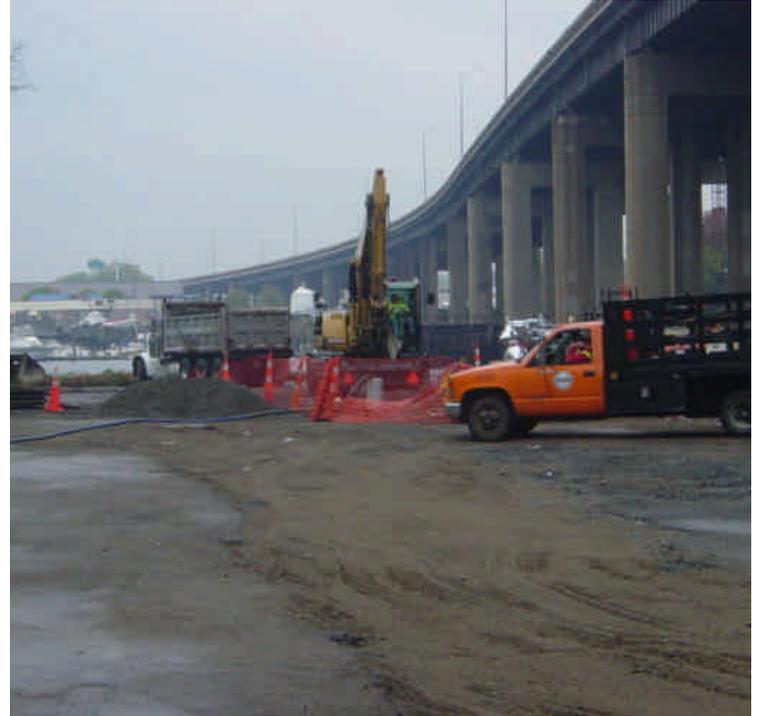
Excavation work is underway near sta. #1015 to correct the conduits which were previously crossed during tie-in work. Continue to sweep residual sediment from adjacent pavement.

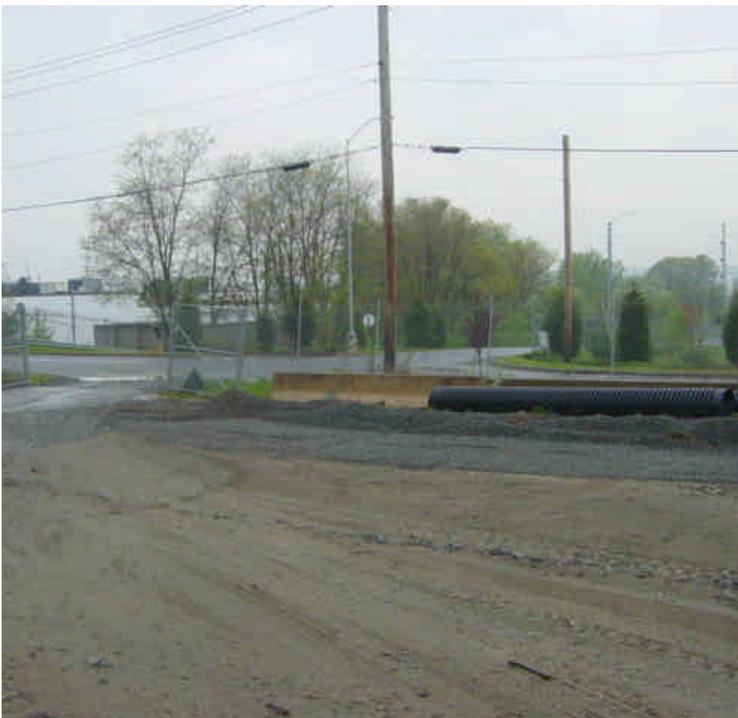
Areas of Inspection	Observation	Recommended Action	Corrected Action
Access Roads and Adjacent Roadways	The crushed-stone berm controlling sedimentation near the entrance to the Shelland Street lay-down yard has been refreshed with additional stone. Accumulated sediment has also been removed. 5/8/08	Continue to monitor area and sweep roadway as necessary. Remove accumulated sediment from behind the stone berm as necessary. 5/1/08	Accumulated sediment has been removed and the berm has been refreshed with crushed stone.
Vault Openings and Trench Construction	Portions of Naugatuck Avenue were closed due to trenching and backfilling activities at sta. #1030-1032. 5/8/08	None. 5/8/08	Not applicable (NA)
	Area near sta. #1015-1016 has been excavated to correct the conduits that were inadvertently crossed during tie-in work. 5/8/08	None. See erosion control section. 5/8/08	NA
Erosion and Sediment Controls	Filter fabric or filter socks remain in catch basins that are down-gradient of/adjacent to remaining areas of exposed soil. 5/8/08	Continue to place a gutter buddy (or similar) in any catch basins with a curb/gutter drop inlet to prevent sediment from entering basin. 5/8/08	Needs regular attention.

The stone berm near the entrance to the Shelland St lay down yard has been refreshed with additional crushed stone and the accumulated sediment has been removed.

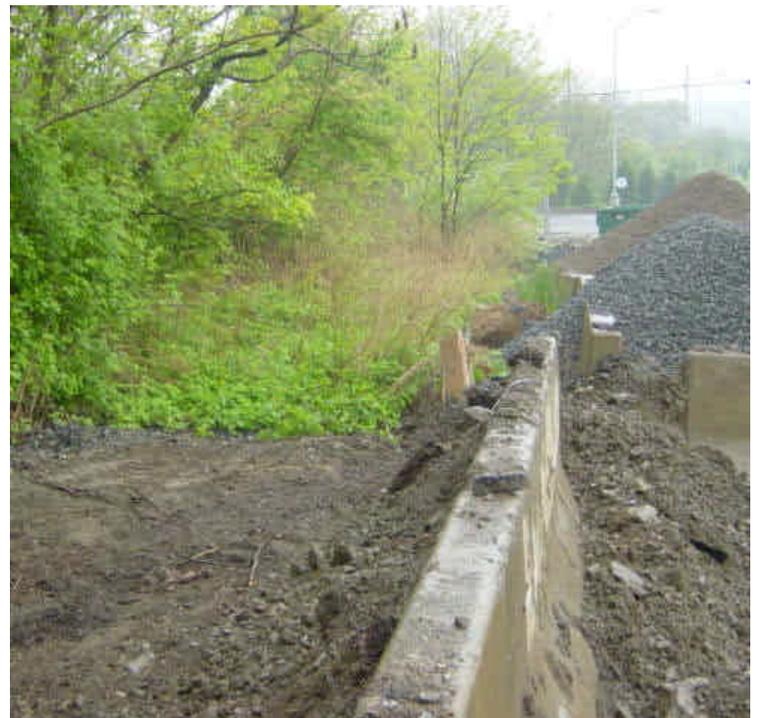
<p>Blasting</p>	<p>No blasting has been proposed. 5/8/08</p>	<p>None 5/8/08</p>	<p>NA</p>
<p>Spills and Material Storage</p>	<p>Reserve spill cleanup materials/kits were observed in the storage yard. 5/8/08</p> <p>Stockpiled materials are overtopping the established storage bins, beyond the perimeter controls of the yard. (noted since 4/25/07) The amount of material has increased (since 3/6/08). Material has been removed from behind one of the bins, but</p>	<p>Continue to bring spill kits to active work sites. 5/8/08</p> <p>Previously, contractors stated the materials will be removed when the area is restored. However, due to the increase in amount of material, consider removing the material beyond the yard limits sooner rather than waiting until yard restoration. 3/6-5/8/08</p>	<p>NA</p> <p>Material has been removed from behind one of the bins. Other bins need additional attention.</p>

Some of the stockpiled material that had overtopped the storage bin has been removed. Additional stockpiles still need attention.
