Docket No. 272 – Development and Management Plan Inspection

Segment 3 Underground Line

Date: May 15, 2008

Location: East Devon Substation to the Housatonic River Crossing

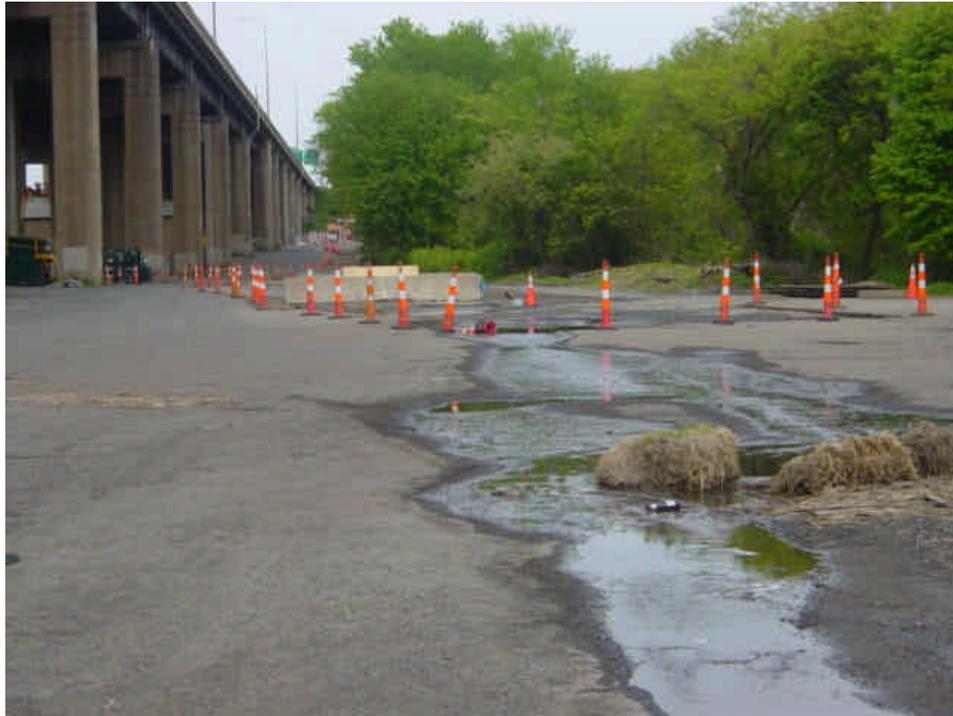
<p>Some of the haybales previously placed along the bank of the Housatonic River near sta. #1015 appear to have been moved and some of the runoff/ groundwater from the recent work area was flowing around the barrier. The runoff appeared to be free from sediment. 5/15/08</p>	<p>Continue to monitor the area for run-off and erosion until work is complete and the area has been permanently stabilized. Controls need to be in place until this time. 5/15/08</p>	<p>Needs attention.</p>
	<p>The soil on the slope near sta. #1049 (vault #3) which had been exposed (noted 7/5/07) remains temporarily stabilized with hard-pack and barrier controls (since 7/25/07). 5/15/08</p>	<p>Continue to monitor the area for run-off and erosion until it is permanently stabilized. 5/15/08</p>	<p>The slope needs final restoration. (Contractors will be working on a future plan)</p>
	<p>A paved berm remains at the top of the slope near sta. #1080 to proactively divert stormwater to a catch basin (noted 7/19/07). 5/15/08</p>	<p>Continue to monitor to ensure diverted storm-water does not affect neighboring properties. See vegetative clearing section for more details. 5/15/08</p>	<p>Continue to monitor.</p>

Excavation work continues near sta. #1015 to correct the conduits which were previously crossed during tie-in work. The dewatering system remains on-site, but was not in operation at the time of the inspection. Some of the haybales previously placed along the bank of the river appear to have been moved and some of the runoff was flowing around the barrier. The runoff appeared to be free from sediment but controls need to be restored until work is complete.
