Docket No. 272 – Development and Management Plan Inspection

Segment 3 Underground Line

Date: May 29, 2008

Location: East Devon Substation to the Housatonic River Crossing

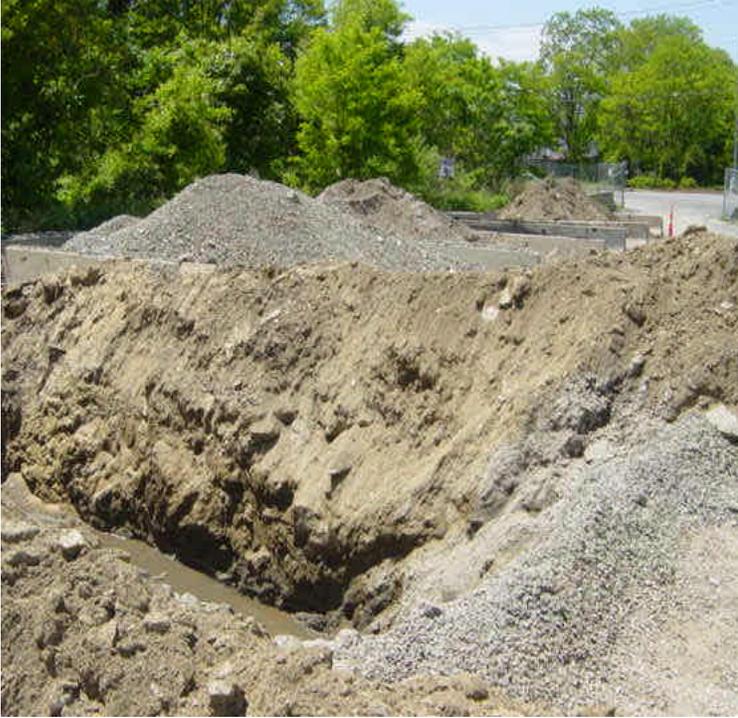
A pit has been excavated in the Shelland Street lay-down yard to accommodate frac tank cleanout material. The excavated material was piled to create a temporary berm. Remain aware of capacity, especially near the yard's perimeter.

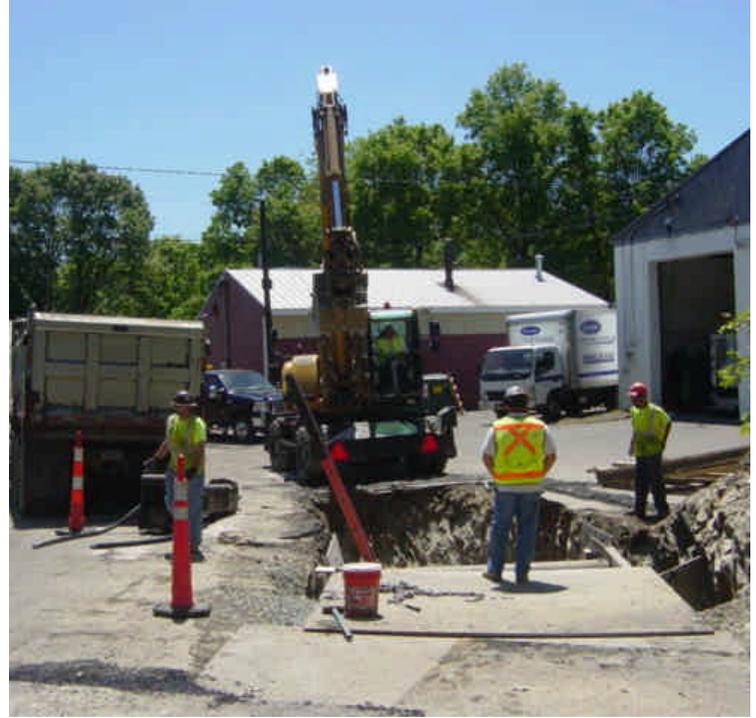
Trenching continues near sta. #1030-1031.

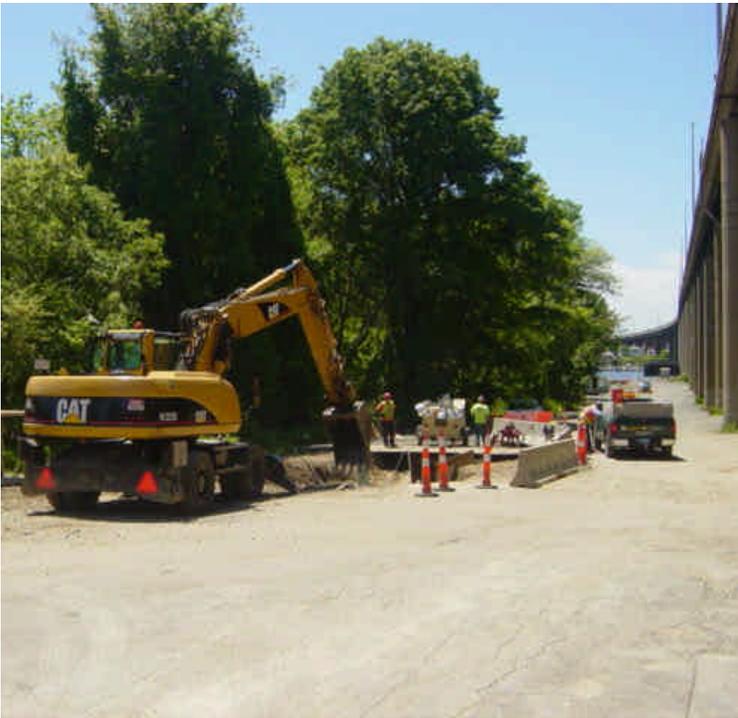
Trenching continues near sta. #1020 to connect to the HDD work.

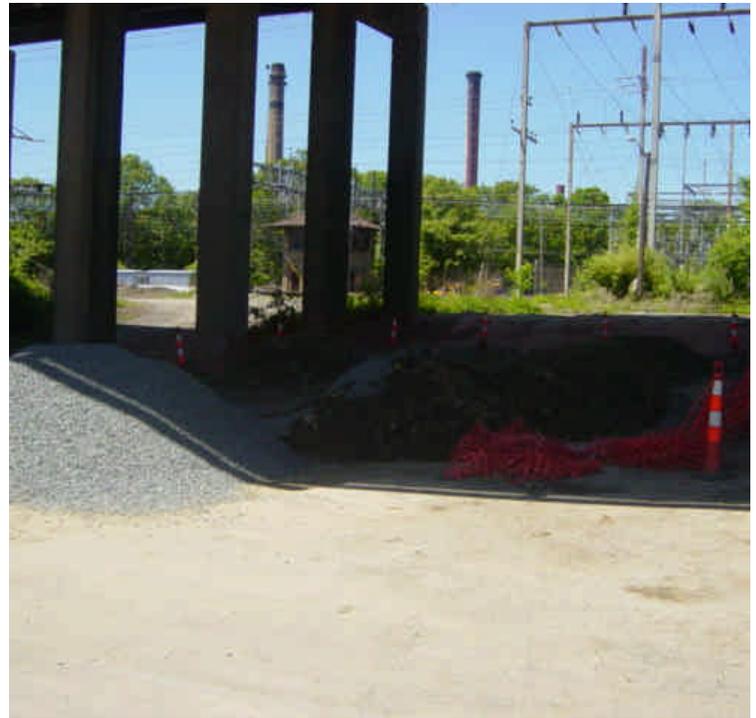
The area near sta. #1020 has been partially excavated to correct the alignment to connect with the HDD work.
