Docket No. 272 – Development and Management Plan Inspection

Segment 3 Underground Line

Date: June 6, 2008

Location: East Devon Substation to the Housatonic River Crossing

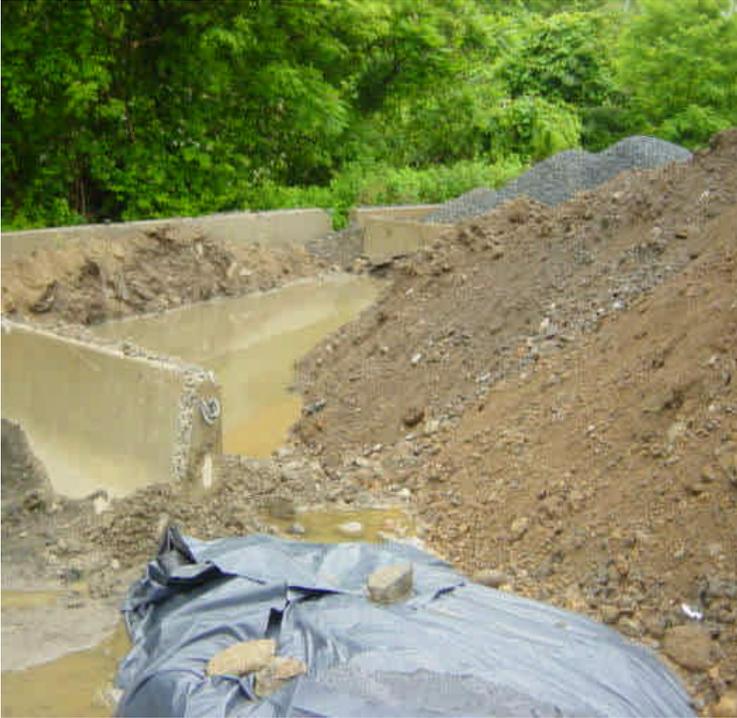
Areas of Inspection	Observation	Recommended Action	Corrected Action
	<p>A large pit was excavated with the Shelland Street yard near the storage bins to accommodate frac tank washout water. The excavated material was stockpiled along the side of the pit to create a containment berm. A breach occurred within the yard. 6/6/08</p>	<p>Contain frac tank washout material within excavated area. Adjust controls as necessary. Remain aware of capacity issues, especially since the pit is near the perimeter of the yard. See Erosion and Sediment Control section for more details. 6/6/08</p>	<p>NA</p>
<p>Soils</p>	<p>During active work, soils are exposed as part of the excavation for trench, vault, and utility work. 6/6/08</p>	<p>Soils appear to have been handled appropriately. Ensure any material stockpiles are contained. 6/6/08</p>	<p>NA</p>
<p>State species of concern, threatened and endangered species.</p>	<p>According to the D&M plan, state-listed species are not located in this work area. 6/6/08</p>	<p>None. 6/6/08</p>	<p>NA</p>

A pit has been excavated in the Shelland Street lay-down yard to accommodate frac tank cleanout material. The excavated material was piled to create a temporary berm. A breach occurred when the last tank was being emptied and some of the material spilled over the surface of the yard. The stone check dam near the entrance to the yard effectively contained the material. Continue to remain aware of any capacity issues, especially with the location of the pit near the yard's perimeter.

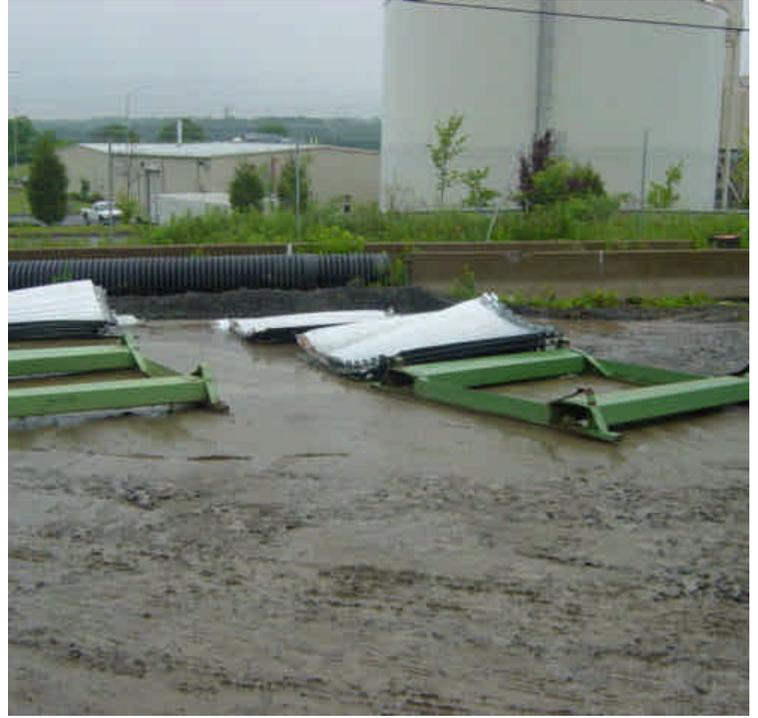
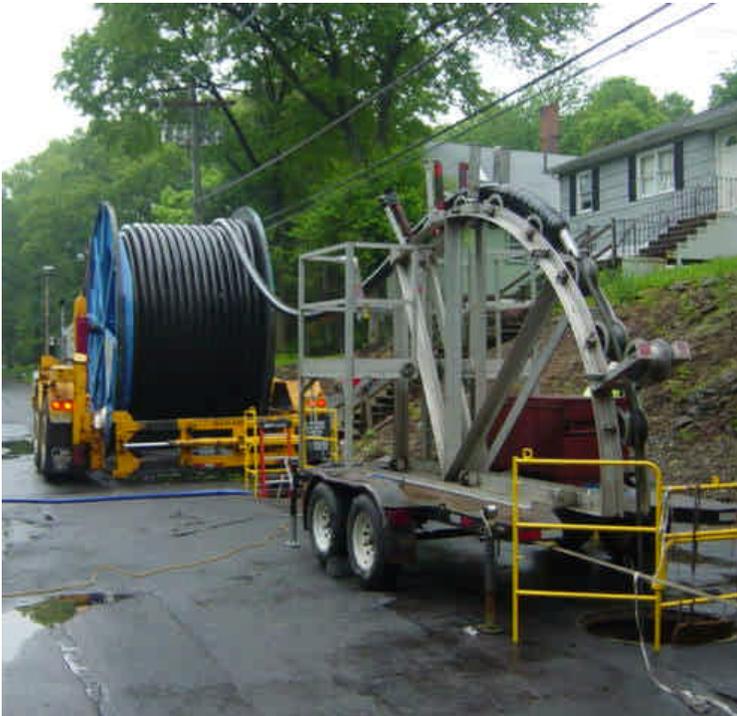
Electrical crews were pulling cable between vaults #2 and #3.

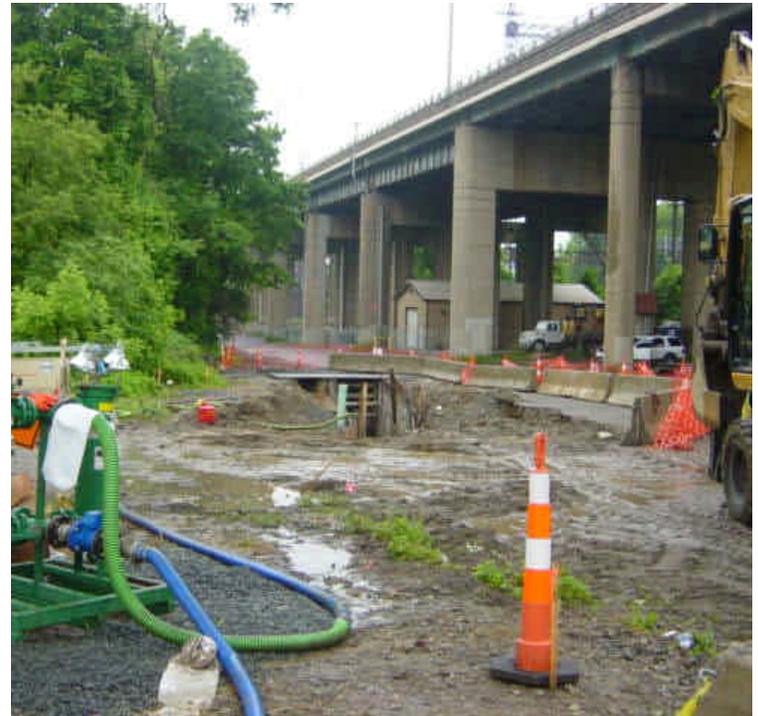
<p>Dewatering</p>	<p>Dewatering was ongoing in the excavation near sta. #1020 following a recent rain event. Several of the frac tanks have been removed from the area and were cleaned and emptied at the Shelland Street Yard.</p>	<p>None. Continue to ensure dewatering discharge is contained appropriately and filtered as per the D&M plan. 6/6/08</p>	<p>Dewatering being performed with measures in place.</p>

Trenching was on hold near sta. #1020 due to the recent rain event. The trench was being dewatered at the time of the inspection.
