Docket No. 272 – Development and Management Plan Inspection

Segment 3 Underground Line

Date: July 25, 2008

Location: East Devon Substation to the Housatonic River Crossing

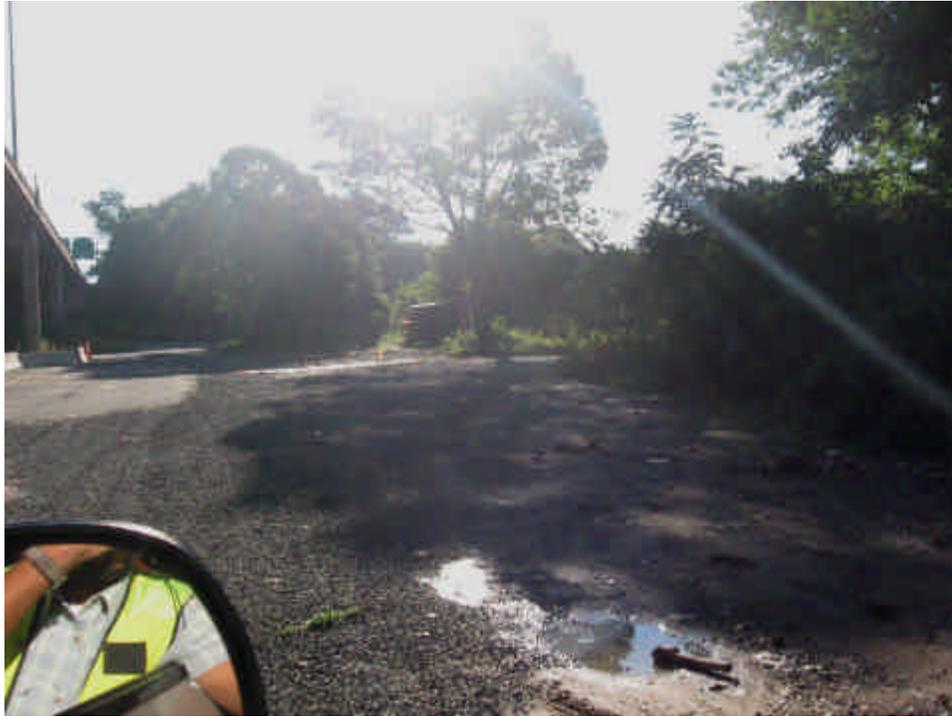
| Areas of Inspection | Observation | Recommended Action | Corrected Action |
|---|---|--|---|
| | <p>Hay bales have been removed from along the bank of the Housatonic River near sta. #1015 and along portions of the edge of the work zone near sta. #1015-1020. Excavation work is complete and the area is stable but the surface is waiting to be paved (portions since 6/6), leaving some potential for run-off. 7/25/08</p> | <p>Continue to monitor the area for run-off and erosion until work is complete and the area has been permanently stabilized. Install new controls if conditions change. 6/6/08-7/25/08</p> | <p>Continue to monitor.</p> |

Hay bales have been removed from along the bank of the Housatonic River near sta. #1015 and along portions of the edge of the work zone near sta. #1015-1020. Excavation work is complete and the majority of the area is stable. Areas without stone surfacing or vegetation still have the potential to run-off.

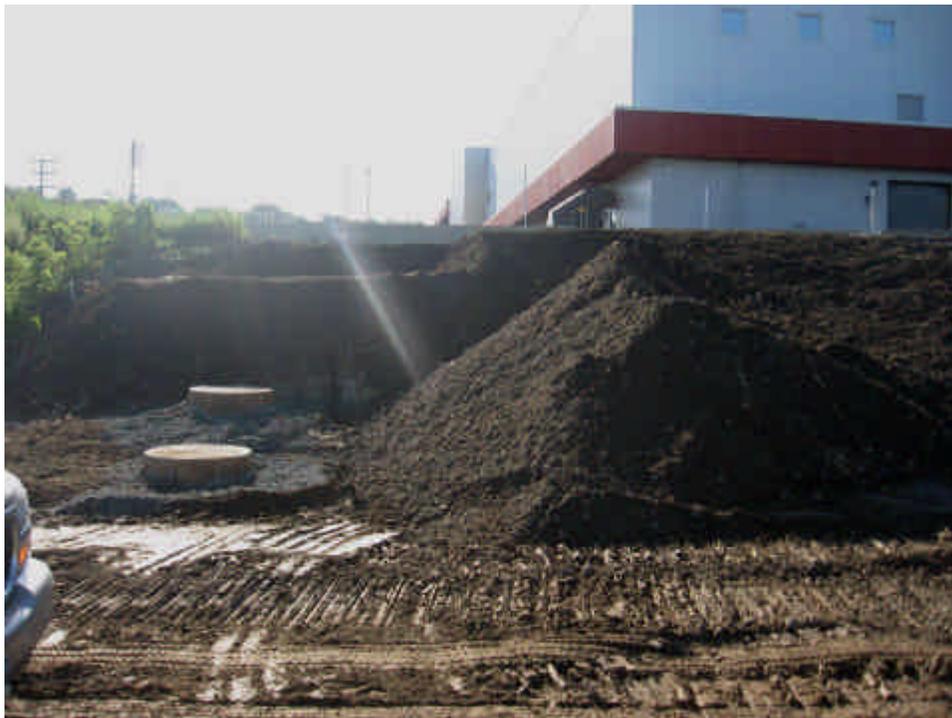
| Areas of Inspection | Observation | Recommended Action | Corrected Action |
|---|---|--|---|
| | <p>The slope near sta. #1080 is currently being regraded as part of the final restoration plan. 7/25/08</p> | <p>Continue to monitor and provide vegetative cover as soon as possible. See vegetative clearing section for more details. 7/25/08</p> | <p>Continue to monitor.</p> |

The slope near sta. #1080 was being re-graded at the time of the inspection as part of the final restoration.
