**Docket No. 272 – Development and Management Plan Inspection**

**Segment 3 Underground Line**

**Date:** August 14, 2008

**Location:** East Devon Substation to the Housatonic River Crossing

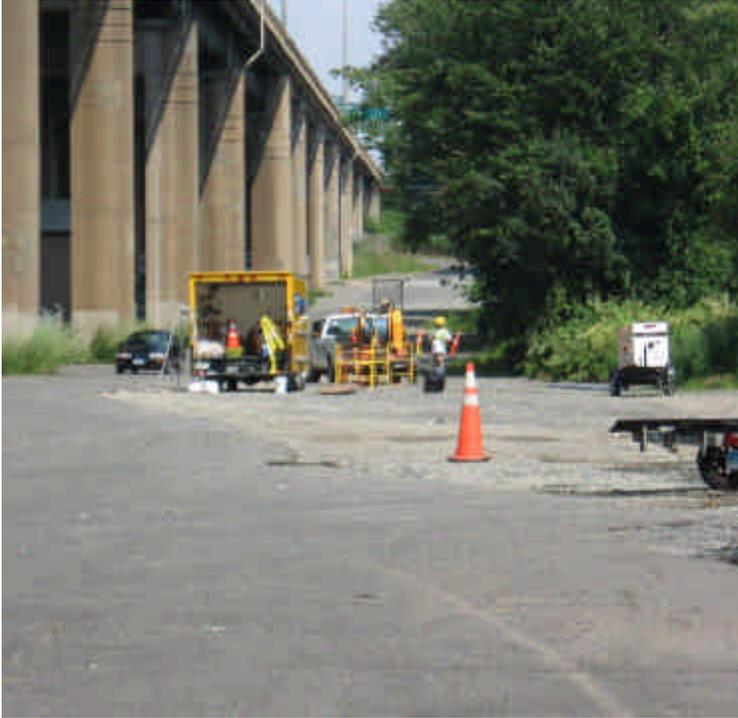
**Electrical contractor was on site at vault #1. The areas have been backfilled with crushed stone and are generally stable. Final restoration is on-hold pending a planned DOT drainage project.**

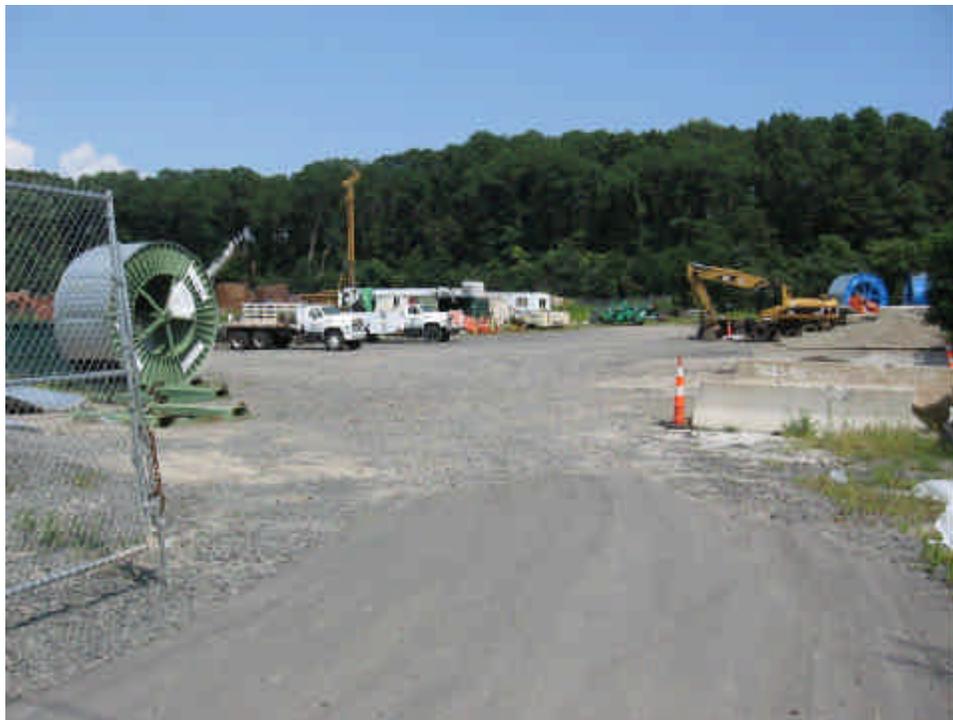
**A contractor lay-down yard is located in Milford off of Shelland St. Stone is in place throughout the yard to reduce mud and subsequent tracking**
