Docket No. 272 – Development and Management Plan Inspection

Segment 3 Underground Line

Date: August 29, 2008

Location: East Devon Substation to the Housatonic River Crossing

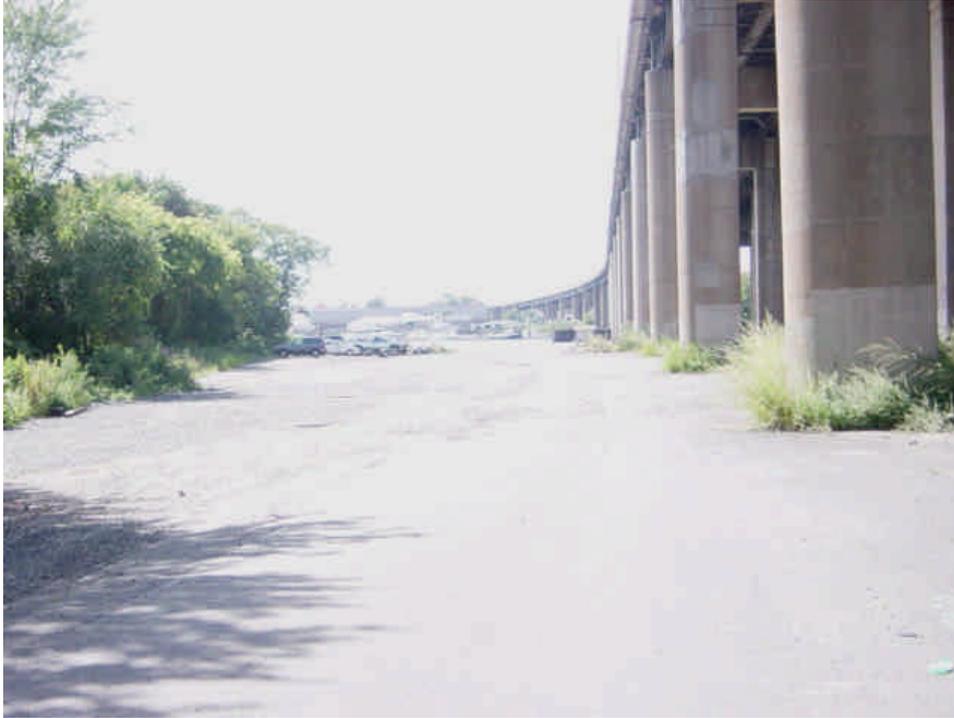
The area near sta. #15-20 has been backfilled with crushed stone and is generally stable. Final restoration is on-hold pending a planned DOT drainage project.
